HOT TOPIC REPORT OF
BOTTOM HEADER DEFECTED
,YGN PLANT 5 IN 2003

KOREA HYDRO AND
NUCLEAR POWER COMPANY

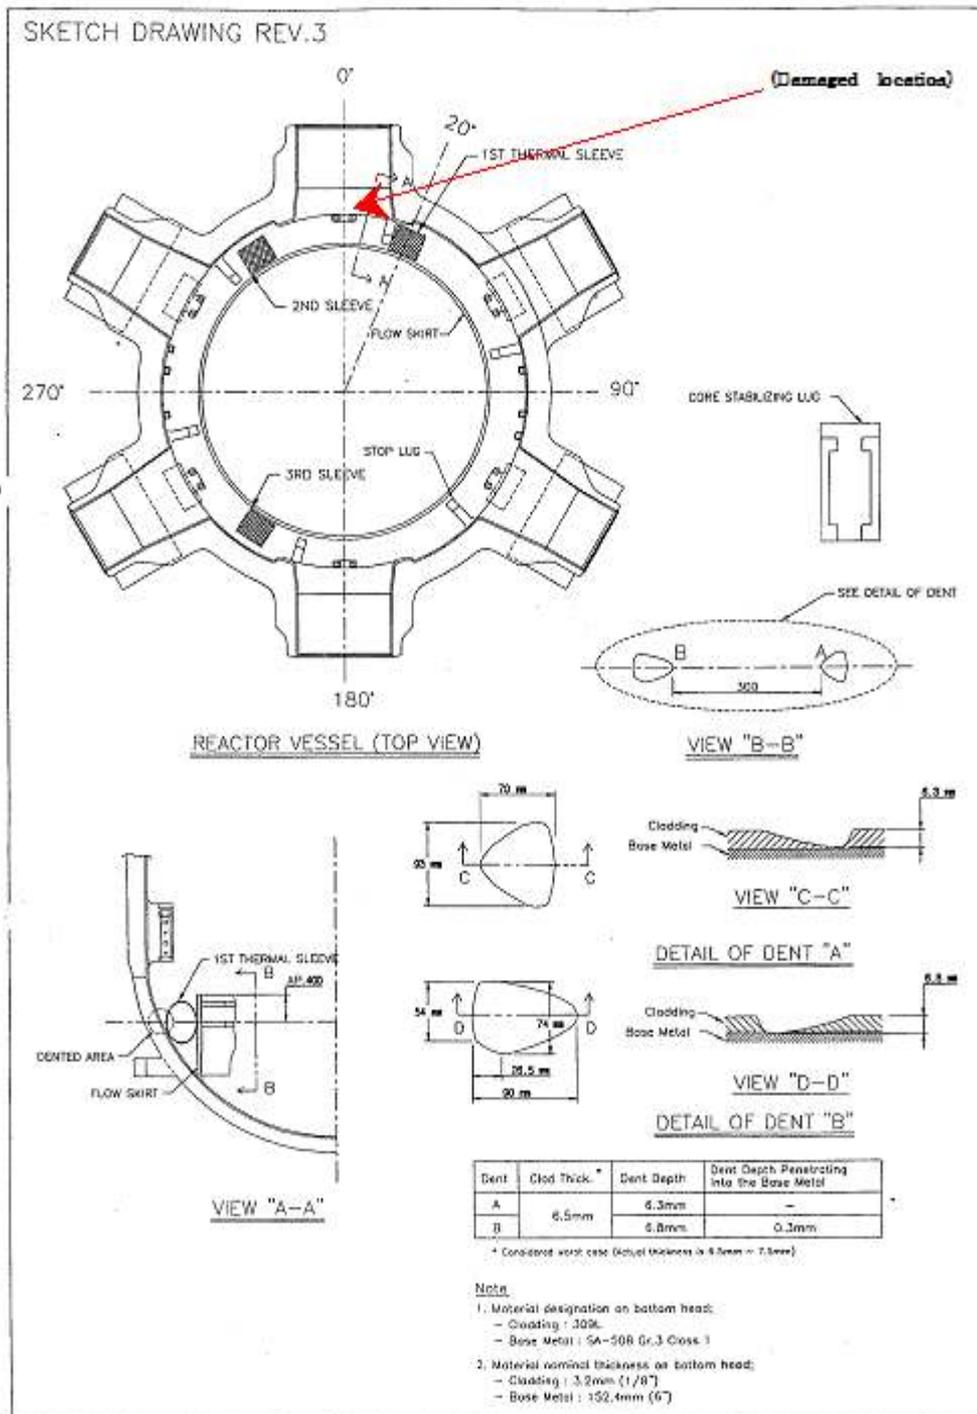
[Picture 2] The location of internal cladding defected at Rx Vessel

The One among these thermal sleeves was located at the Bottom of Rx Vessel, occurring impact against the surface of Bottom Header and damaged two location against the surface of Rx Bottom. Fortunately There is no problem in process of safety operation according to the result of test which associated with Rx vessel integrity in consideration of the long term safety operation during the periods of design life time.

1) Location of Bottom Header Defected

Two locations to the side of the lower flow skirt within a radius of 2° and 347° angle at Rx Vessel

2) The size of Bottom Header defected [Refer to picture 2]

Location of Defect	Size of Defect(mm)			Remarks
	Length	Width	Maximum Depth	
# A	70	93	6.3	-
# B	90	74	6.8	-

The bottom Header defected will be conducted in accordance with the sealing welding under water and NDE procedure equipped with attaching seal plate after processing smoothly with Ring shaped

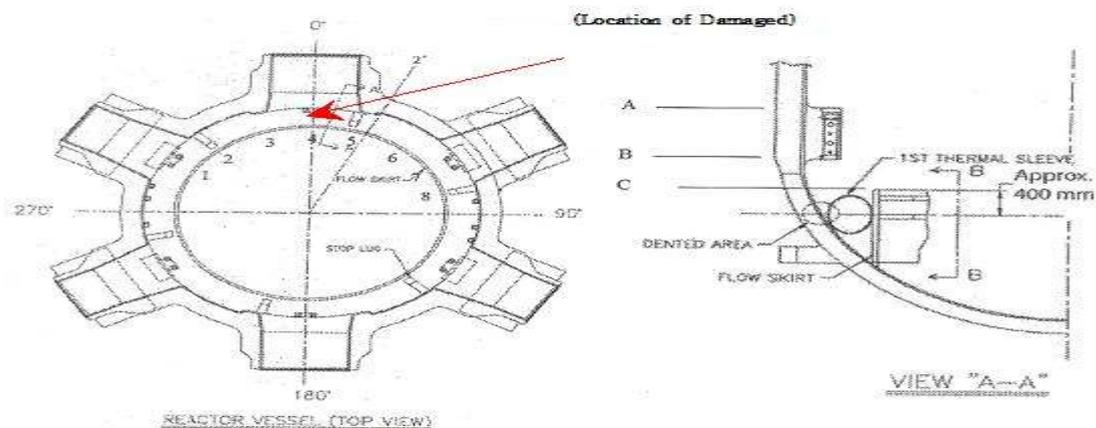
[Picture 4)] Location of Bottom head defected

Survey Location	A				B			C		
	Contact	Distance 30 cm	Distance 60 cm	Upper stabilizing lug	Contact	Distance 30 cm	Distance 60 cm	Contact	Distance 30 cm	Distance 60 cm
1(300°)	1,630	80	6	1,630	100	50	4	20	15	2
2	100	-	-	-	100	-	-	20	-	-
3	200	-	-	-	100	-	-	20	-	-
4(0°)	1,890	70	5	1,902	200	40	5	20	15	2
5	200	-	-	-	70	-	-	20	-	-
6	120	-	-	-	10	-	-	20	-	-
7(60°)	1,160	-	-	1,160	100	-	-	20	-	-
8	200	70	5	-	50	30	2	20	3	5

The Location of maximum radiation dose rate exists within radius of the 0° angle from core stabilizing and within the range of bottom head damaged which affects chiefly as the main radioactive source term.

It seemed probably that core stabilizing lug had been more activated with radioactive source term than others of why it located within the least range from the fuel assembly.

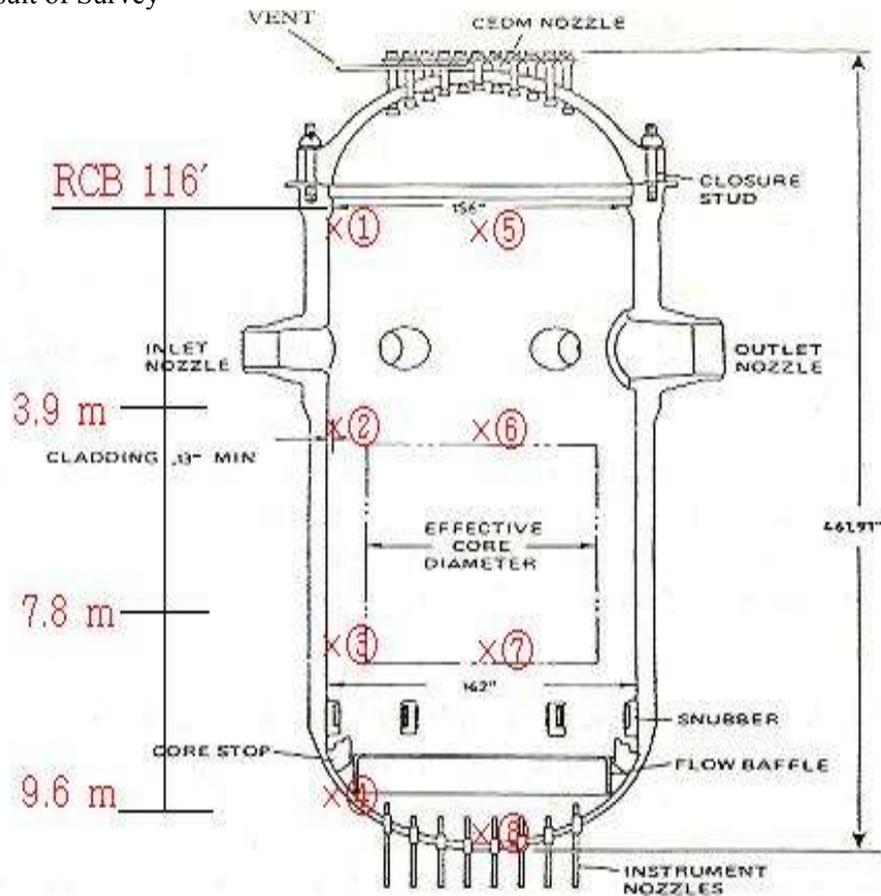
[Picture 7]) Survey points of Vessel

Section	TLD	ADR	Hi-Hi teletector	Section	TLD	ADR	Hi-Hi teletector
①	5	5	0.2	⑤	0	0	0
②	1	1	3	⑥	0	0	0
③	206	165	275	⑦	0	0	0
④	62	64	238	⑧	5	5	1
