# **HOT TOPIC REPORT OF BOTTOM HEADER DEFECTD, YGN 5 IN 2003**

**KOREA HYDRO AND NUCLEAR  
POWER COMPANY**

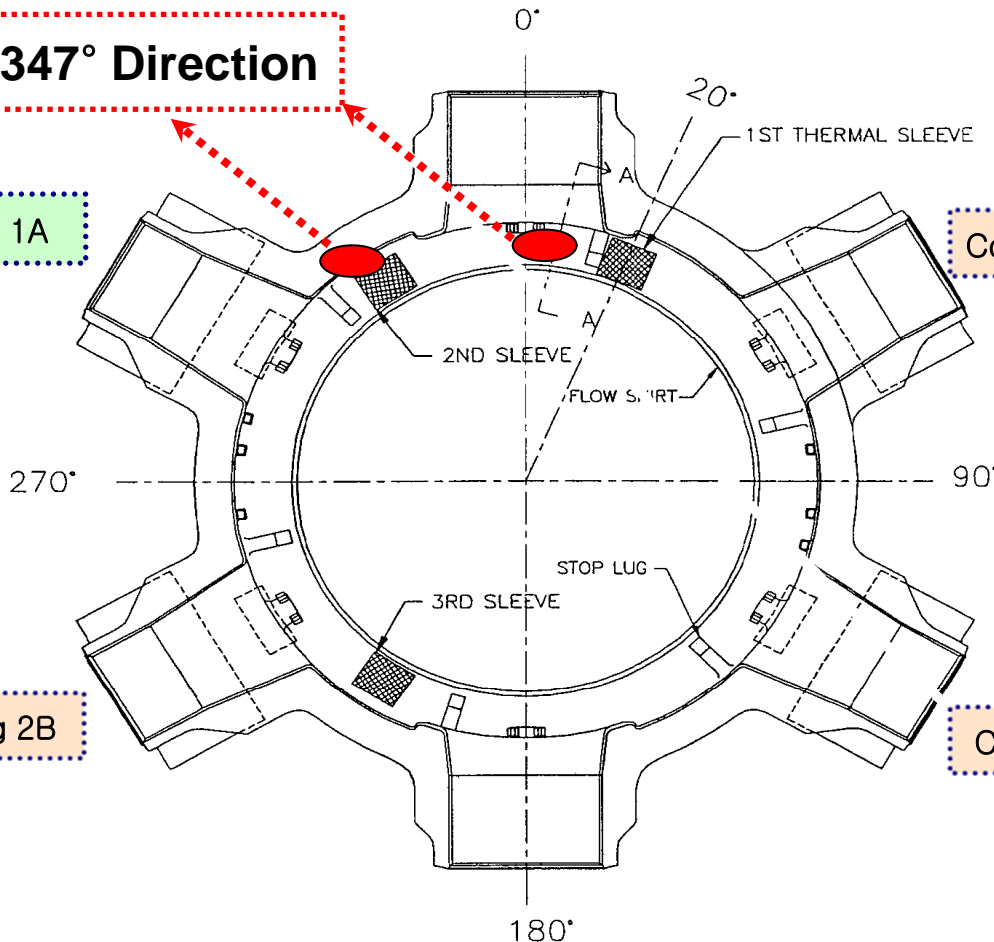
REACTOR VESSEL (TOP VIEW)

**Damaged two location at the surface of RX Bottom**

# Location of Bottom Head Defected

2° and 347° Direction

Cold Leg 1A

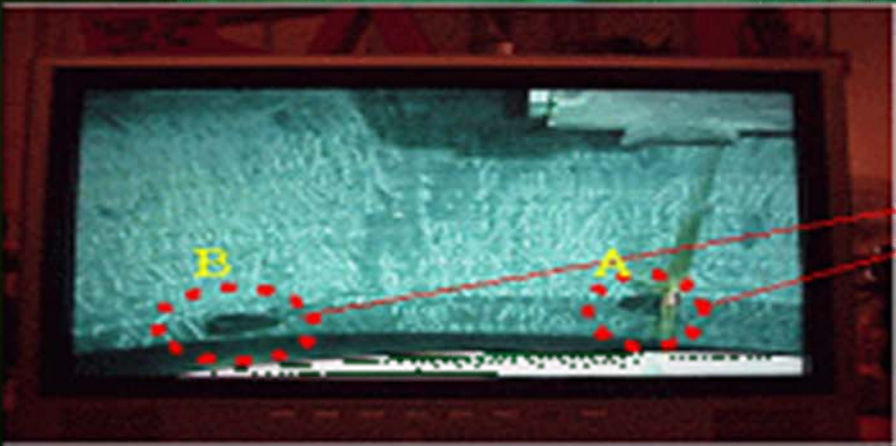
Location of Defected

Location Of Defect	Size of Defect (unit : mm )			Remark
	Length	Width	Maximum Depth	
# A	70	93	6.3	
# B	90	74	6.8

# The Photography for Bottom Head Defected

**The bottom Header defected will be conducted in accordance with the sealing welding under water and NDE procedure equipped with attaching seal plate after performing smoothly with Ring shaped**

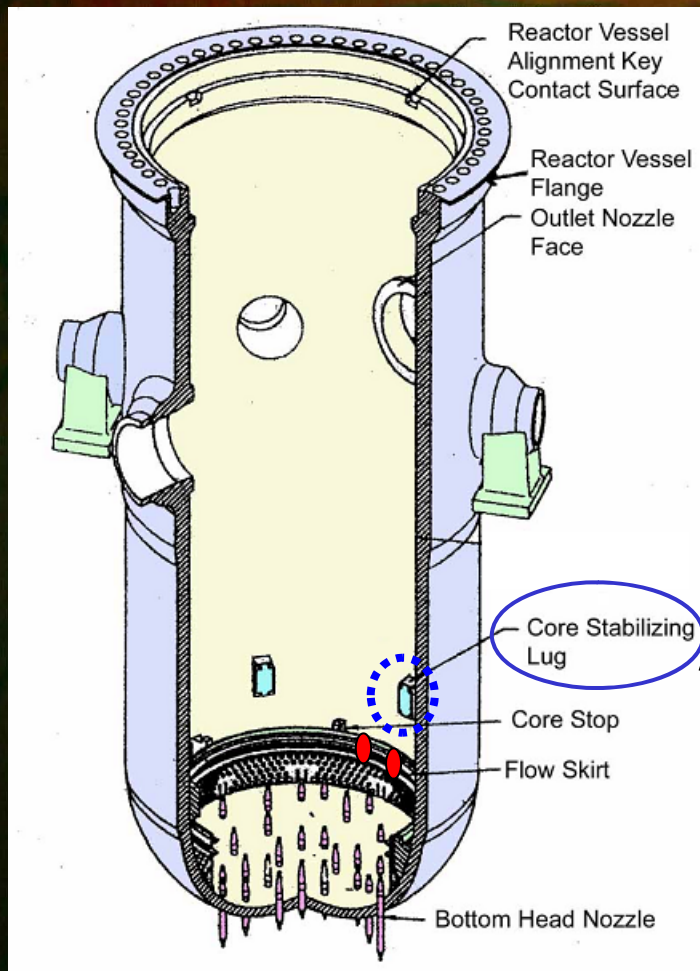
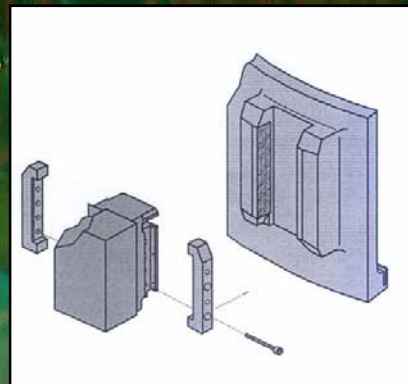
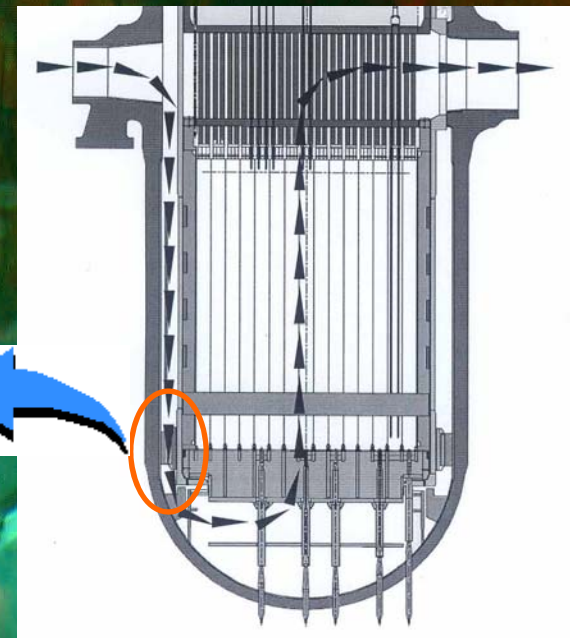
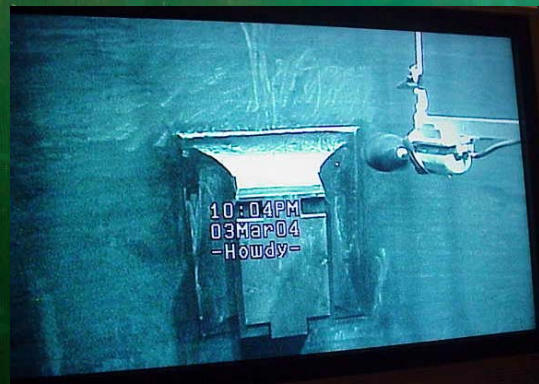
# Location of Bottom Header Defected

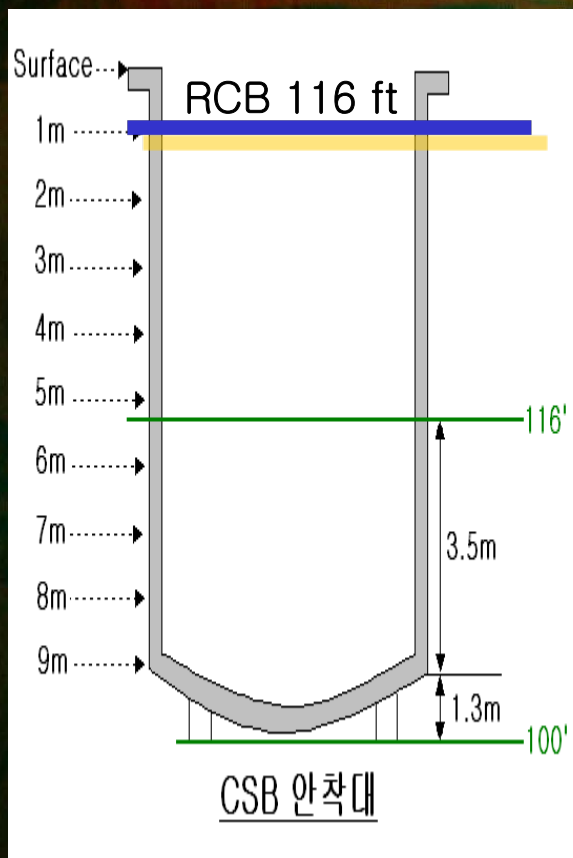
# Radiation Dose at RX Bottom Head Defected

Location	Inside wall					Outside wall				
	1st	2nd	3rd	TLD	ADR	1st	2nd	3rd	TLD	ADR
Surface	2.8	2.7	3.0	4.0	4.0	8.4	3.4	1.5	3.5	5.8
1m	4.2	4.4	4.2	-	-	1.3	1.6	1.1	-	-
1.9m	4.9	5.1	4.7	2.4	2.6	1.3	1.3	1.3	1.0	0.9
3m	5.1	4.3	5.2	-	-	3.0	2.8	2.1	-	-
3.9m	15.8	23.4	9.0	16.9	1.52	4.0	3.6	2.2	1.8	1.8
5m	44 Sv/hr	38 Sv/hr	89 Sv/hr	-	-	1,520	1,627	1,170	-	-
6m	5.1m - 120Sv			-	-	6,630	6,537	5,707	-	-
7m	It's impossible to measure dose rate more than 5.1m			-	-	6,718	6,776	6,120	-	-
8m				-	-	7,442	6,947	6,500	-	-
9m				142.4 Sv/hr	70.6 Sv/hr	3,620	3,546	7,880	3.42 Sv/hr	3.49 Sv/hr
