Radiation protection aspects of a fuel handling incident at Forsmark NPP 2013

Forsmarks Kraftgrupp AB, SE-742 03 Östhammar, Sweden
ISOE European Symposium April 9-11, 2014 Bern, Switzerland

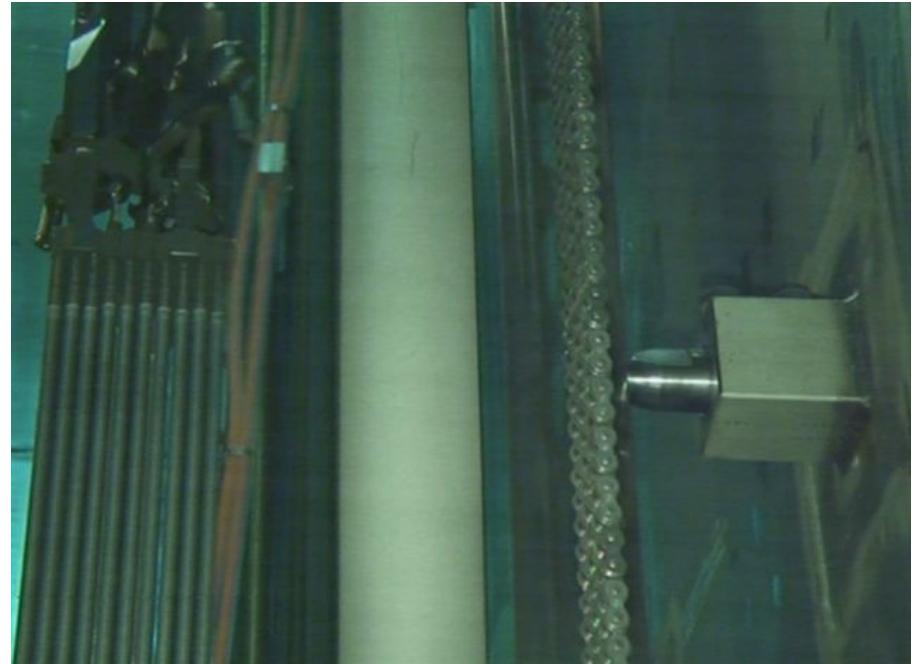
At spacer 5, the fuel bundle got stuck just before passing the upper part of the fuel box.

Efforts were made to lower the fuel bundle back into the box; but it remained stuck.

Refuelling machine holding the element.

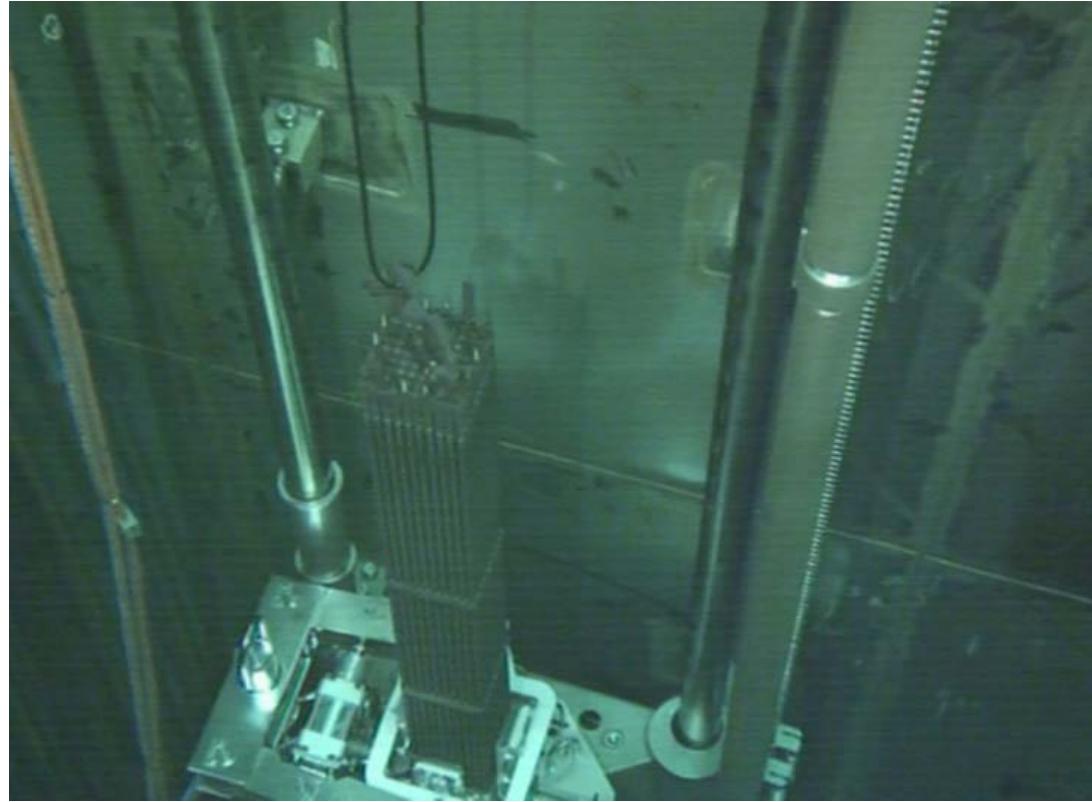
We were now in a situation with 1,3 meters fuel bundle sticking up out of the box. And it wouldn't go either up or down (except between between spacer 4 and 6)

The bundle was lowered so that spacer 6 rested on spacer 5.

A picture of the fuel bundle stuck 1,3 meter out of the box exchange equipment. (Photo is from later stage; at this time; the fuel handling machine held the element).

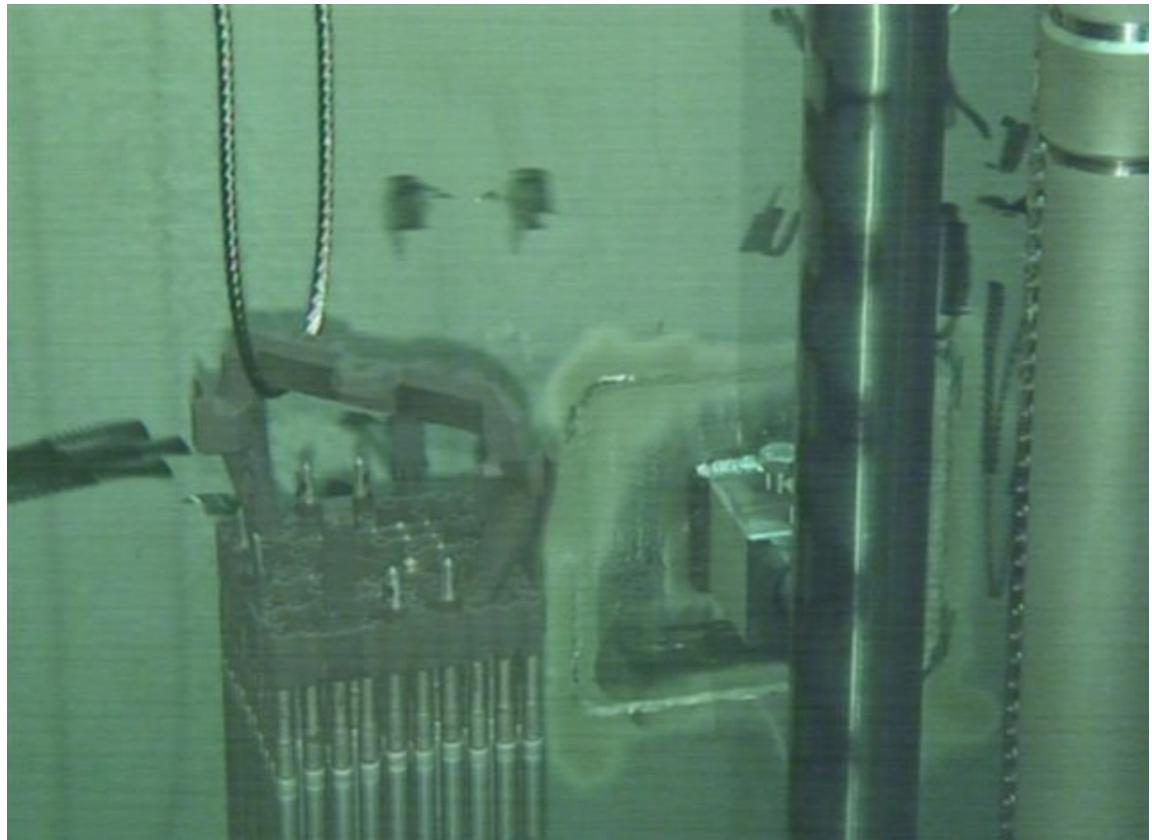
However, the bundle remained stuck.

2 weeks later a grip had been constructed and the fuel assembly was secured with a wire and released from the refueling machine.

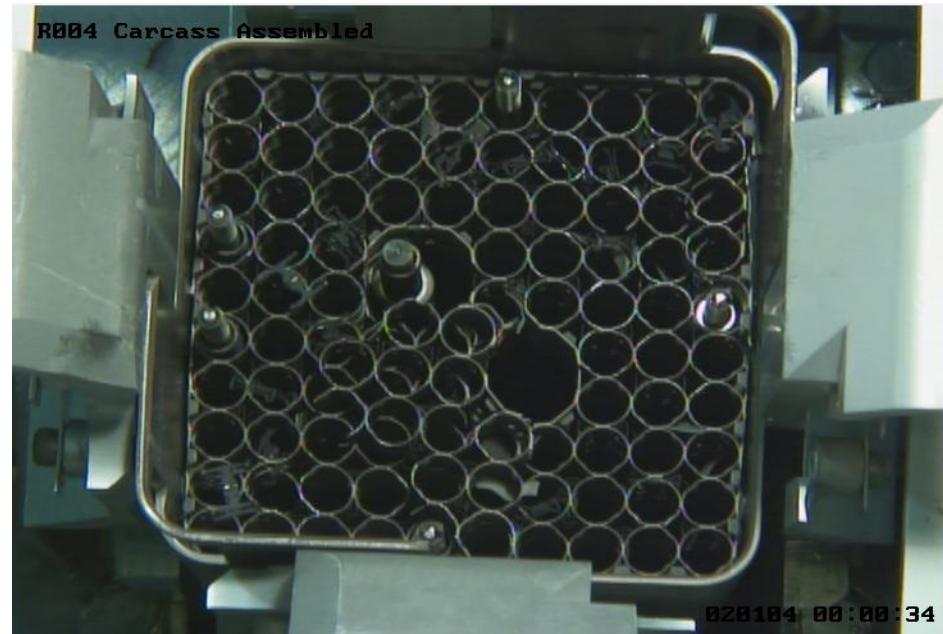
However one spacer on the fuel element was badly damaged.

3 fuel rods remaining with 2 extra dummy rods inserted to hold the upper tie plate.

All except 3 fuel rods were removed and placed in a new box in september 2013.

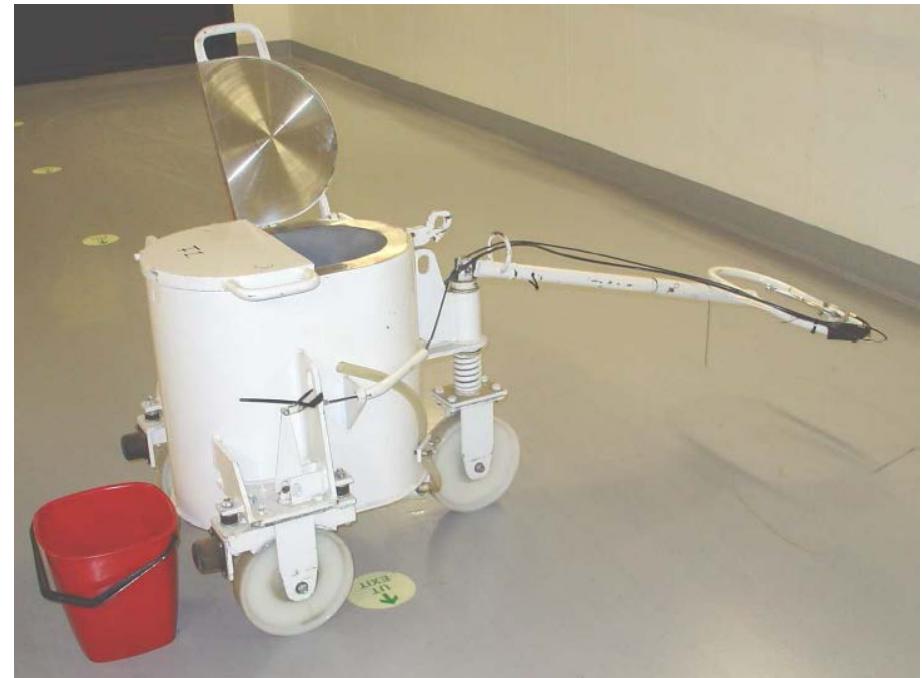
Collected debris ~3500 mSv/h, was loaded underwater in shielded container. (Mainly spacer 6, 7 and 2 water channel pieces)

5 filters from pool cleaning ~20-350 mSv/h, transported in shielded container to waste management building.
