**HOT TOPIC REPORT OF BOTTOM  
HEADER DEFECTD, YGN 5 IN 2003**

**KOREA HYDRO AND NUCLEAR  
POWER COMPANY**

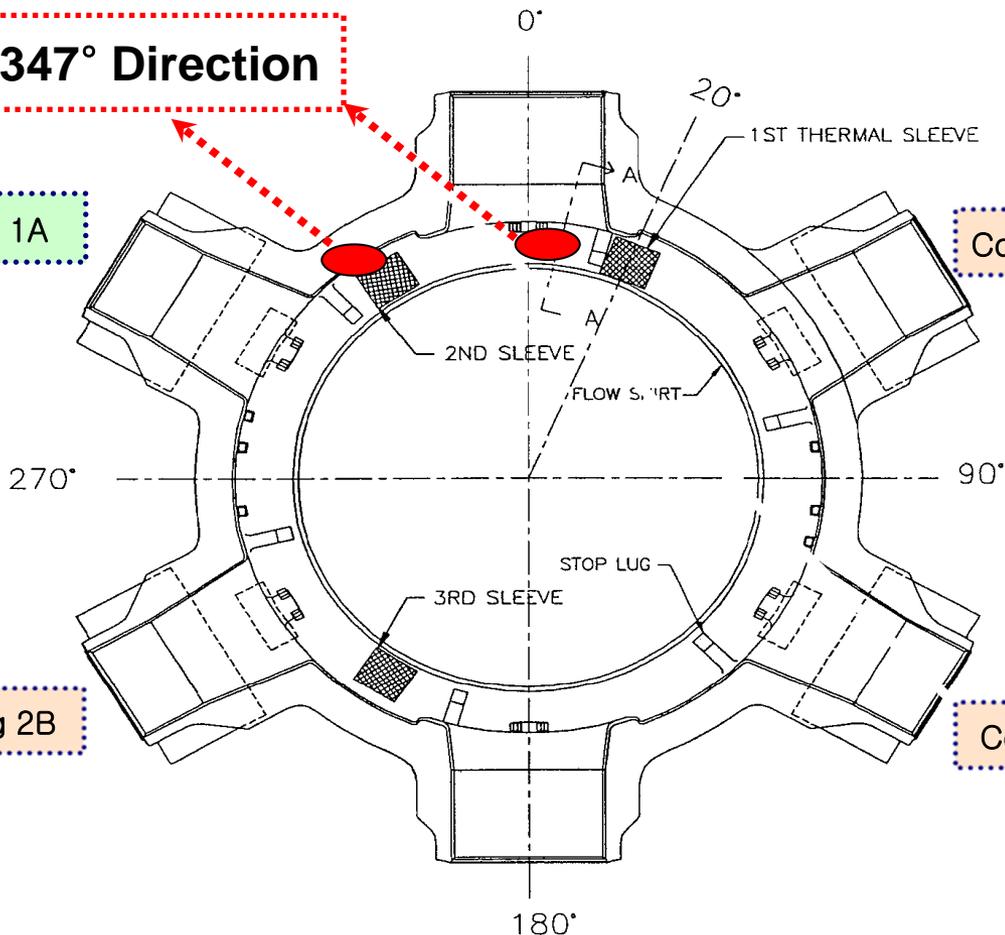
REACTOR VESSEL (TOP VIEW)

2° and 347° Direction

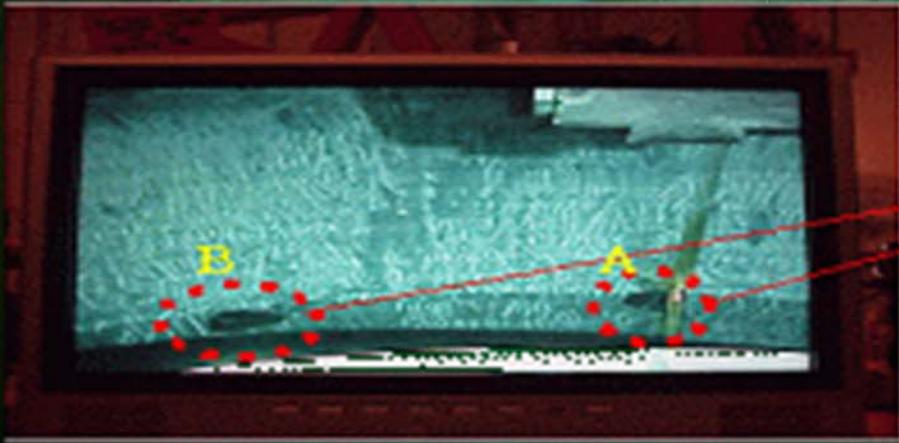
# The Photography for Bottom Head Defected

**Damaged two location at the surface of RX Bottom**

Location Of Defect	Size of Defect (unit : mm )			Remark
	Length	Width	Maximum Depth	
# A	70	93	6.3	
# B	90	74	6.8

**The bottom Header defected will be conducted in accordance with the sealing welding under water and NDE procedure equipped with attaching seal plate after performing smoothly with Ring shaped**

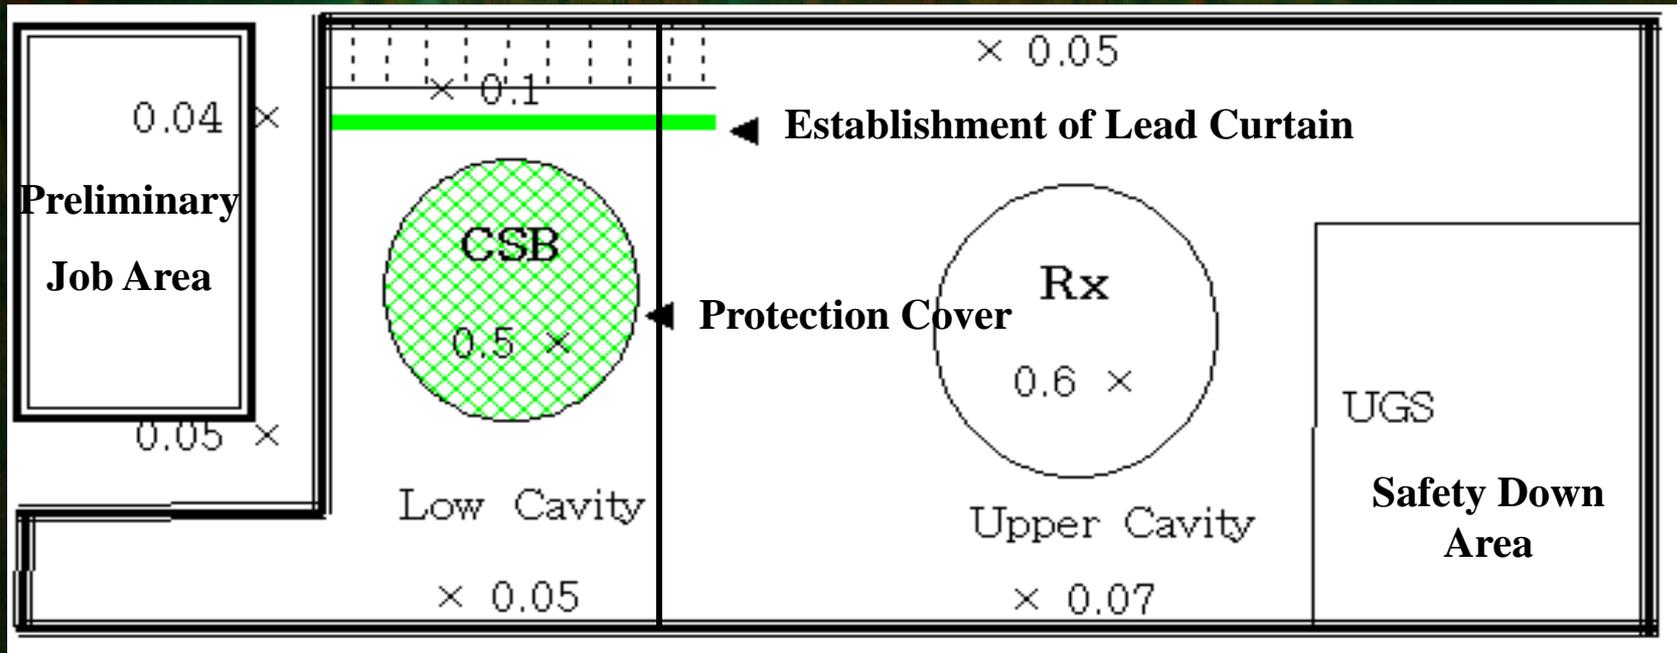
# Survey of Radiation dose Around RX Cavity

RX Cavity with Full Water (140')

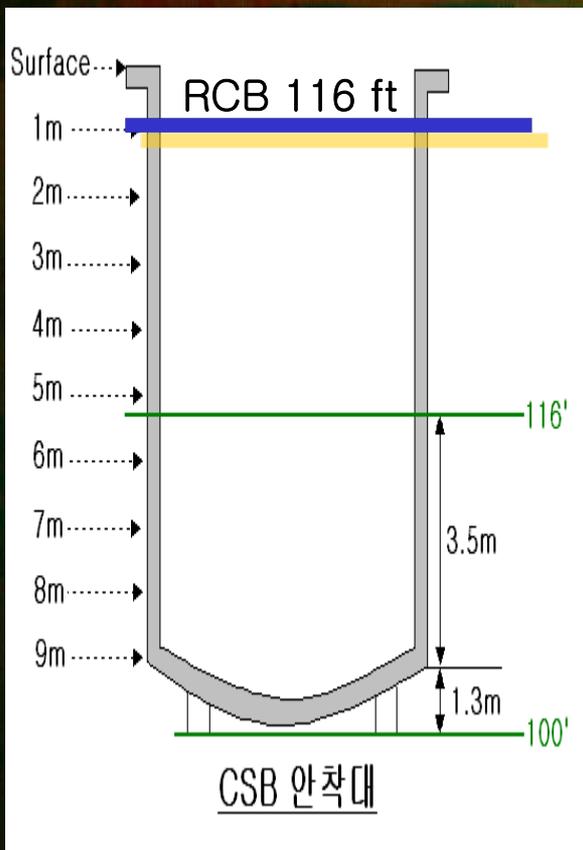
# Radiation Dose at CSB

Location	Inside wall					Outside wall				
	1st	2nd	3rd	TLD	ADR	1st	2nd	3rd	TLD	ADR
Surface	2.8	2.7	3.0	4.0	4.0	8.4	3.4	1.5	3.5	5.8
1m	4.2	4.4	4.2	-	-	1.3	1.6	1.1	-	-
1.9m	4.9	5.1	4.7	2.4	2.6	1.3	1.3	1.3	1.0	0.9
3m	5.1	4.3	5.2	-	-	3.0	2.8	2.1	-	-
3.9m	15.8	23.4	9.0	16.9	1.52	4.0	3.6	2.2	1.8	1.8
5m	44 Sv/hr	38 Sv/hr	89 Sv/hr	-	-	1,520	1,627	1,170	-	-
6m	5.1m - 120Sv			-	-	6,630	6,537	5,707	-	-
7m	It's impossible to measure dose rate more than 5.1m			-	-	6,718	6,776	6,120	-	-
8m				-	-	7,442	6,947	6,500	-	-
9m				142.4 Sv/hr	70.6 Sv/hr	3,620	3,546	7,880	3.42 Sv/hr	3.49 Sv/hr

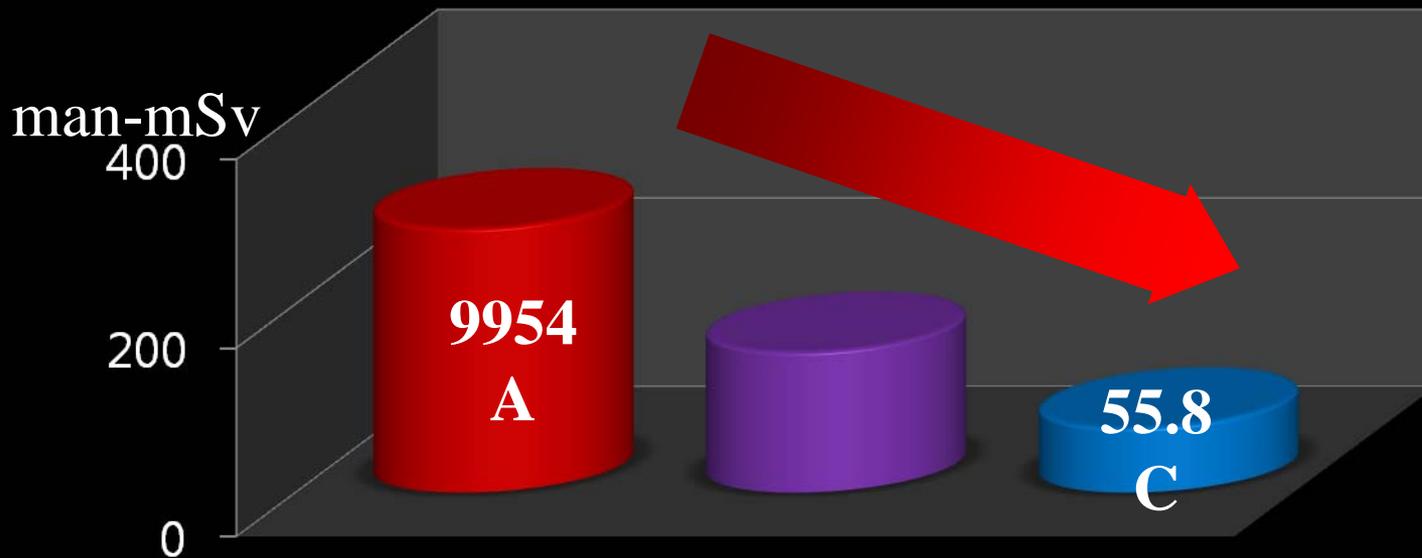
Expected Data VS Result Data

A : Expected Collective dose without shielding.

C : Actual Collective Dose with shielding.
