Steam Generator Replacement of the Belgian Doel 1 unit: follow-up and on site dosimetry

B. Walschaerts*, J. Defloor**, R. Wyckmans**

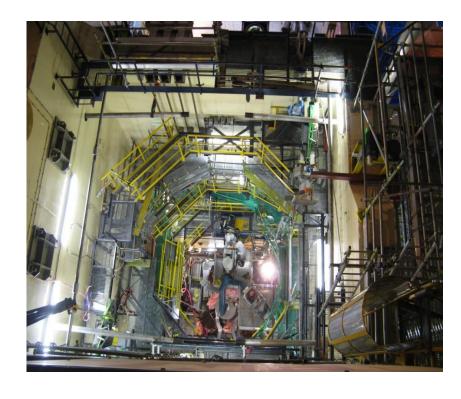
- Problem: Doel 1 built in 1975
 - SGR was not considered in the design of the plant
 - The doors of the reactor building too little
 - Handling inside the reactor building was not considered

Lift the steam generators out of their cells through the ceiling of the reactor building!

- This solution demands special ALARA care:
 - Shutdown of the reactor
 - Emptying the core
 - Temporary closure of the reactor building
 - Reactor building always in under pressure

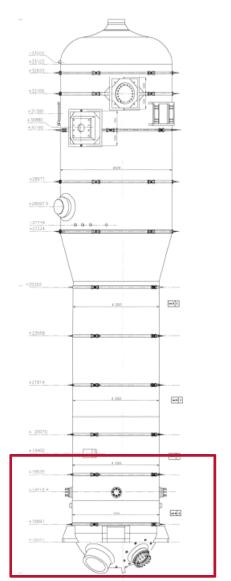
Insulation problem : possible presence of asbestos fibres

- Never done before in Belgian unit
- This specific job demands more work, more people and more time
- · Negative influence on the dose objective
