Lessons Learned from the Fukushima NPS Accidents

2012 International ISOE ALARA Symposium
Jan 9 - 11, 2012

IAEA,OECD/NEA ISOE Committee 7th Chairman

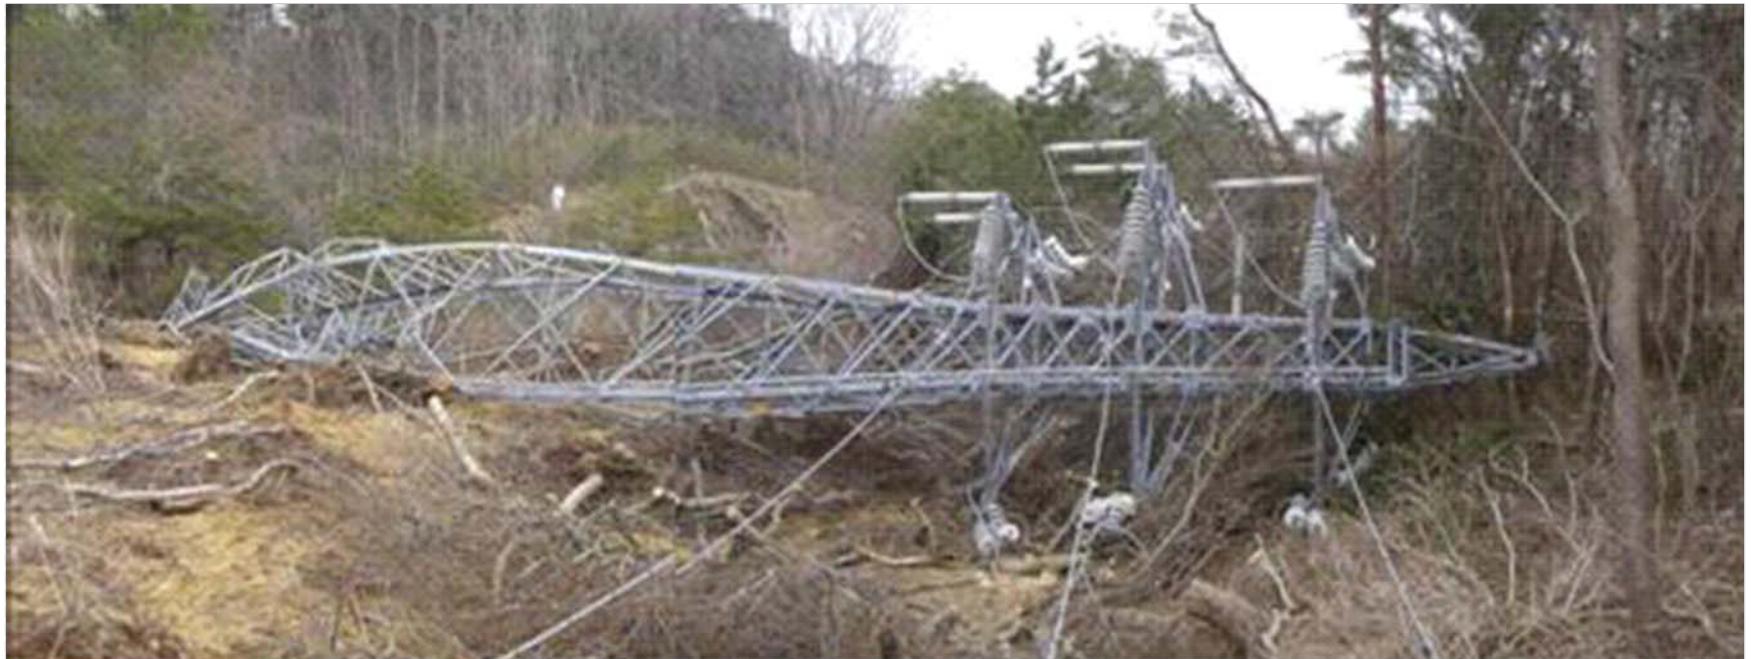
Collapsed Tower

- Damage of external power supply systems of the Fukushima Dai-ichi and Dai-ni NPSs**

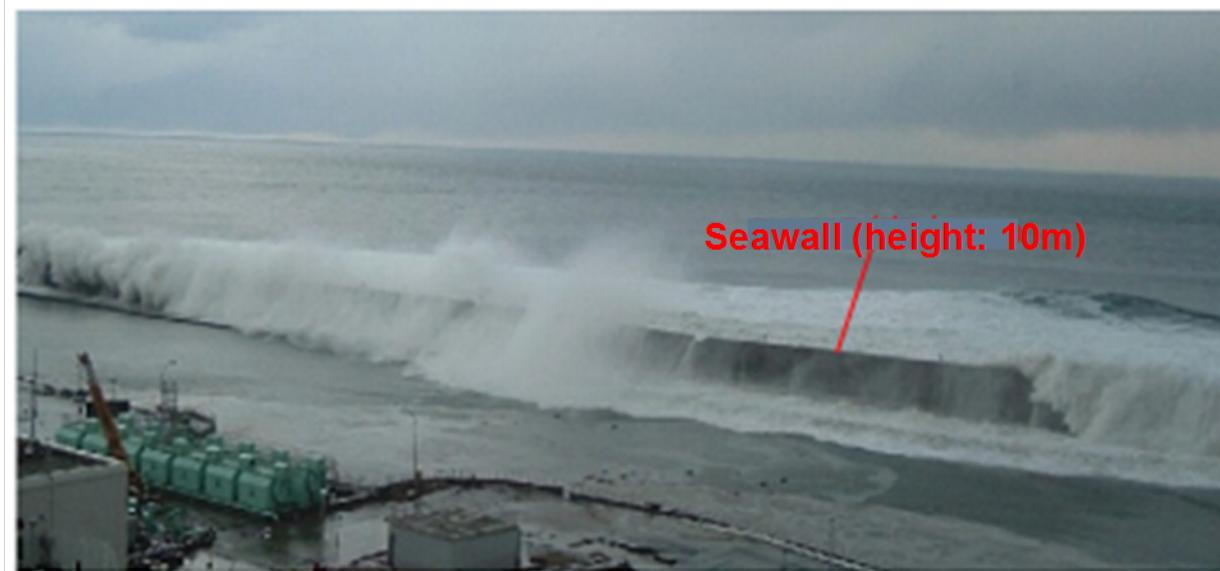
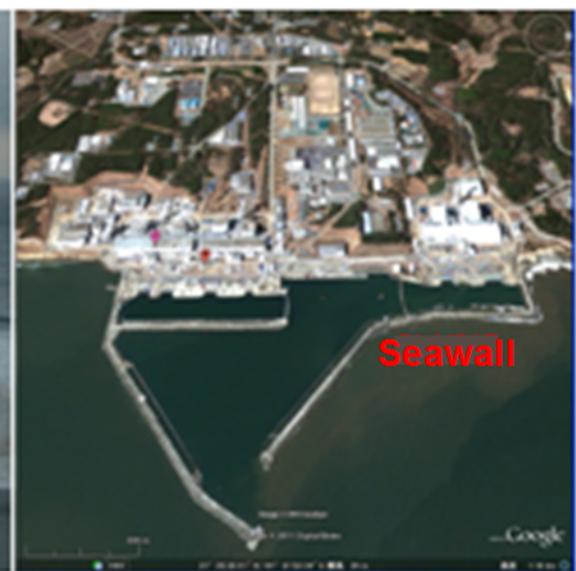
Tsunami getting over seawall

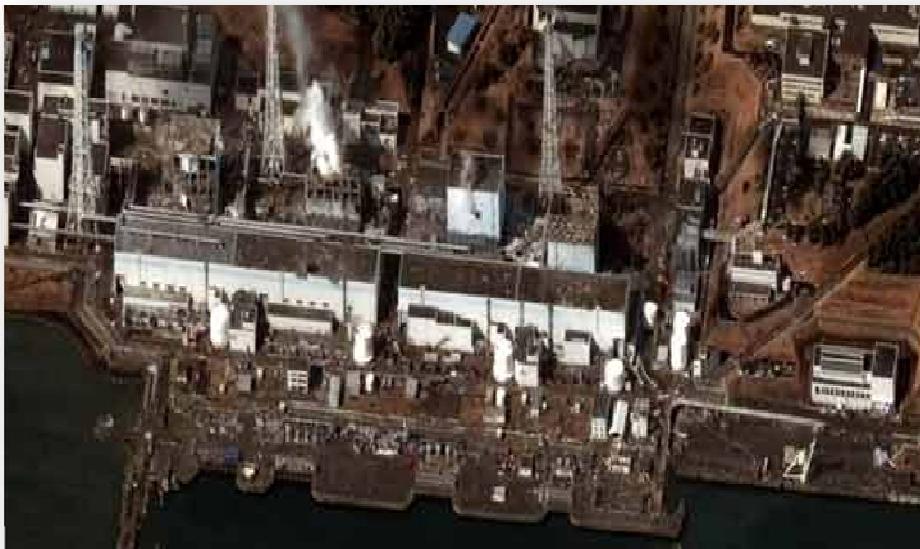
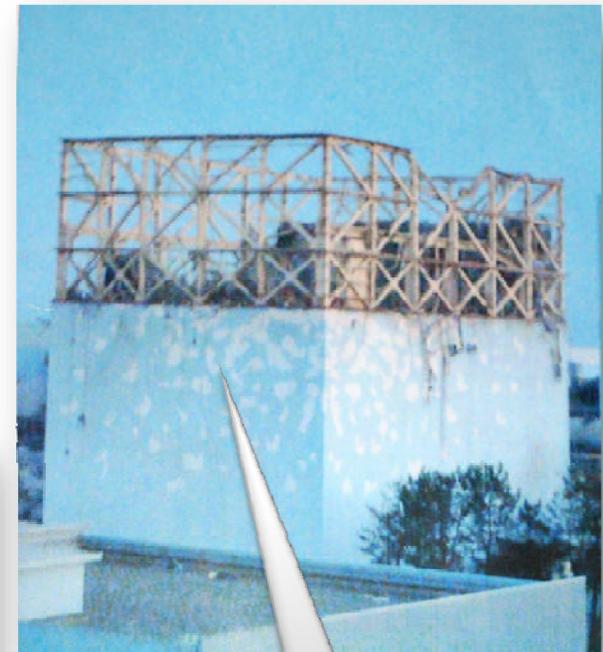
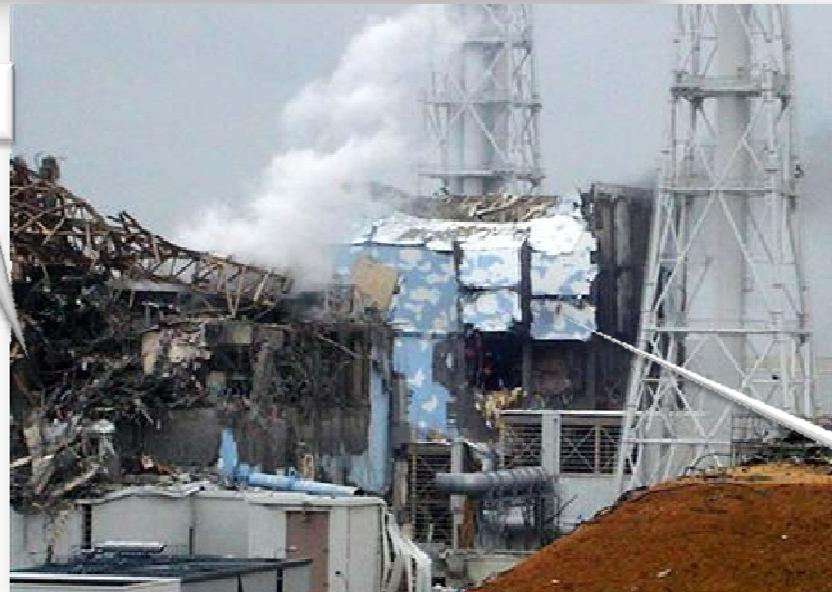
Damage of reactor buildings

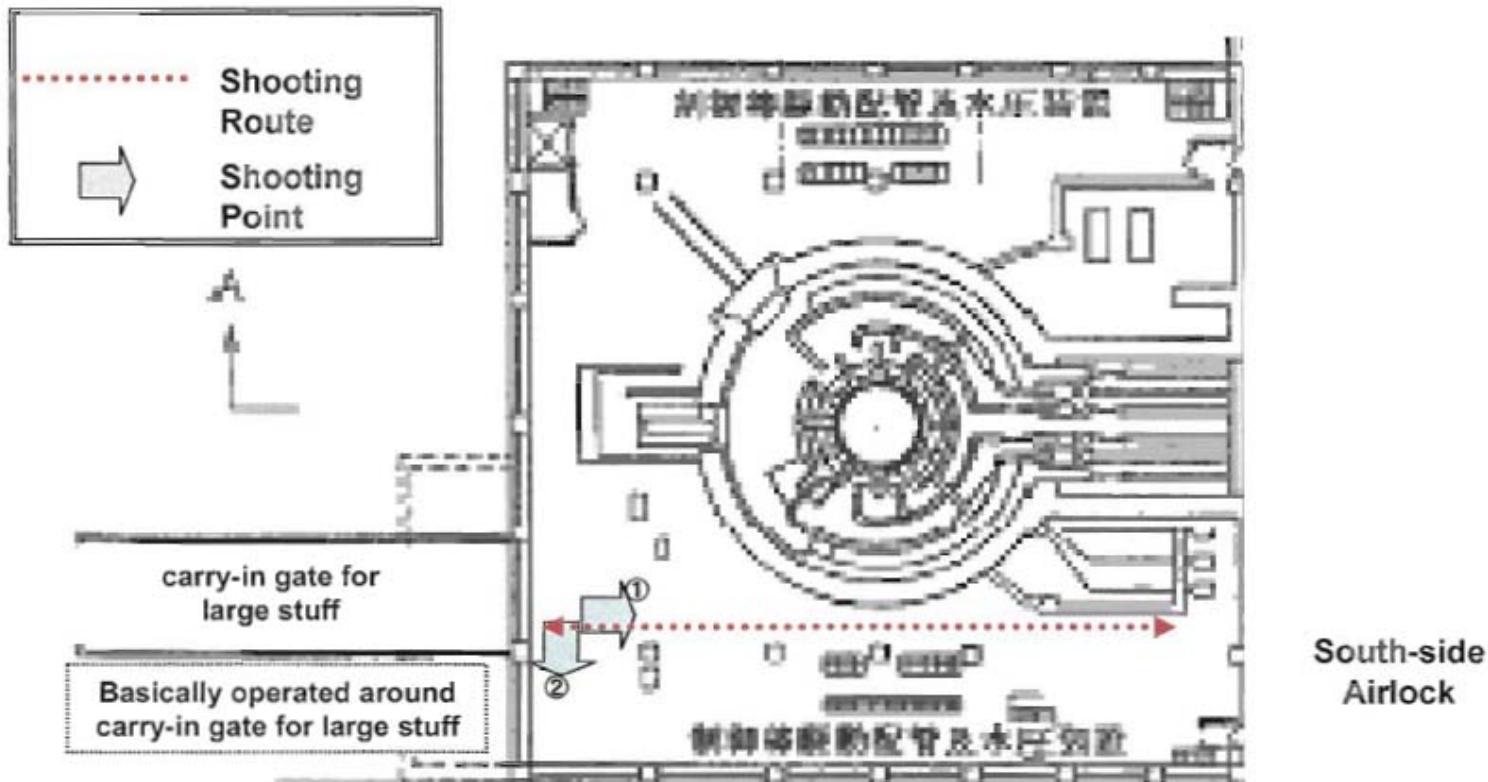
May 20th Dose-measurement Points by γ camera
in the Reactor Building of Unit 1

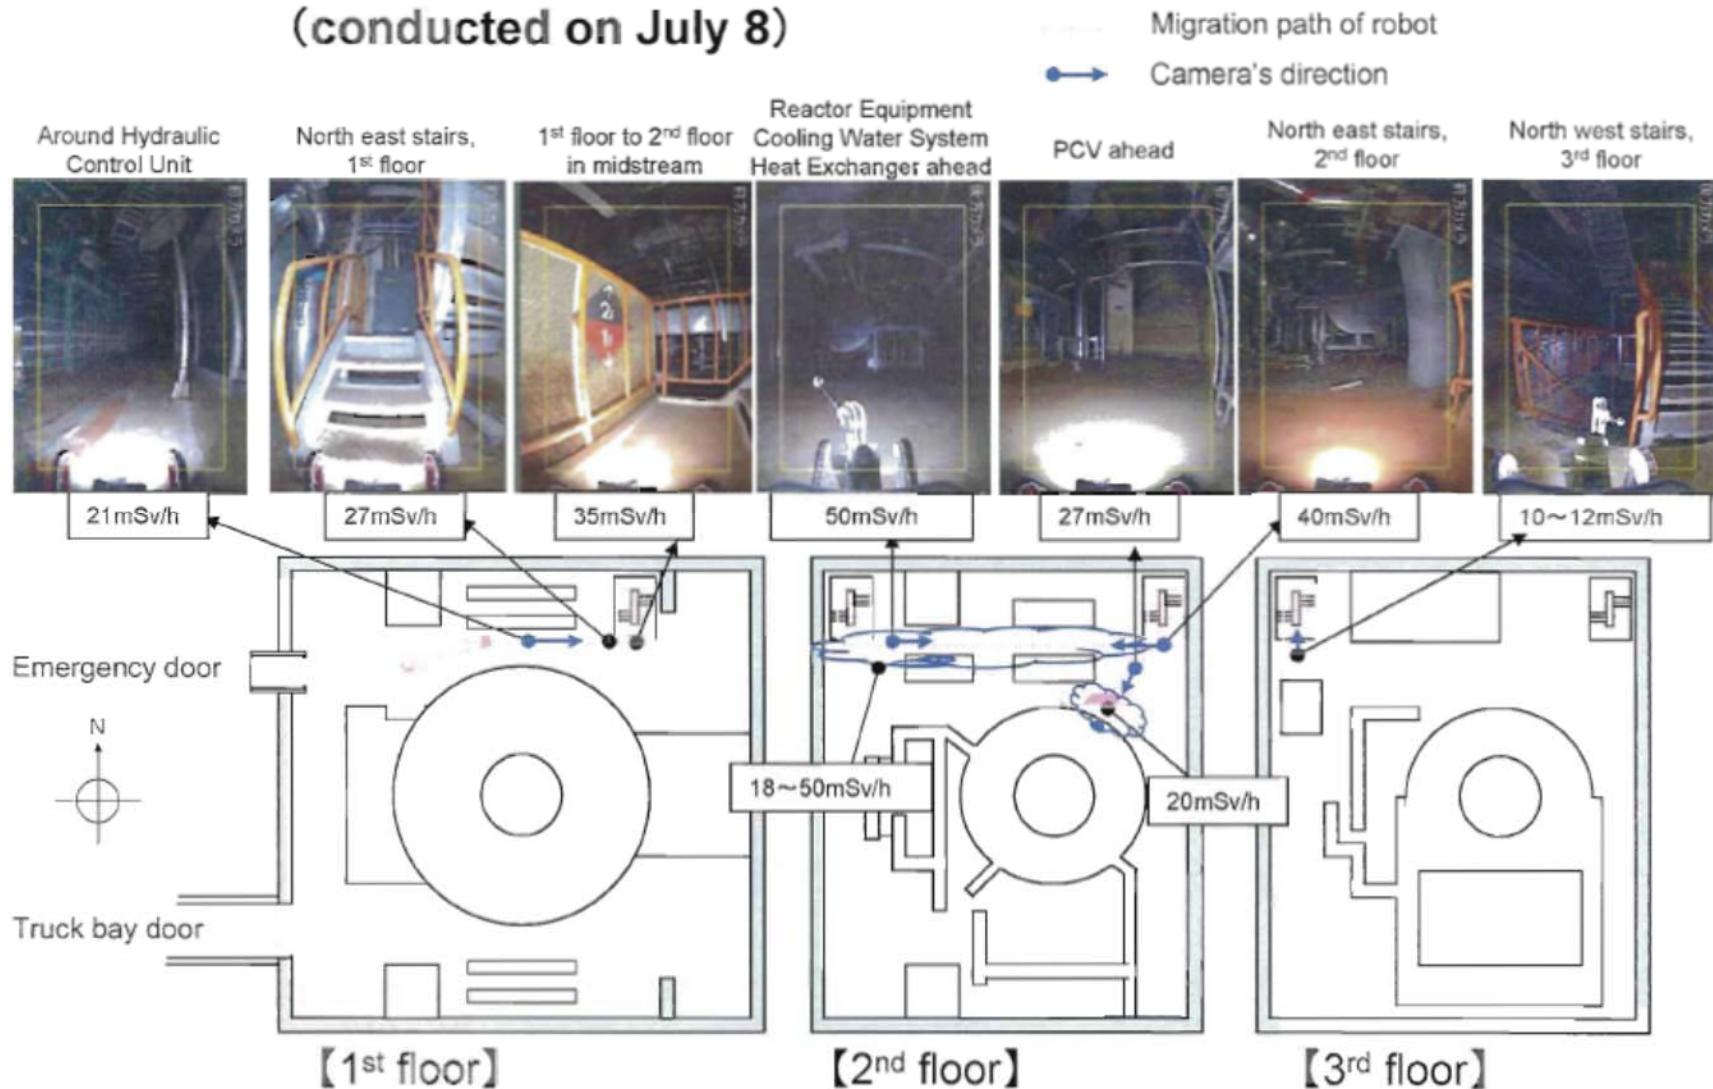
Measurement Results of Dose Rate at Unit 2 Reactor Building of Fukushima Daiichi (conducted on July 8)

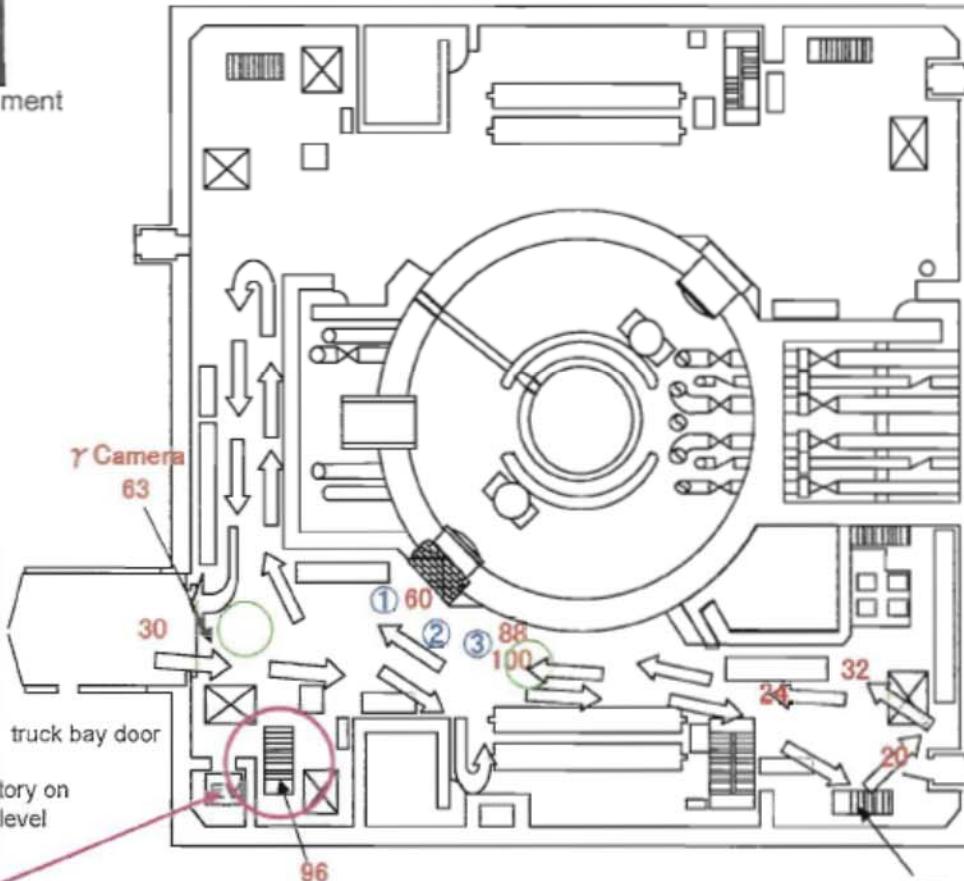
Result of radiation dose survey at reactor building of Unit 3

Date of survey : June 9, 2011 11 : 47 am ~ 0:14 pm
 Number of Workers : Total 9 (TEPCO 5, Partner Company 4)
 Dose : 5.88~7.96mSv
 Area : South side and west side of first floor, reactor building of Unit 3

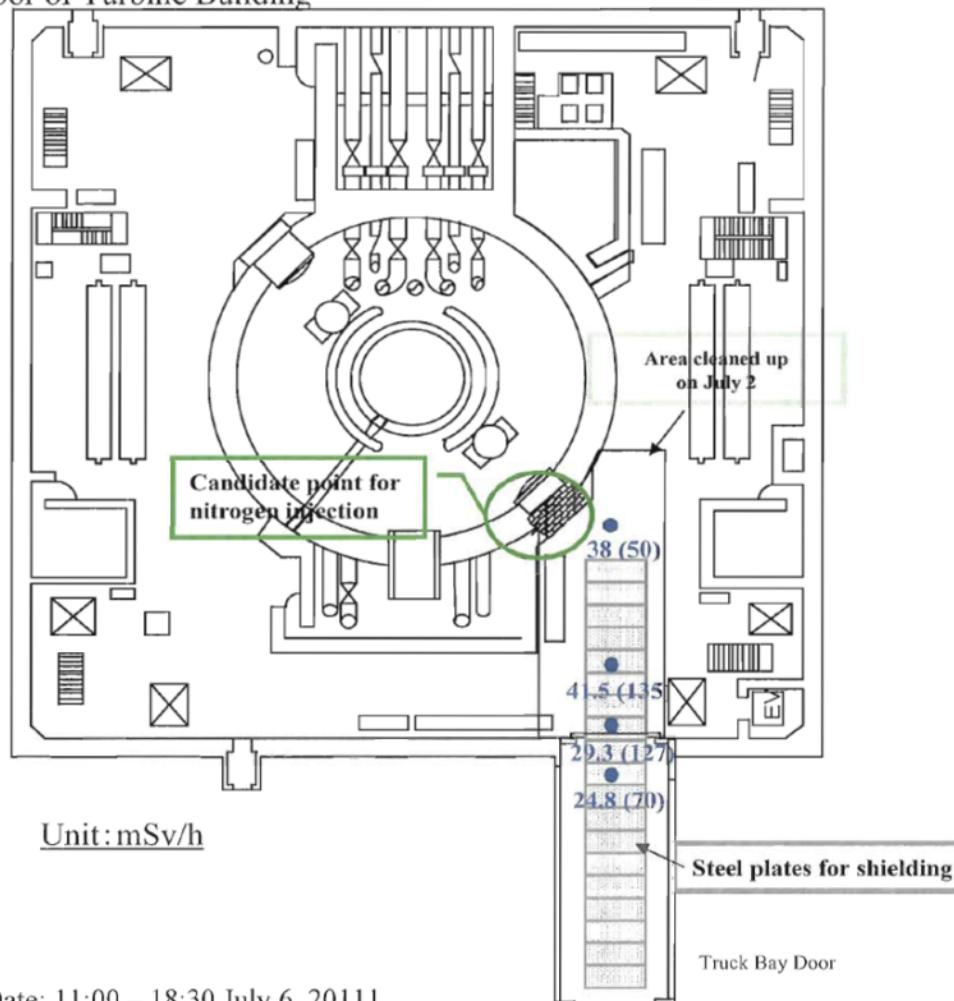
Result of radiation dose survey inside the Unit 3 Reactor Building
at Fukushima Daiichi Nuclear Power Station

Survey Date: 11:00 – 18:30 July 6, 2011

Exposure dose: 2.41mSv~6.96mSv

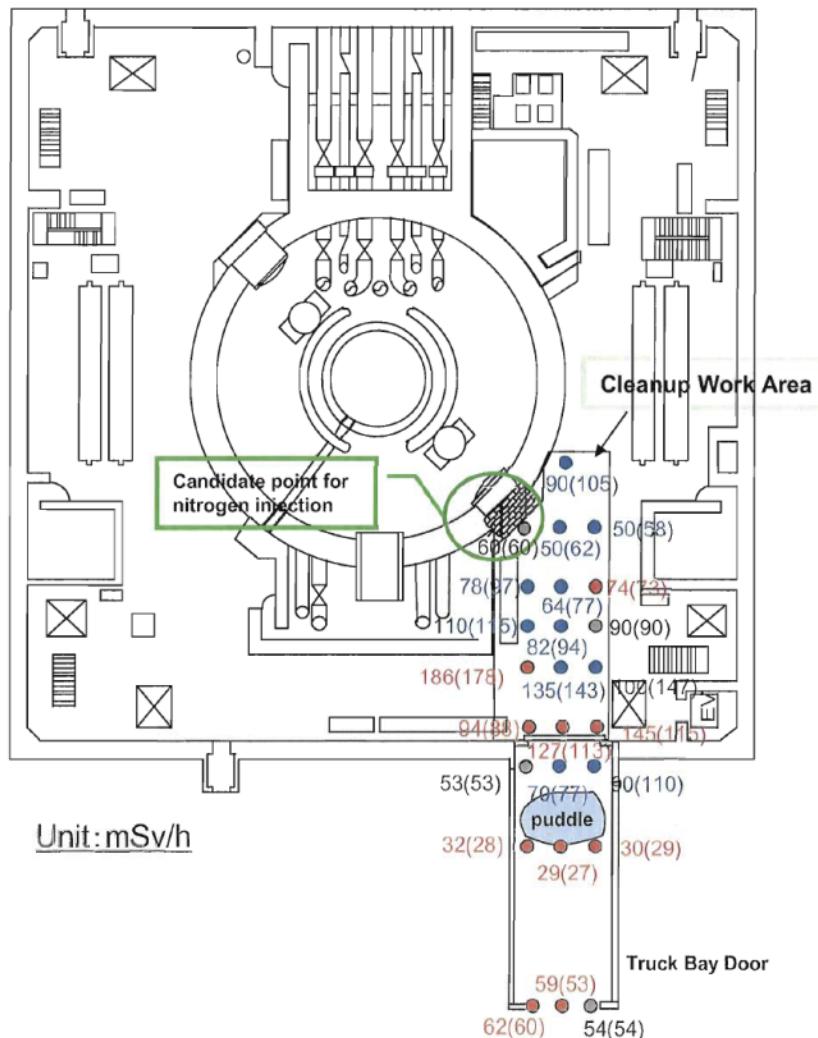
Result of radiation dose survey inside the Unit 3 reactor building
in Fukushima Daiichi Nuclear Power Station
1st Floor of reactor building

Survey Date: 10:59-12:14 on July 2, 2011

Exposure dose: 1.10mSv~1.63mSv

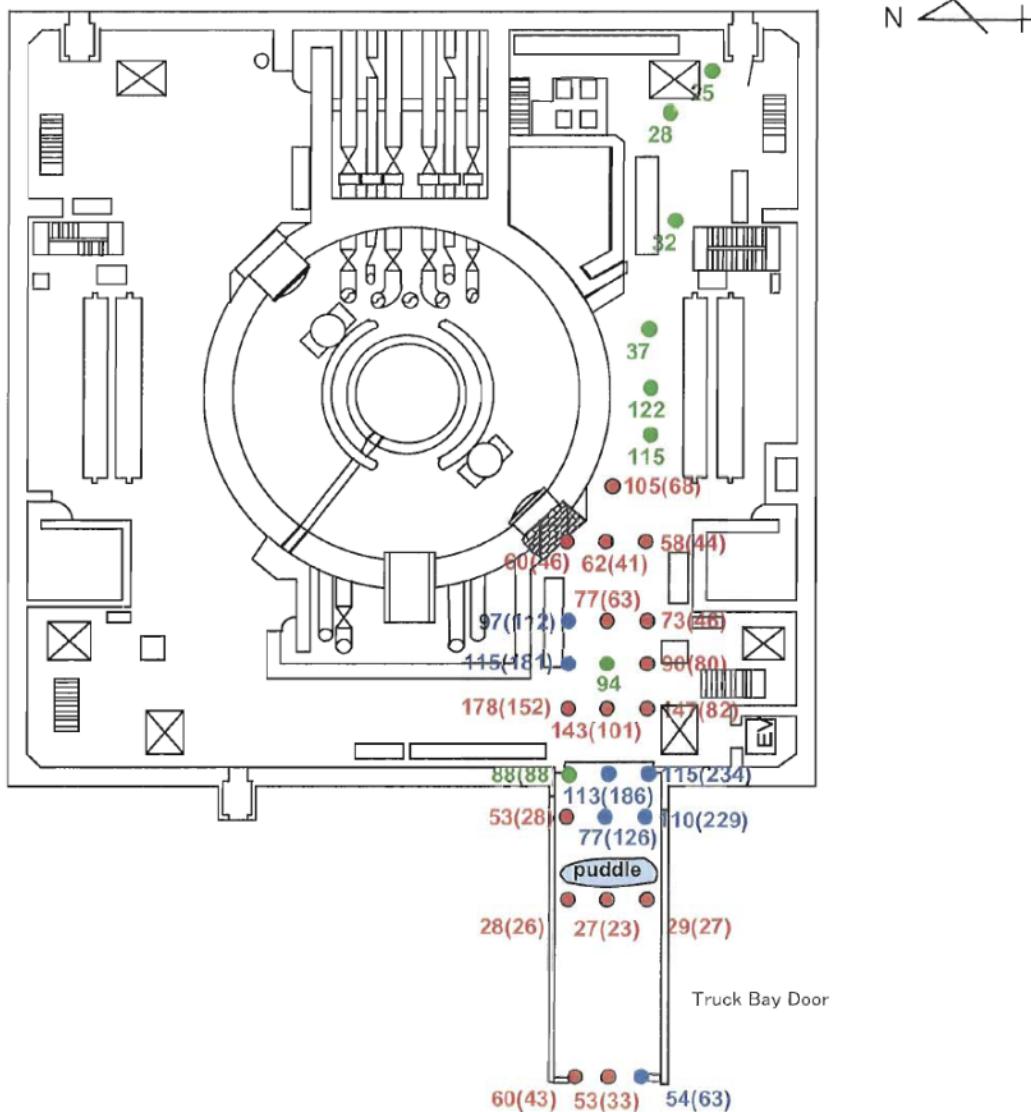
Result of radiation dose survey inside the Unit 3 reactor building in Fukushima Daiichi Nuclear Power Station

Survey Date: 10:31-12:42 on June 24, 2011

Exposure dose: 1.17~1.76mSv

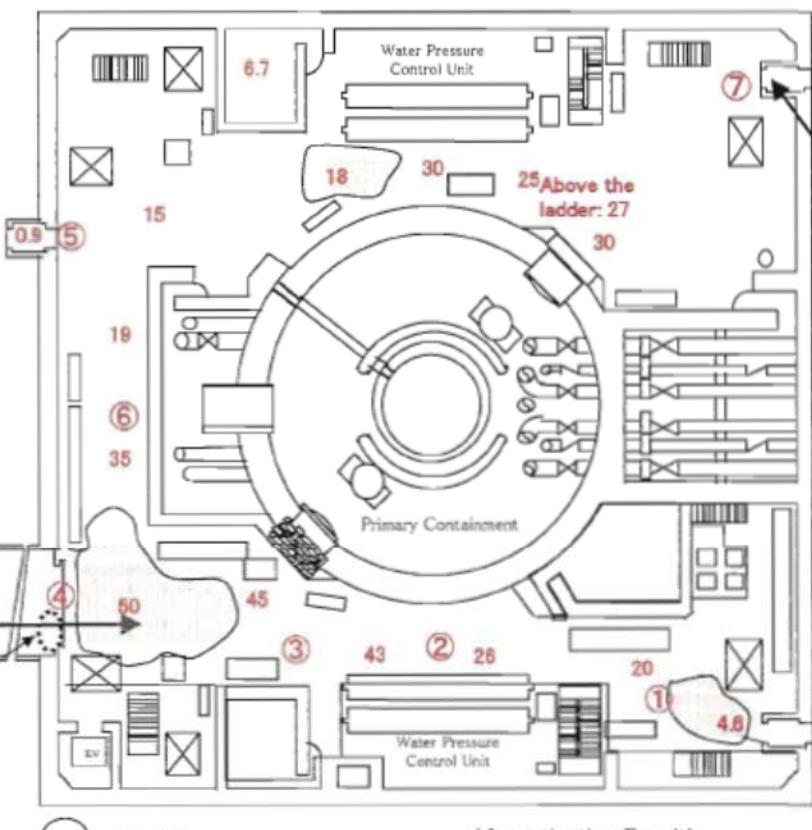
Unit 2: The result of investigation of the inside the R/B (1st floor) and of radiation dose measurement.

- Neutron measurement result: 0mSv
- Surveyed all over the 1st floor, entering through the air lock in the south.
- The radiation dose data are shown in left.
- Temperature as well as humidity inside the building are both high.
- Sensible temperature rises as getting close to the northwest of the floor from the front of the carry-in gate for large stuff.
- Difficult for workers to stay in the area for more than 15 minutes due to physical capacity.
