“ALARA” VERSUS REACTOR SAFETY CONCERN - A PRACTICAL CASE

Staffan Hennigor
Forsmarks Kraftgrupp AB
SE-742 03 Östhammar
Sweden
E-mail: sig@forsmark.vattenfall.se

Introduction

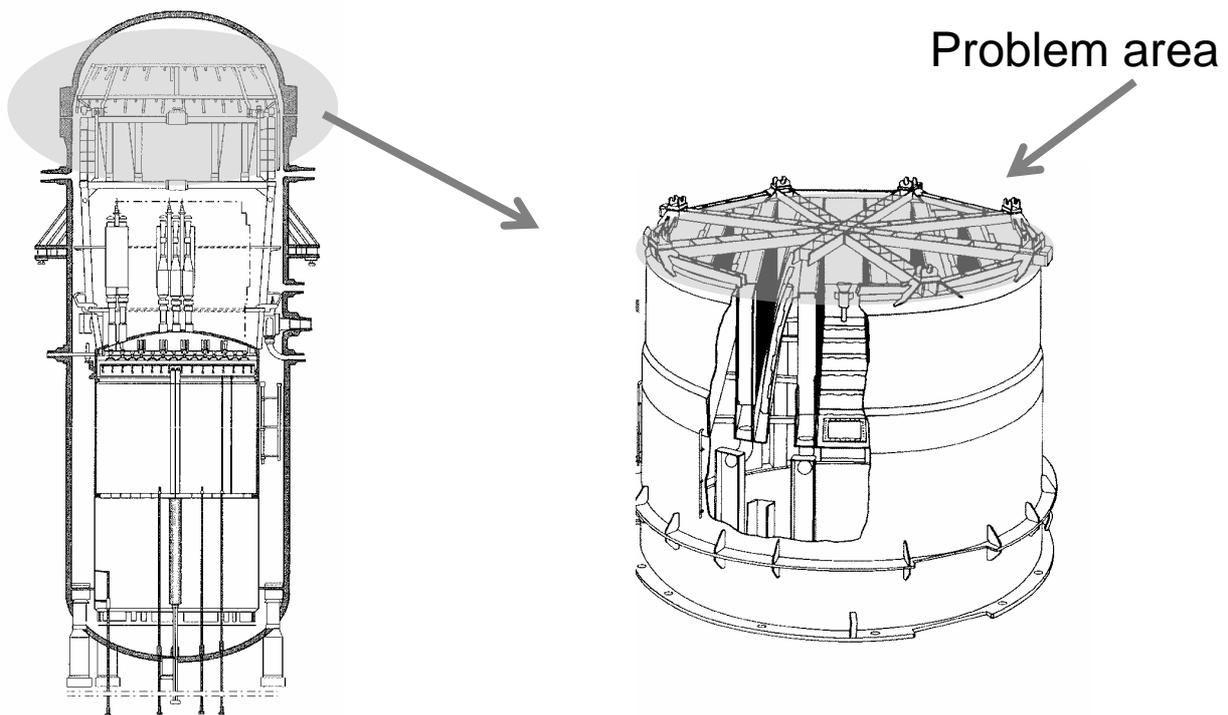
During the outage 2003 at Forsmark unit 2 it was planned to make a modification to the moist separator (an internal part of the reactor vessel), see figure 1. The work was initiated due to extensive cracking found in welds, which challenged the mechanical integrity of the moist separator and also loose parts lost in the reactor vessel. The cracks had been known for several years but until now no measures were deemed necessary.

Figur 1: The problem area on the upper part of the steam dryer.

Measures to be performed were to remove the supporting consoles and to weld an extra beam on to the existing, thus ensuring that the cracks and fractures in the original beams would not endanger the integrity of the structure. Also there will be no need for future materials inspection of the old beams since their function is entirely replaced by the new ones.

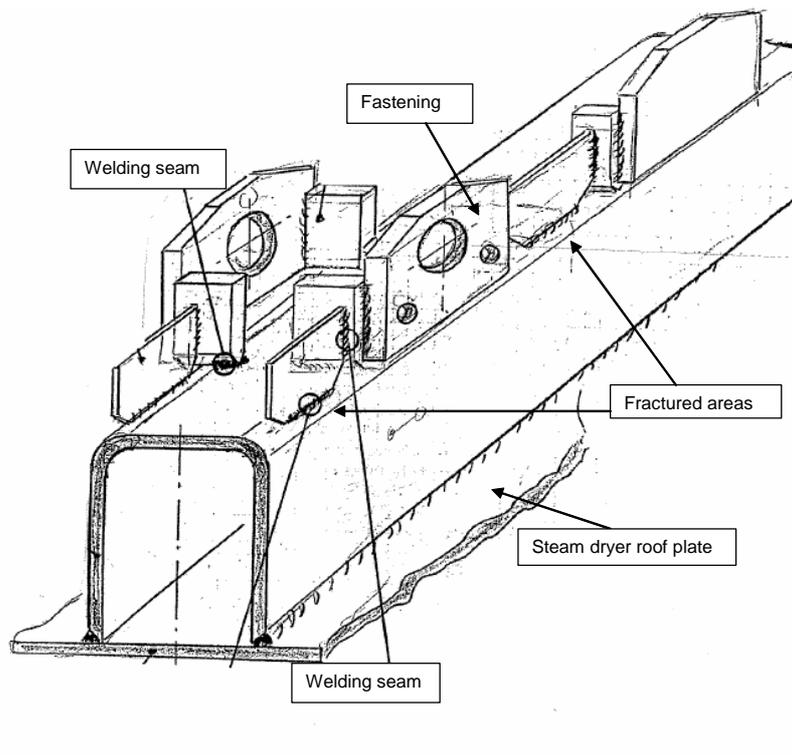
After some years of operation cracks were observed in the weldings connecting the supporting consoles to the beams of the steam dryer, see figure 2.

Figure 2: Consoles welded on top of steam dryer.

Not until the beginning of year 2003 the cracks were judged to be a serious challenge to the mechanical integrity of the reactor vessel internals (integrity of the beams) and also the risk of having parts coming loose in the reactor vessel was of concern.

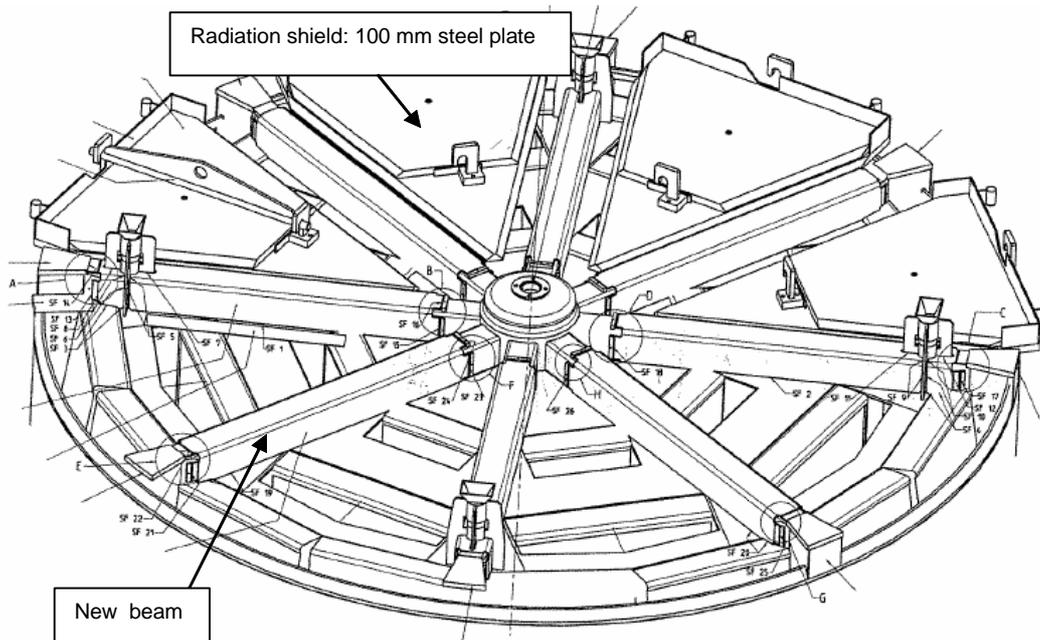
but higher near the unshielded beams. According to measurements and calculations a radiation shield consisting of steel plates forming a working platform were constructed, see figure 3. The steel plates were to be supplemented by additional lead blankets over the beams not being worked on.

Figure 3: Steel plate radiation shields.

Measurements of source term and dose rates with shielding plates in place (check points 2 & 3) showed dose rates on working area in excess of predicted values. General dose rates were in the range of 0,7-0,8 mSv/h with values of about 2 mSv/h on working distance from unshielded beams.

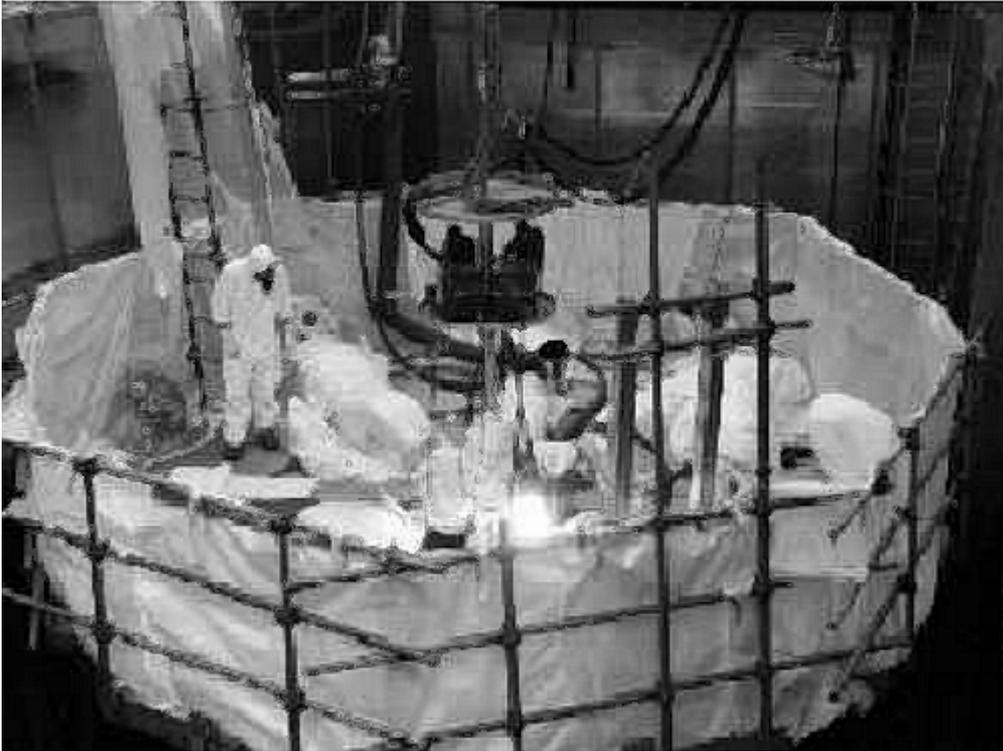
Figure 6: Working area with protective measures implemented

The choice of working methods made it possible to perform the work without tents over the work place, but extra ventilation and thorough cleaning procedures had to be implemented.
