# **Development of working methods used inside reactor pressure vessel at Oskarshamn from the radiation protection point of view**

**Christer Solstrand  
OKG Aktiebolag  
S-572 38 Oskarshamn, Sweden**

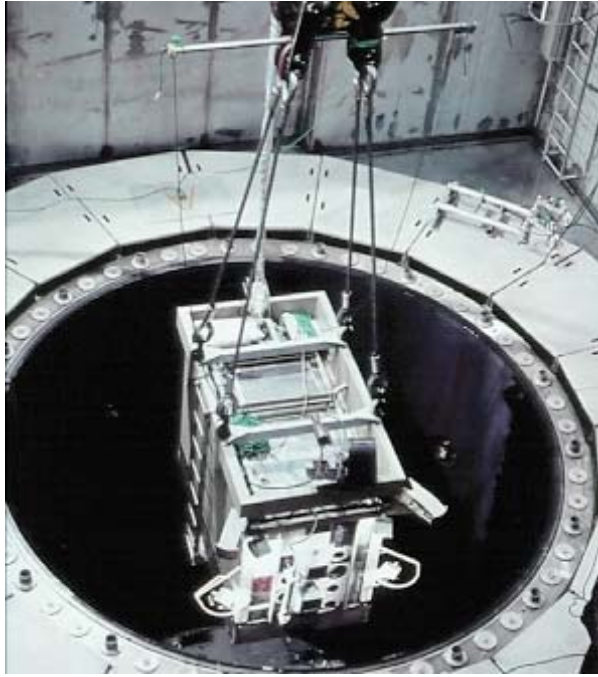
In 1974 the feed water ring at Oskarshamn 1 was replaced because of cracks found in the material. Initially all fuel was removed from the reactor pressure vessel to the fuel pond. The water level in the RPV was kept 50 cm above the core grid as a radiation shielding. Though the dose rate was too high to perform the planned job. Complementary radiation shielding had to be provided in order to be able to perform the repair work in an acceptable way from the radiation protection point of view.

Picture 1: The lead box hanging in the reactor hall crane.

Therefore a lead box was constructed and manufactured of lead bricks with a thickness of 10 cm. In the lead box there were space for two workers. It was equipped with a window made of lead glass, holes for the arms and over pressure ventilation. The lead box was hanging in the reactor hall crane and moved up and down in the RPV. Using conventional work tools the feed water ring was cut away and four new feed water spargers were welded in place.

The work was performed on three shifts and a total of 107 workers were during shorter or longer times engaged in the work. Totally 55 workers took part in the work from the lead box. The total collective dose for the job was 440 mmanSv of which only 50 mmanSv received in the lead box. The rest of the dose was received in the reactor hall. The highest individual dose was 20 mSv and the highest hand dose was 34 mSv.

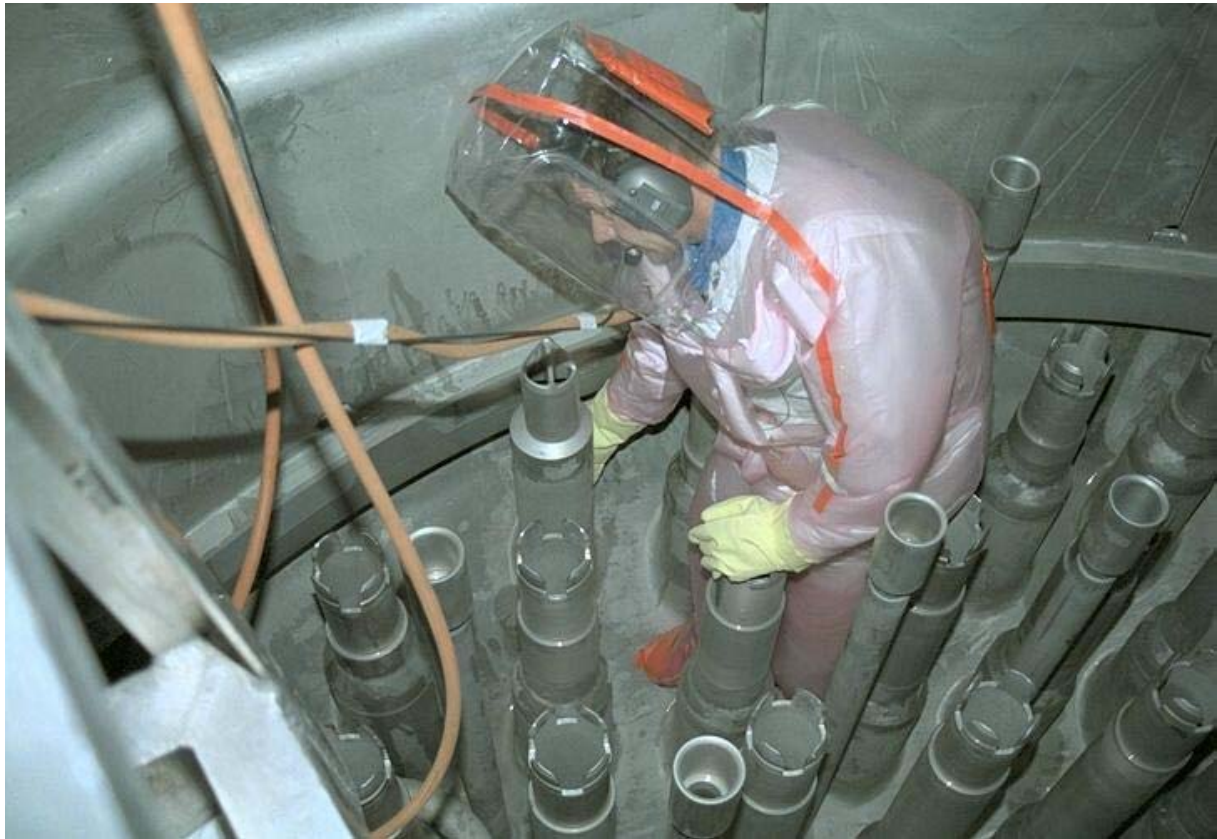
In 1994 in-service inspections of the bottom nozzles of the RPV at Oskarshamn 1 was performed. In order to be able to perform this job using conventional equipment a system decontamination of the RPV was performed. The system decontamination was very successful and the contamination levels and the dose rates at the bottom of the RPV were fairly low. The contamination levels varied between 500 and 10 000 kBq/m<sup>2</sup> and the dose rate level was about 0,04 mSv/h.

Picture 2: Picture of the bottom nozzles of the reactor pressure vessel.

The workers were wearing only airflow protective suits in order to prevent inhalation of any particles and to minimise the spread of contamination. Anyhow the system decontamination cost a lot of money and time but the inspections could be performed by conventional equipment. The collective dose for the in-service inspection of the bottom nozzles of the RPV was 115 mmanSv.

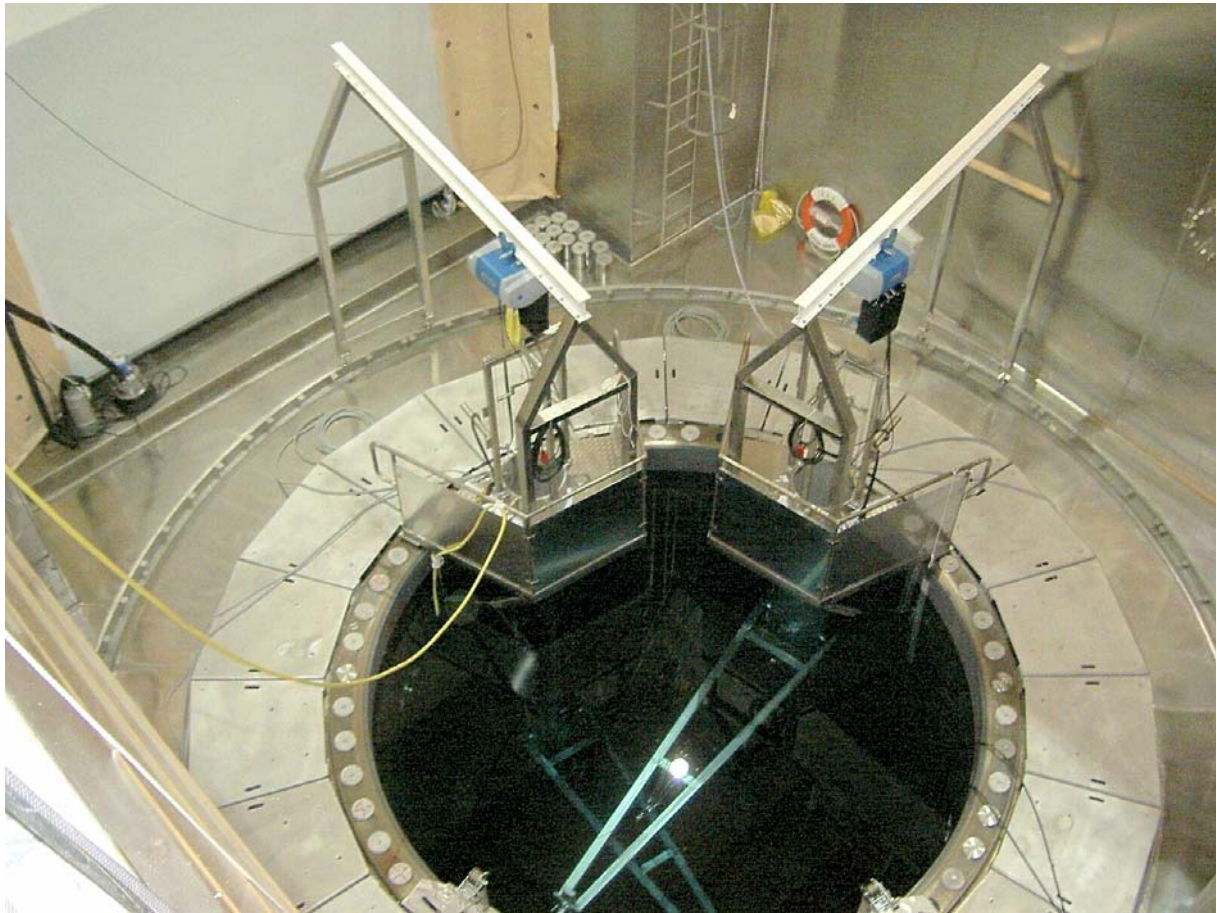
During the outage period of Oskarshamn 2 in 2003 in-service inspection of the water level measuring nozzles (LMN) of the RPV was performed. Several indications were detected. In 8 indications of totally 15 LMN:s cracks were found and measures had to be taken. Because the results were expected a repair method had been carried out during the two months before the outage.

Picture 3: Picture of the two work shafts attached to the flange of the reactor pressure vessel.

The LMN: s are situated on three different levels, 4, 6 and 14 m down from the RPV flange. Repair work was performed through special designed shafts. These were attached to the flange of the RPV and went down to the LMN:s and attached to the wall of the RPV by a gasket covering the LMN:s. All water was evacuated from the shafts.

The diameter of the shafts was about 50 cm. Special equipments for milling, welding and testing were constructed to fit into these shafts. The function was tested on special designed mock-ups. Cameras were mounted on the equipment to make it possible to locate, observe and operate the equipment from TV-monitors. The equipments were hanging in wires in the shafts and operated electrically and pneumatically from the floor of the reactor hall.

The repair work started with milling of the flange of the LMN, after that welding and finally testing. It was possible to perform repair work parallel in two separate shafts.

The repair work lasted for 30 days. The dose rates on the working area at the RPV flange varied between 0,07 and 0,2 mSv/h. The total collective dose of this job was only 47 mmanSv.
