Ramiro Fragío, Iberdrola-Cofrentes NPP (Spain)
ISOE Congress (Lyon, March 2004)

Unexpected Dose Increase at Cofrentes NPP during Refuelling Outage 14 (2003)

UNEXPECTED DOSE RATE INCREASE AT COFRENTES NPP, SPAIN (BWR-1100MWe) IN THE DRYWELL DURING REFUELLING OUTAGE 14 (2003)

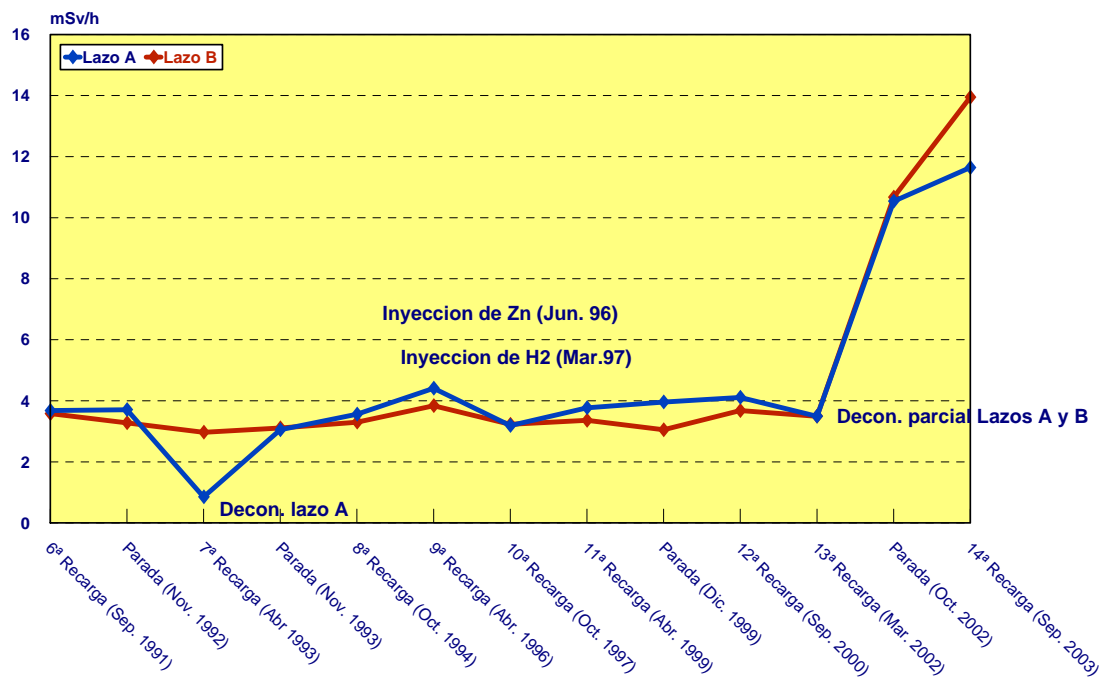
Figura 1. The historical BRAC point behaviour at Cofrentes

At the beginning of the outage 14 for refuelling at Cofrentes NPP (September 2003) elevated radiation fields were observed in the drywell. A three time increase was measured in contact with the surfaces of the reactor water recirculation system piping, the main source of the drywell general ambient dose rate. This behaviour is shown below in Figure 1.

This increase in RFO 14 was uniform in nature (no hot spots) and was accompanied by a 2X increase in general area dose rates.

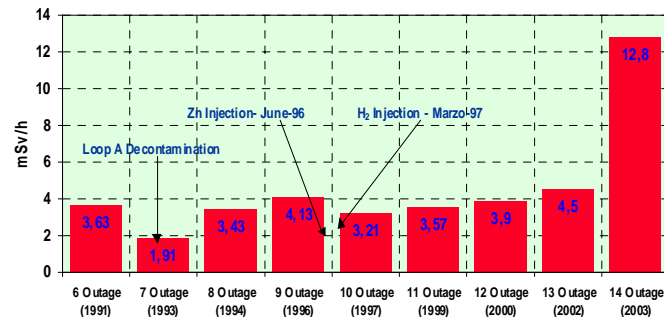
Historical Evolution of the BRAC Dose Rate in the Drywell

- Increase in average BRAC contact dose rates of ~3X
- Increase in drywell general dose rates of ~2X in lower areas
- Uniform increases...no hot spots
- Final outage collective dose 2,6 Sv-p. Previous estimate 1,8 Sv-p

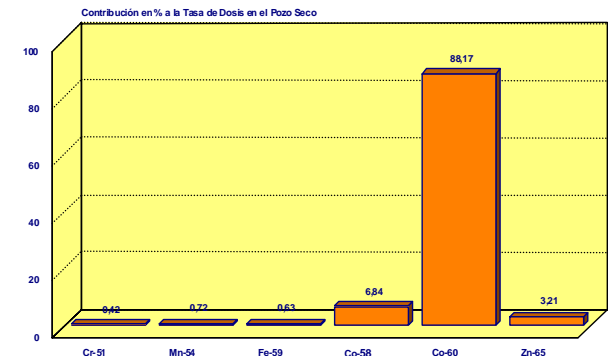
Isotopic Contribution to the Drywell Dose Rate

- Reactor water cobalt-60 constant over past 3 cycles
Higher than average for the fleet
- Measured feedwater cobalt also constant
- Soluble cobalt-60 incorporation in corrosion film increased in cycle 14, also Zn-65 and Mn-54
- Reactor water copper decreased Cycle 12 to Cycle 14
- Conductivity constant and typical of fleet apart from transient in Cycle 13
- Good control of hydrogen (with less shutdowns and more turn downs in Cycle 14)
- Reactor water zinc slightly lower than fleet average
- ECP decreased slightly Cycle 12 to 13 but no data for Cycle 14
