**2nd EC/ISOE Workshop on
“Occupational Exposure Management at NPPS”
Tarragona, Spain, 5 – 7 April 2000**

**Exchange of Reactorwater Level Indicator Pipes in Lower Plenum
In Reactor Pressure Vessel, Oskarshamn 1**

Mats Hjelm

OKG Aktiebolag, Oskarshamn NPP, Sweden

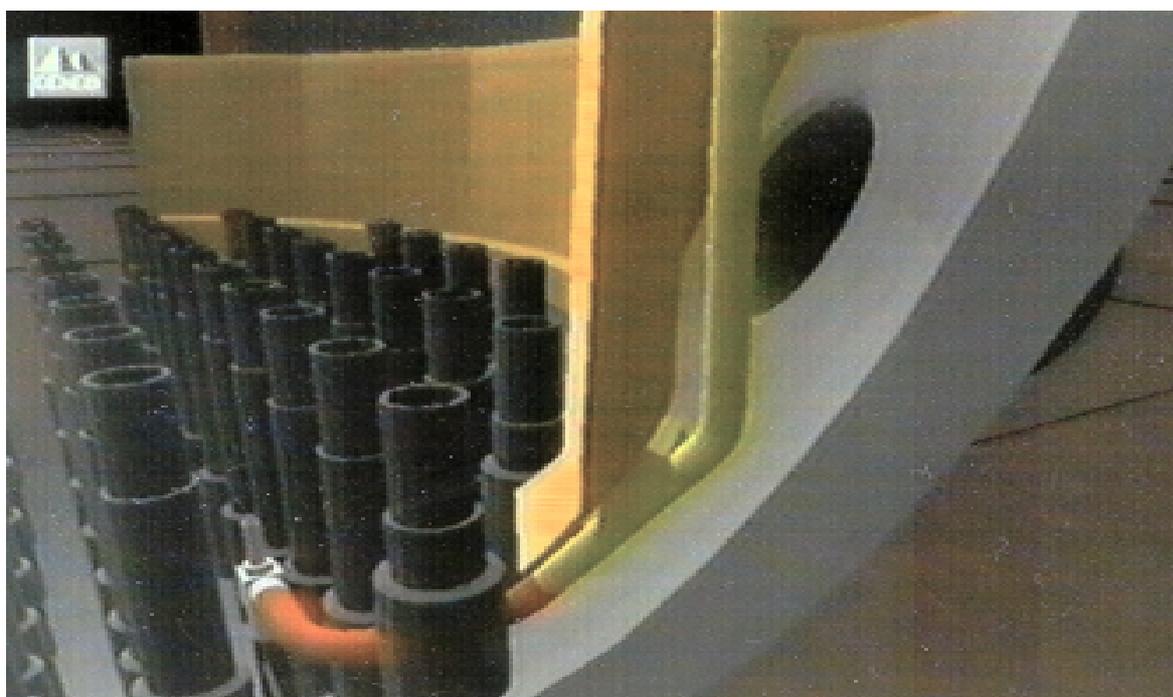
Figure 1, Location of the reactor water level indicator pipe at RPV lower plenum.

The reactor pressure vessel was opened and inspection through TV-camera showed that the assumptions based on the pressure measurement was true. The measure pipe was totally cut off at a level just above the support where the pipe is fixed to the main recirculation baffle. Even the support was partly demolished.

Replacement of all four pipes for reactor water level indication considering the installation made in reactor lower plenum during the FENIX project ended 1995. The installation of the reactor water level measure pipes is shown on first page in figure 1. The mechanical implications of the installation may not be discovered directly from the figure. But bearing in mind that the distance between the pipe and the Reactor Pressure Vessel wall is only 45 millimetres some practical matters is to overcome.

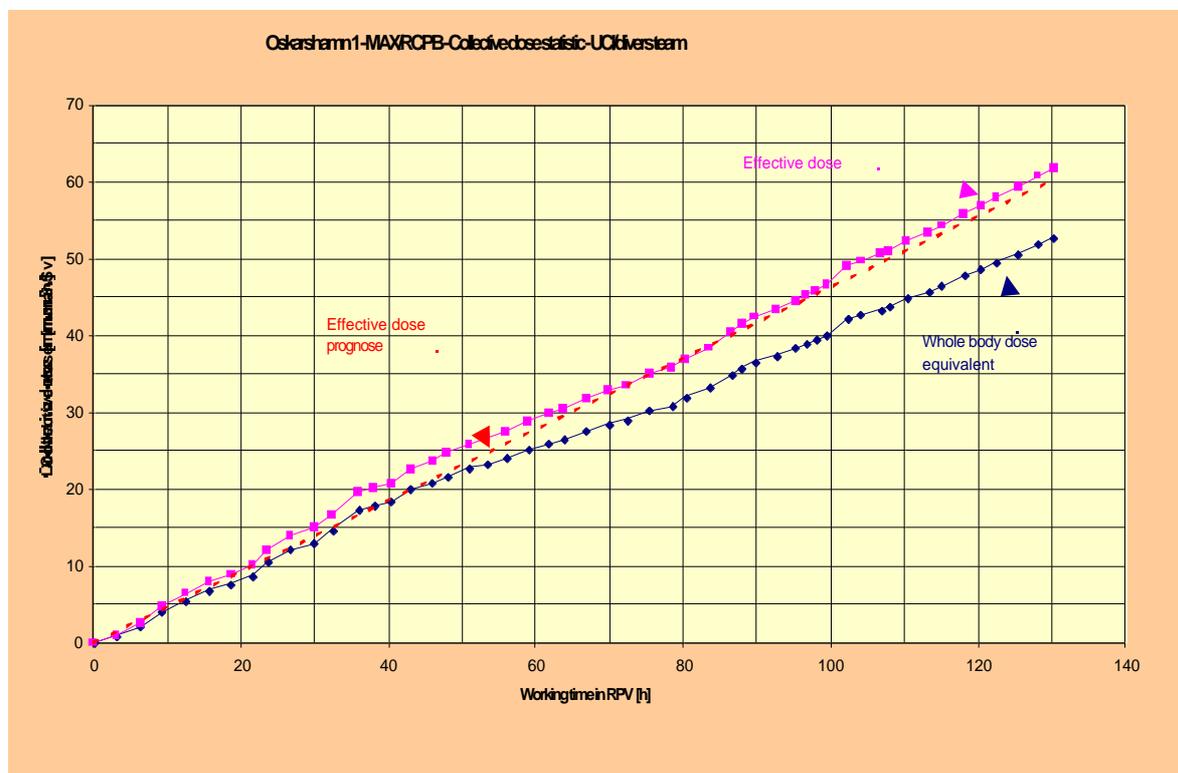
Total collective effective dose	61,95	mmanSv
Highest individual effective dose	9,66	mSv
Average individual effective dose	7,74	mSv
Number of personnel involved	8

Figure 2, collective dose statistics for the divers work in Oskarshamn 1 – RPV.

The dose prognoses made during the site acceptance test did underestimate the whole body dose equivalent while the effective dose matched the prognoses in a reasonably good agreement.

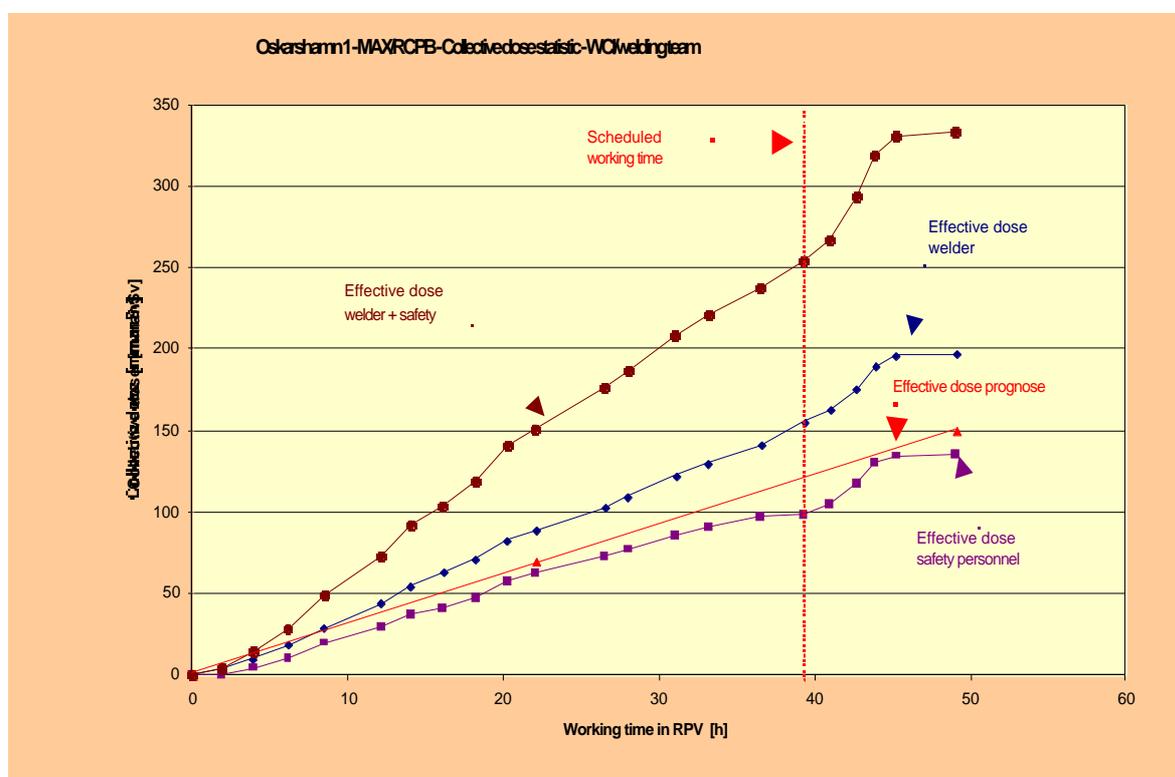
When the works really started things went reasonably okay but the time spent in the RPV seemed to increase more and more after each decent. The individuals dose developed significant faster than expected as determined from the site acceptance test. The dose statistics for the safety related personnel developed also witch was not to expect. Understanding things gave definitely a hint of that “those things downstairs” was not performing as was planned. At this state the time schedule was almost at the end point. The collective dose prognoses were significantly overridden and only about 40 % of the work done on the four pipes upper welds. Discussion with the welder’s supervisory hierarchy pointed in two directions. The welders were very keen on the quality of the welds performed witch made them standing in the high

doserate field most of the time. Being afraid that the automatic welding machine wouldn't do its job properly and in case leave them a rework to be done manually. To some extent this was understandable but not satisfying in any way remembering all time and efforts spent on both training and qualification at site acceptance test. A qualification that the risk assessment was partly built from. Secondly it also was to understand that the automatic machine did demand a lot more time of over viewing and adjustment now compared to during the qualification pass.

Figure 3, Effective dose statistics for the welding task.

The task, to weld in four new pipes exceeded the scheduled time with a factor of two concerning time outside the shielding cave, but the time spent in the RPV increased only with around 20 %. The collective effective dose was 333,02 mmanSv. This was out of range with a factor 2,5 times the prognosis. Individuals dose statistics were:

Total collective effective dose	332,02	mmanSv
Highest effective dose	36,84	mSv
Average effective dose	15,00	mSv
Number of personnel involved	22

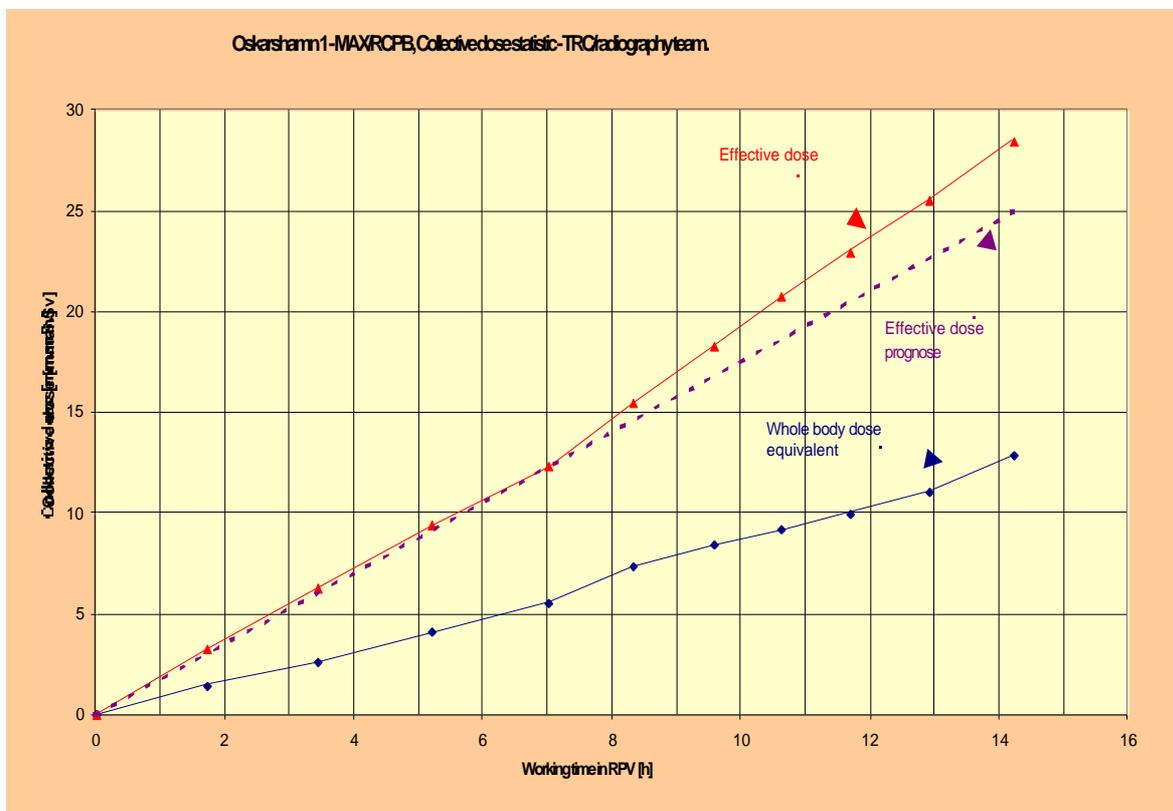
Figure 4, Effective dose statistics for the radiography personnel.

Radiography of the eight welds on the four new pipes did an exact match in time to the scheduled time. The collective effective dose was 28,51 mmanSv. This was only 3,5 mmanSv higher than the prognosis made from the site acceptance test. Individuals dose statistics were:

Total collective effective dose	28,51	mmanSv
Highest effective dose	8,21	mSv
Average effective dose	7,12	mSv
Number of personnel involved	4

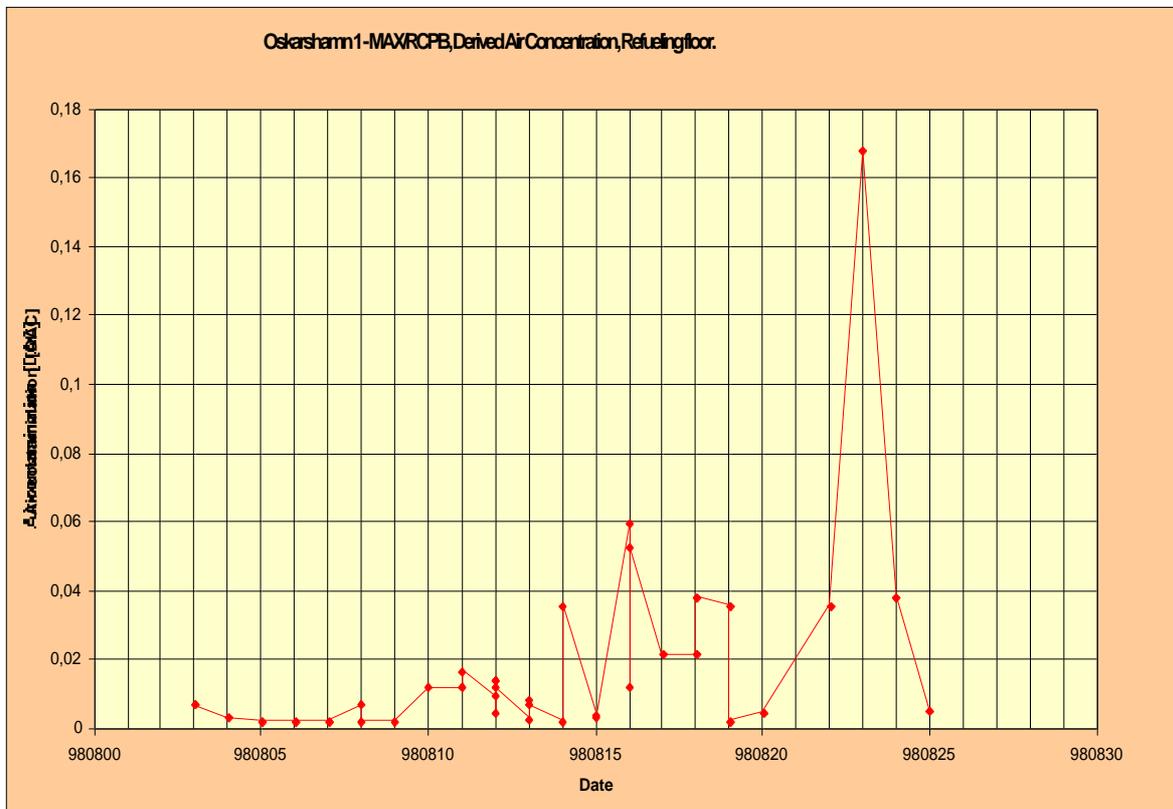
Figure 5, measured air contamination on refuelling floor.

During the performance of the task down the RPV no significant rise of air borne contamination at the level of refuelling floor could be seen as evidence of that the ventilation was wrongly built or malfunctioning. The periodically increase in air activity is related to moments in the “dry working” period when equipment was brought up from the RPV to refuelling floor level without enough care. Especially and to a certain extent understandable this is valid for the highest peak when the air concentration reaches a DAC value of 0,17. This DAC value corresponds to the re-establishment of the RPV at end of the project.
