Reactor vessel head replacement

Reactor Vessel Head Replacement at Tihange 3 – Transport conditions and storage of the reactor vessel head

02 june 2016

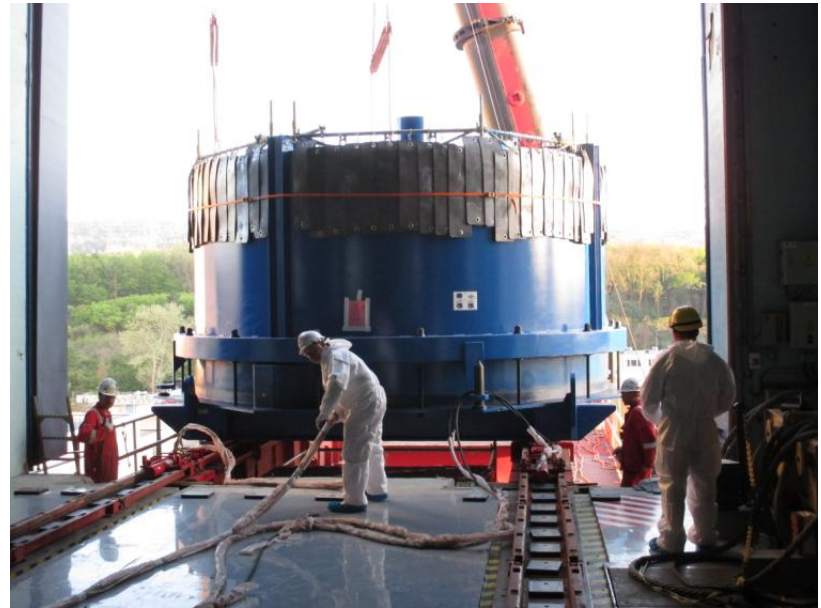
- *During reactor vessel head preparation, the measured dose rate was higher than expected dose rate.*
- *Decision to shield the higher dose rate area to respect LSA-I criteria*

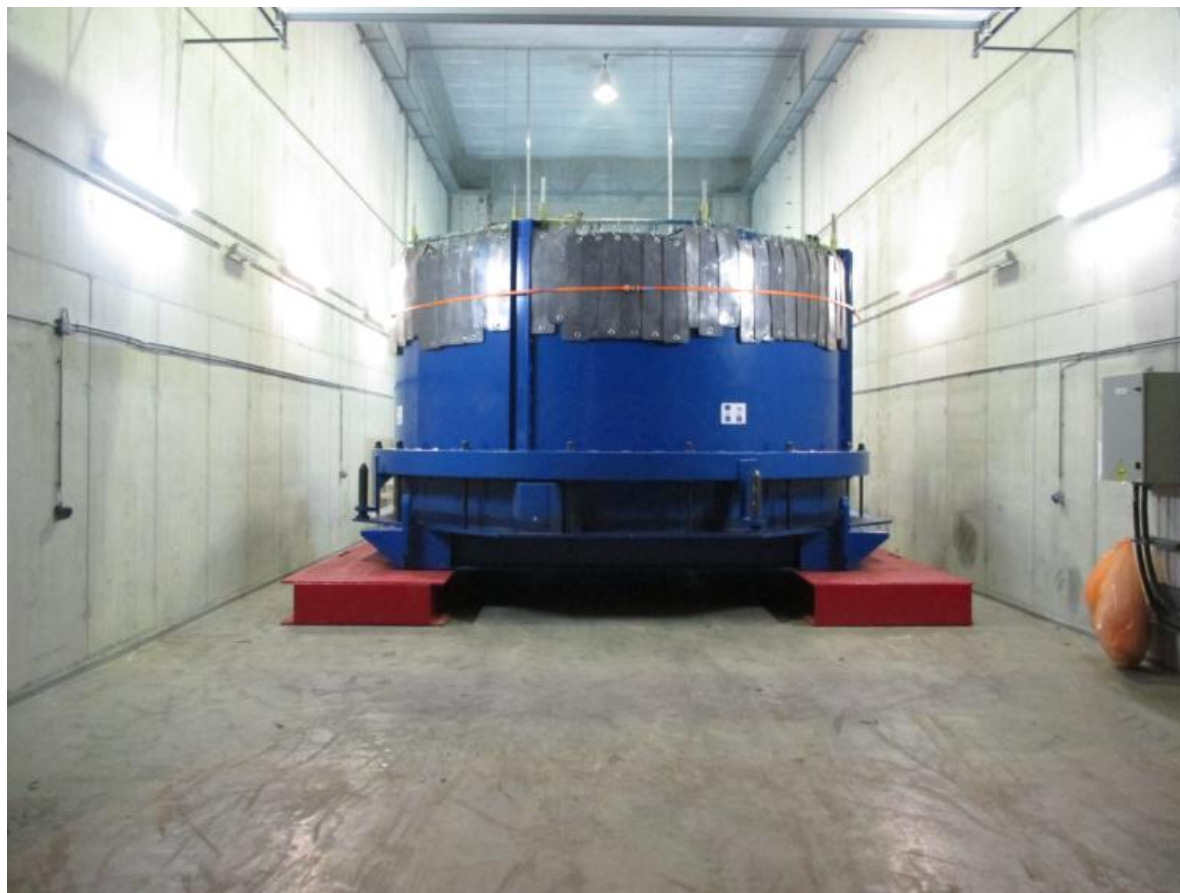
- *In Tihange, 9 used steam generators are stored in a specific building “SGV”.*
- *The building is also used for the storage of a reactor vessel head from Tihange 1.*
- *The building is a supervised area : risk of irradiation but no risk of contamination.*
- *The reactor vessel head of Tihange 3 has been placed in this building near the main entrance door*

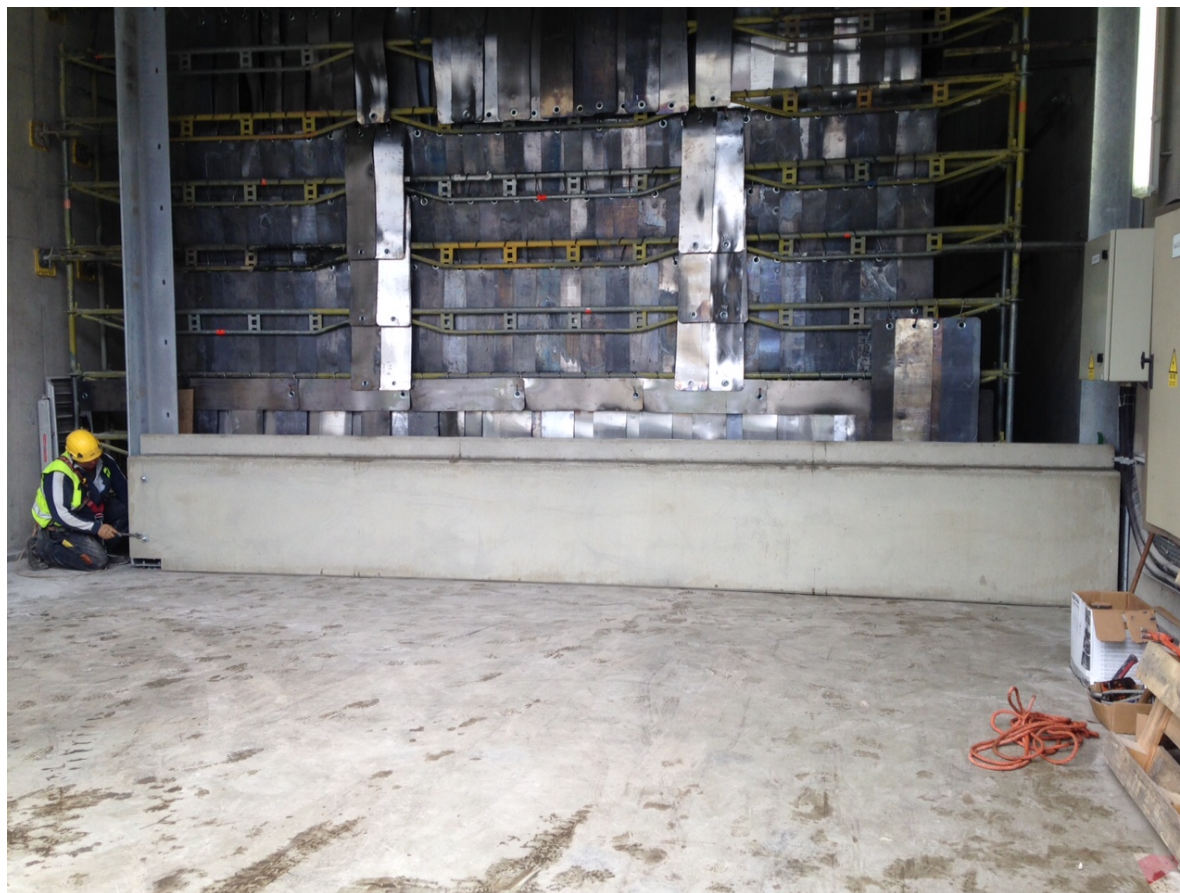
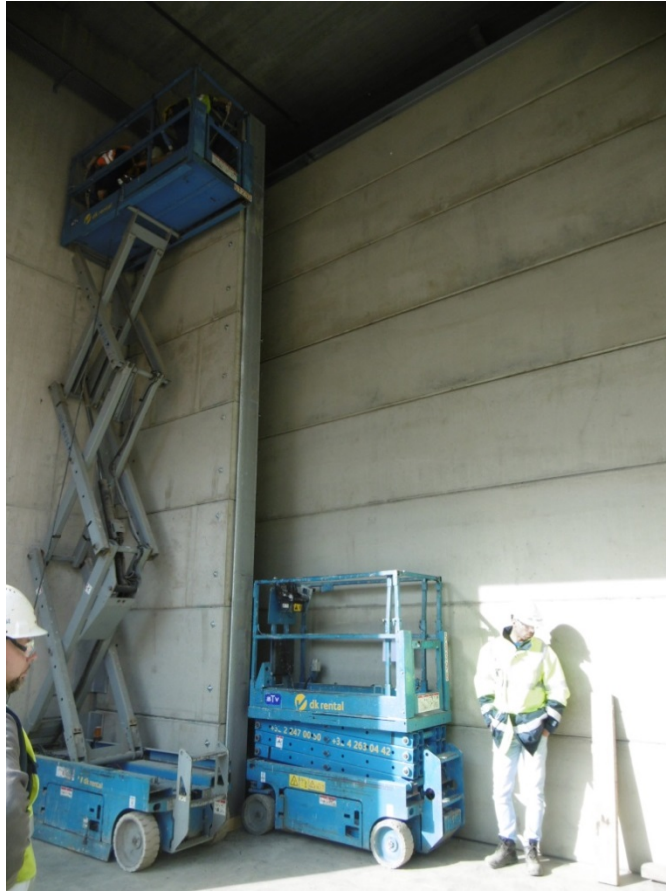
- *After storage, the measured dose rate outside the building was between 8 and 19 $\mu\text{Sv/h}$*
 - *It was expected that the dose rate will be between 2 and 7,5 $\mu\text{Sv/h}$*
 - *The difference is due to a observed dose rate on the reactor vessel head higher than expected*
 - *The risk of non respecting the operating license was not identified before authorising the transport*
 - *Authorities were immediately informed of the dose rate outside the building*
- Rem. : this transport was observed by the authorities during a inspection concerning nuclear transport*

- *In the project, the construction of a wall between the reactor vessel head and the main entrance door was planned*
- *Due to the observed dose rate and to limit the risk outside the building, the wall has been build in 6 months*
- *The temporary shielding wall has been removed and the dose rate outside the building is 1,2 $\mu\text{Sv/h}$ max.*
- *The shielding on the reactor vessel head is still in place to limit the dose rate on the roof.*
