Decontamination and post-decon Passivation treatment of the RRS Loops and RWCU System as a measure for Collective Dose Reduction and Recontamination Reduction at the NPP Cofrentes in Spain

Juan de Dios Sanchez Zapata, Maria Amparo Garcia Martinez,
Ashim Basu, Stephan Hoffmann-Wankerl

ISOE International Symposium
1. - 3. June 2016, Brussels

Chemical Decontamination at CN Cofrentes during Outage R20 in 2015

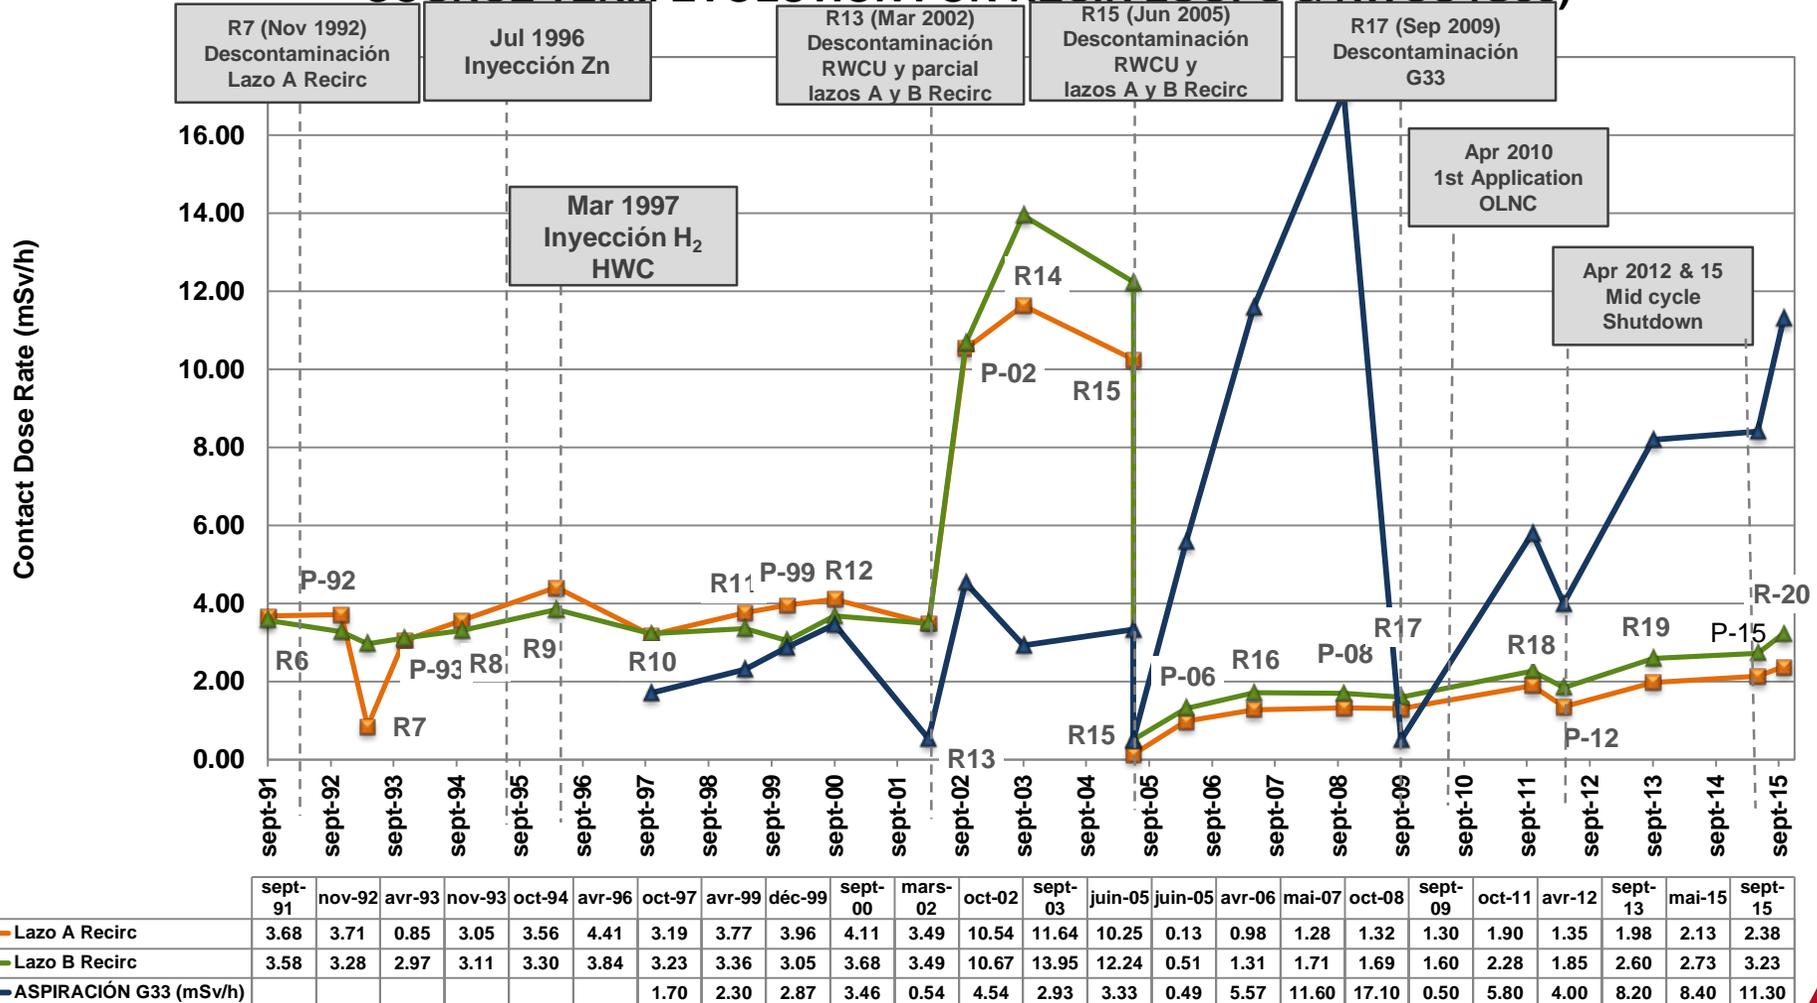
SOURCE TERM EVOLUTION FOR RECIR LOOPS & RWCU (G33)

- ▶ **The RWCU piping sections upstream the heat exchangers were decontaminated with the AREVA CORD® CS process in 2002, 2005 and in 2009**
- ▶ **A fast and climbing recontamination of the piping sections was observed after each decontamination treatment**
- ▶ **Transitioning of the plant to HWC/OLNC/Zn operation in 2010 did not result in the expected decrease in dose rates**
- ▶ **NPP Cofrentes therefore planned another decontamination of the RWCU system in 2015 to reduce the collective radiation exposure during the outage maintenance works and then wanted to minimize the recontamination effect**

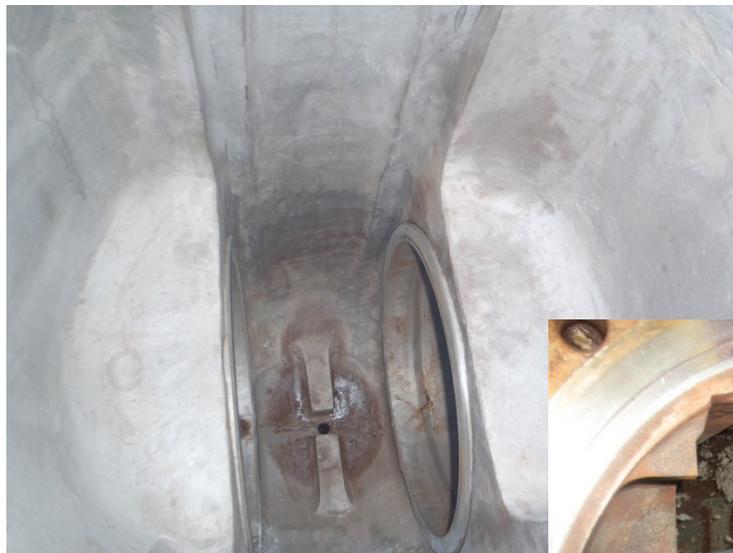
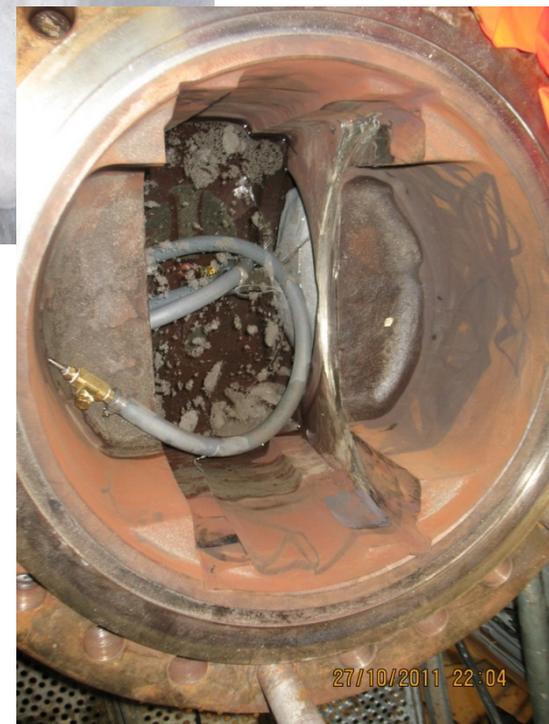
- ▶ **Metallic shining surfaces after chemical decon and passivation treatments**
- ▶ **Considerable dose rate reduction in the lower elevation of the drywell**
- ▶ **Total collective dose for Decontamination works during the outage : 105 mSv (compared to the 110 mSv estimated)**
- ▶ **Total Net Personnel Dose savings in RFO20: 650 mSv·p**

RRS valve housing after chemical decontamination in 2015 (above) as compared to after high pressure water cleaning in 2011 (to the right)

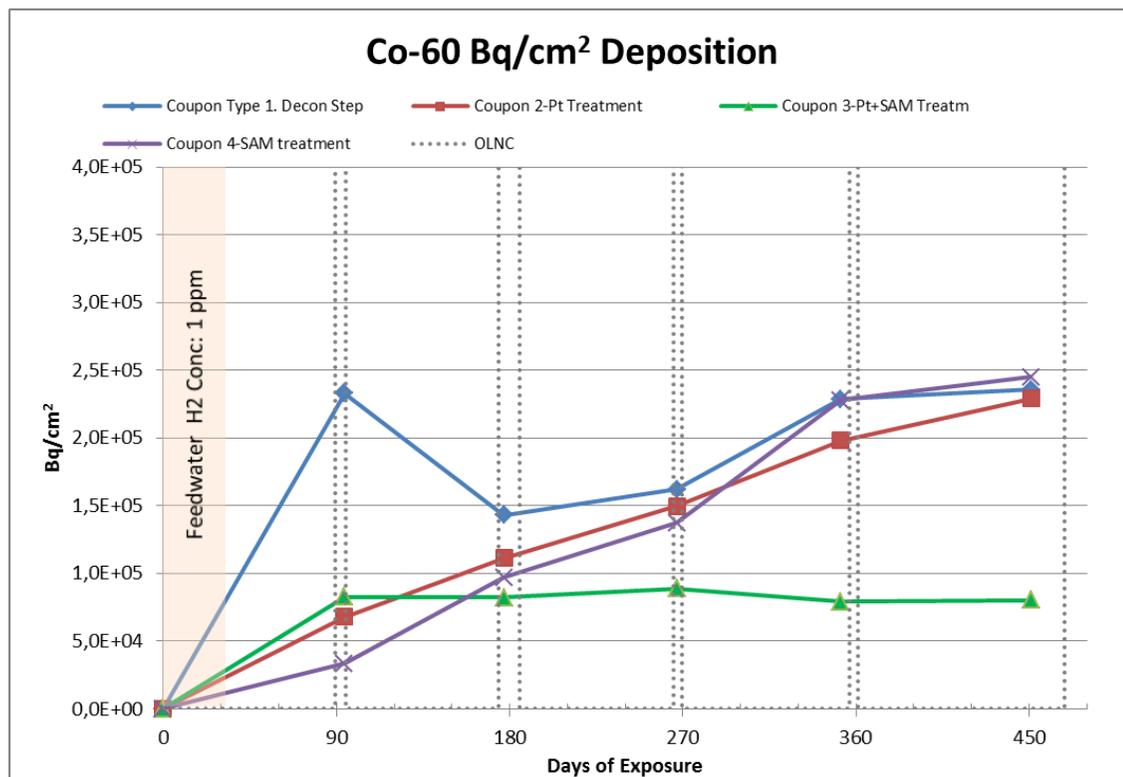
SITUATION AFTER 15 MONTHS IN-PLANT EXPOSURE

- ▶ Stable Co-60 trends after fifteen months of exposure
- ▶ Pronounced decrease in Co-60 activity of the Post Decon samples after 3 months of exposure can be explained by the conversion of the oxide layer induced by the OLNC treatment (particle release)
- ▶ Examination of the microstructure of the oxide layers after exposure has been done.

▶ SAM treatment showed a benefit after 3 months (see ISOE 2014) but it has not kept the initial positive trend.

▶ Positive results obtained after 15 months lead to the choice of Pt+SAM as the surface treatment for the coming RFO20 decontamination

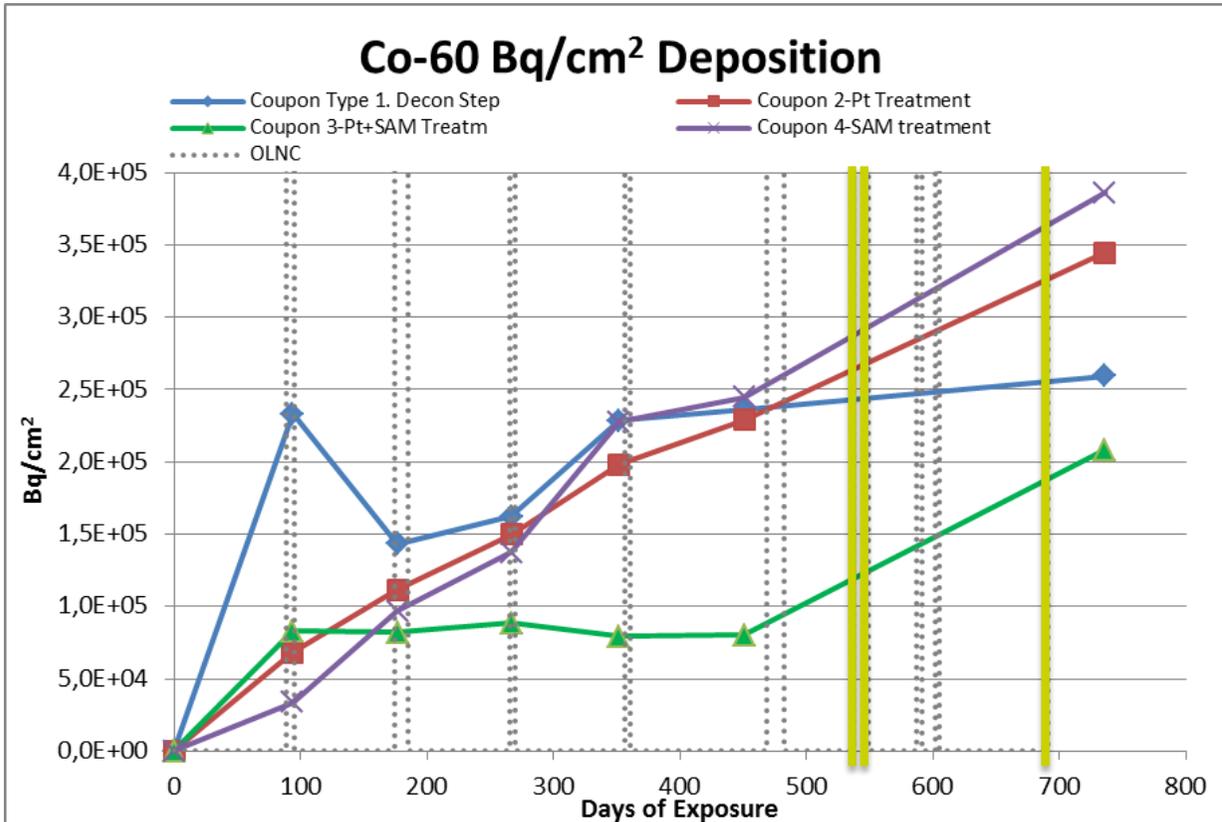
SITUATION AFTER 24 MONTHS IN-PLANT EXPOSURE

- ▶ Last set of samples extracted and analyzed at the end of the RFO-20
- ▶ The plant had a shutdown at the end of April-15 for replacing a fuel leaker and the outage started on Sept 27.
- ▶ Co-60 and other isotopes point out that the steady trend has moved and activity incorporation on surface has activated.
- ▶ The two shutdown operations and the activity released may have played some role on the drift of the trend.

▶ A new examination campaign for the last extracted coupons is on going to find out the cause for the change
