# Unplanned Exposure During Diving in the Spent Fuel Pool

**Andreas Ritter, KKL**

Kernkraftwerk Leibstadt

## August 31st 2010, during RFO26

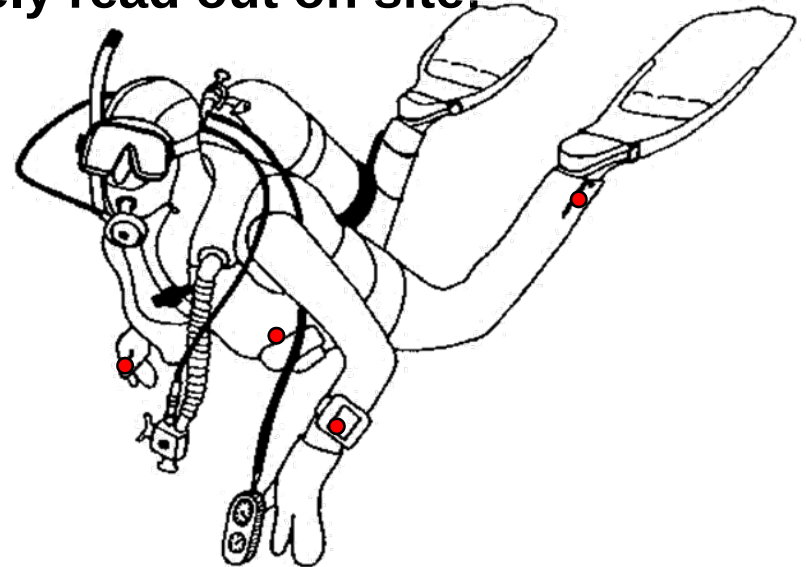
- When a diver left the spent fuel pool, his electronic dosimeter was alarming. The display showed 40,1 mSv.
- The divers TLDs were immediately read out on site:

- ✧ Whole body: 19 mSv
- ✧ Right finger: 1123 mSv
- ✧ Left hand: 306 mSv
- ✧ Left foot: 11 mSv

- The dose limit for hands (500 mSv/a) was exceeded
- The situation concerning the whole body (dose limit: 20 mSv/a) was questionable (2 different readings, TLD and EPD)

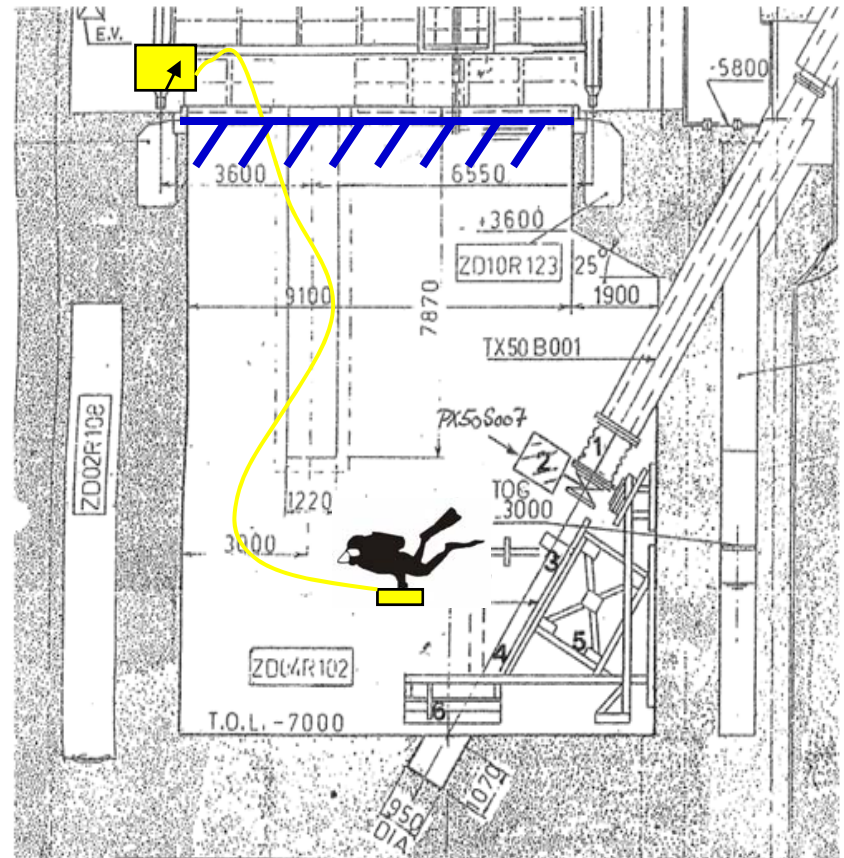
# The Survey (before start of cable exchange)

- Dose rate survey with submerged probe performed by diver at place of work (locations 1 – 6)
- Reading outside water at RP post
- Reading at locations 1 – 6 within expectations: no danger

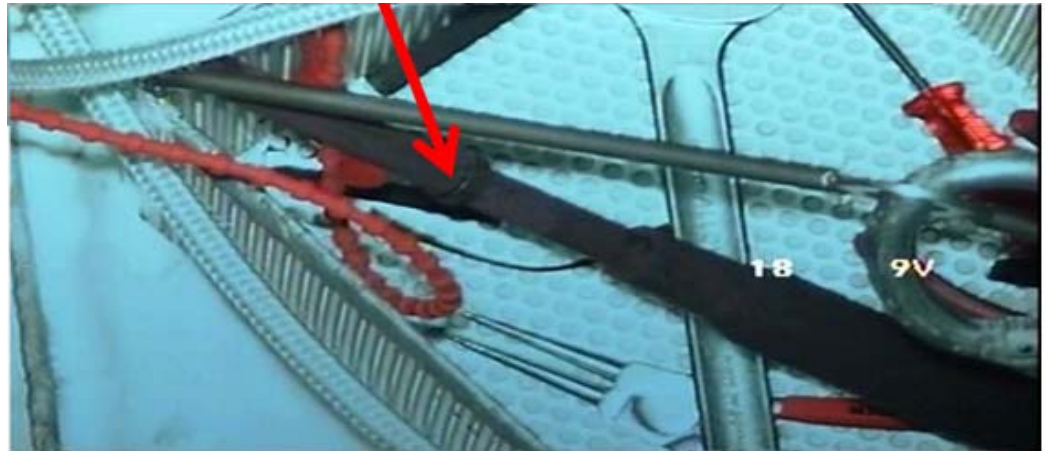
# What happened?

- The diver spotted an unidentified object during an interruption of the task
- Asked the diving supervisor what to do
- Was told to put it in his tool basket
- While lifting of the basket the Area Radiation Monitor alarmed, with the basket still submerged. Teletector reading at pool railing was elevated
- Basket lowered again
- Diver leaves pool

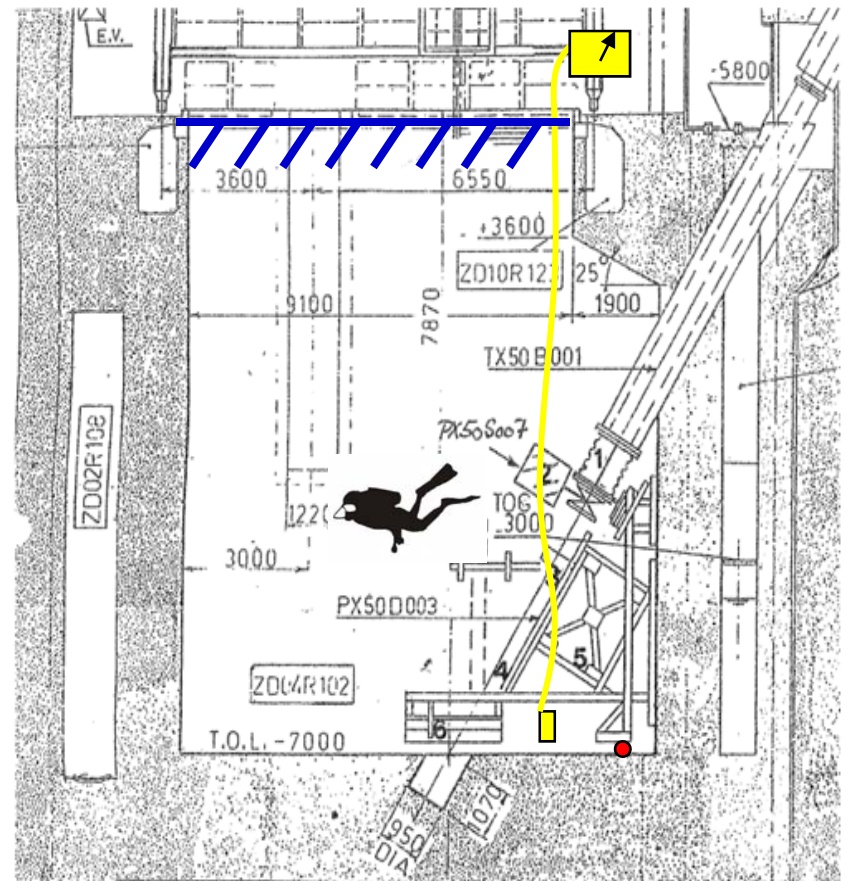
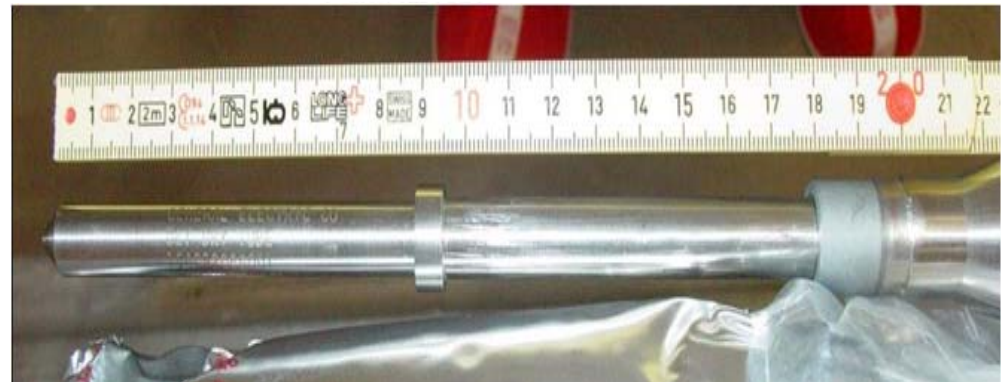
# The Object

- Dose rate reading in excess of 100 Sv/h (10'000 R/h) contact
- Identified as top part of Dry Tube (= housing of neutron monitors in the reactor core). Highly activated by neutron flux
- Found in a remote part of pool
- Not accessible to submerged probe from outside pool due to geometry

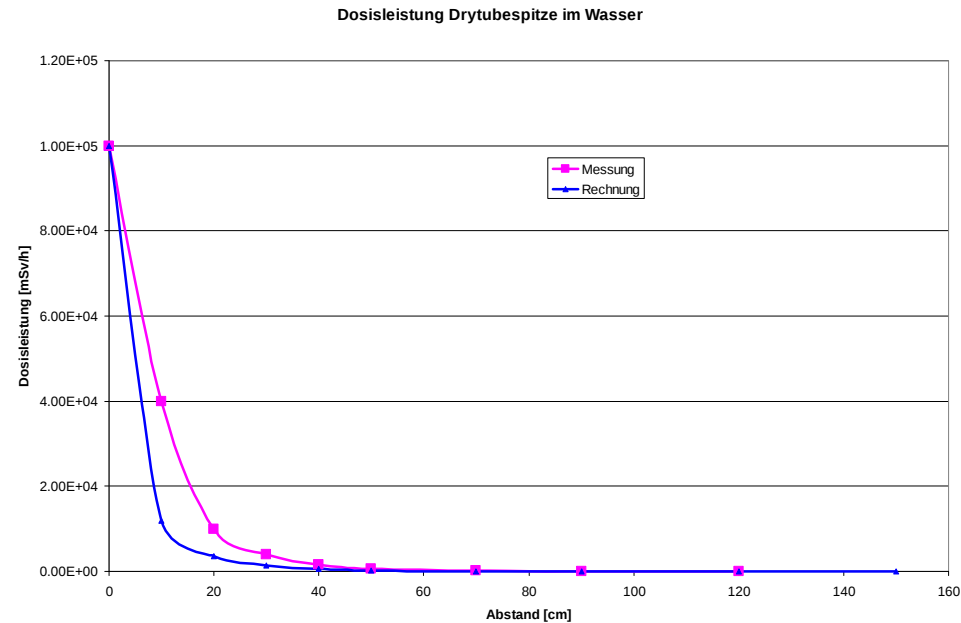
# The Shielding

- Water shielding is very effective
- No dose rate in a distance  $> 1.4$  meters of drytube
- Source is hard to localize by dose rate surveys
- Extremely high dose rates if source is brought close to parts of body
- Dose rate change is very fast

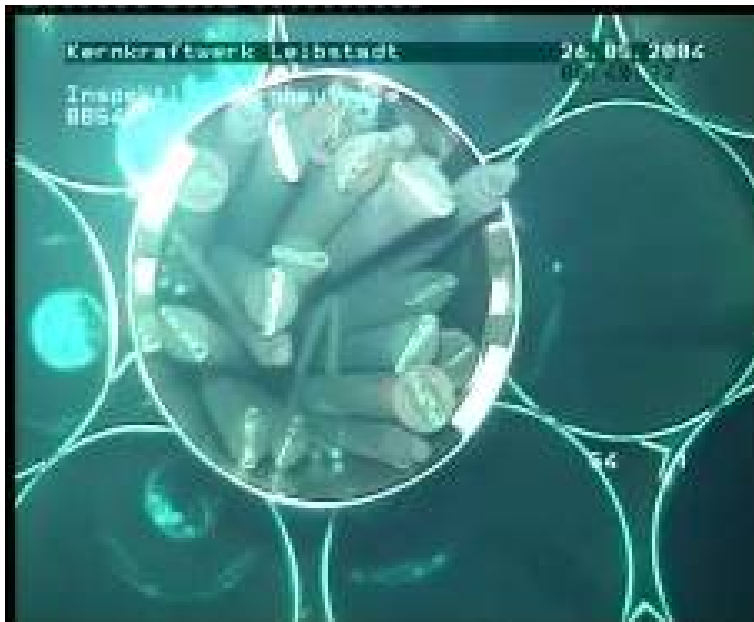
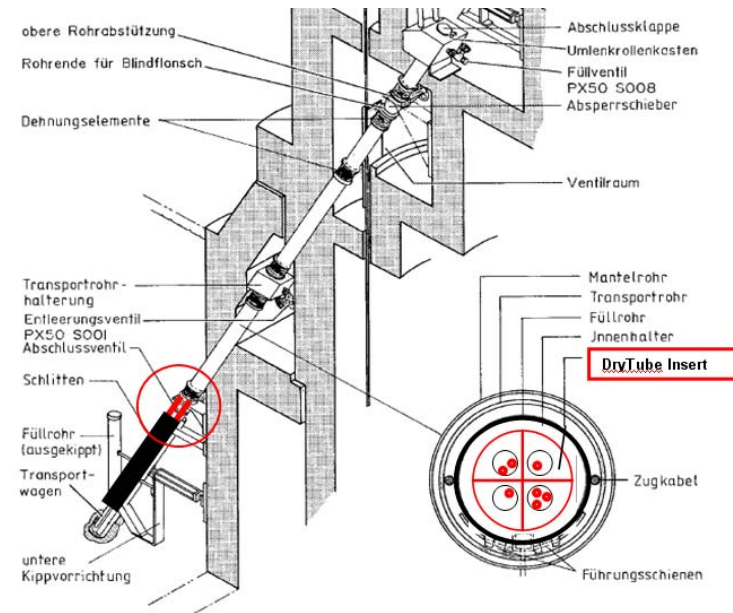
# How did the Drytube get there?

- Drytubes were removed and cut in pieces in the reactor cavity during RFO2006
- Some pieces were slightly longer than drytube insert for IFTS
- During tilting operation of the IFTS cask, the top part of a drytube was probably sheared off
- Drytube top part was on bottom of spent fuel pool since 2006

- **Drytubes will be moved in a closed container (done)**
- **A procedure for collection of loose material in pools shall be put in place (was missing before)**
- **The audible alarm of the divers EPD will be brought on his headset**
- **Teledosimetry will be installed on the divers body**
- **A procedure to track the loss of hazardous material shall be developed**
- **Pre-job-briefing improvements**

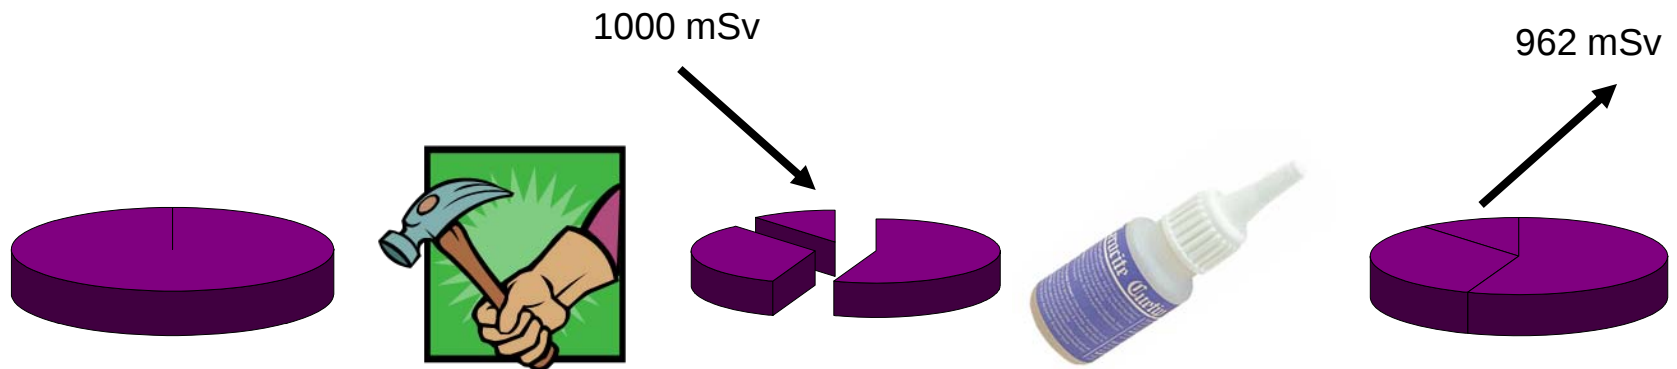
## Side effect: the broken TLD

- The divers TLD at the finger was broken due to mechanical loads during use
- The broken TLD was repaired with instant glue and processed „normally“
- This process was validated:
