#### DC Cook Baffle Bolt Inspection and Repair

ISOE Joint Session on NPP Aging ALARA Planning

DC Cook Radiation Protection Department

November 8, 2017

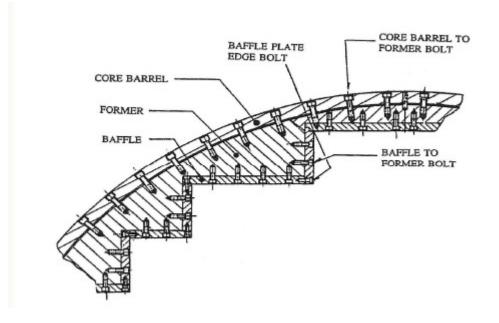
### So, What's a Baffle Bolt?

- Baffle bolt degradation was found at the Indian Point and Salem Plants in March and April 2016
- Industry response guidance, endorsed by the US Nuclear Regulatory Commision, issued in 2016 by Westinghouse Reactor Services Group
- Both units of Cook Units 1,2, along with Indian Point 2&3, Salem 1,2, and Diablo Canyon 1 fall into the most urgent category of response
- Cook's current strategy is to replace at least 200 bolts during each of the next two refueling outages on each unit. Total population per reactor is about 800 baffle bolts.
