## Spread of contamination through goods taken out from RCA - Lessons learned

### The incident

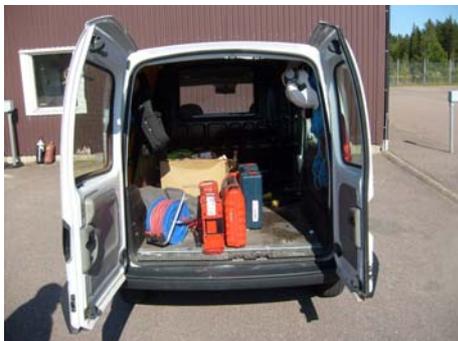
In the end of May 2009 a contaminated car was discovered by the vehicle monitoring system at Forsmark NPP in Sweden. The inside of the luggage compartment was found to be contaminated, but there was no specific contaminated equipment or goods.

The total activity spread by this incident is estimated to 25 MBq, mainly corrosion products normally found in the reactor water system. About 6 MBq of the total activity had remained in the car when the contamination was discovered.

The contaminated car

All the contaminated goods were transported to RCA and cleaned of loose contamination. Also the storage outside RCA and the outside areas were cleaned.
