Pressurizer Heater Sleeve Replacement

San Onofre Nuclear Generating Station

5th ISOE Workshop on “Occupational Exposure Management at Nuclear Facilities”
Essen, Germany, 15-17 March 2006

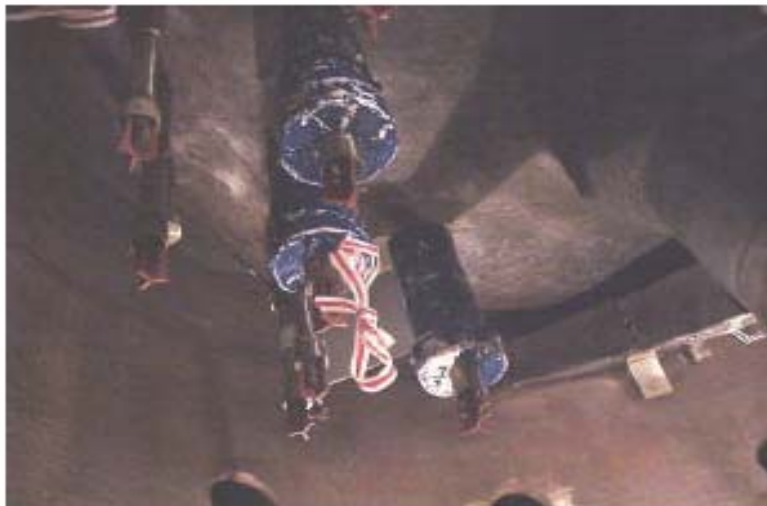
Photo 1: Original design of NSSS CE Pressurizer

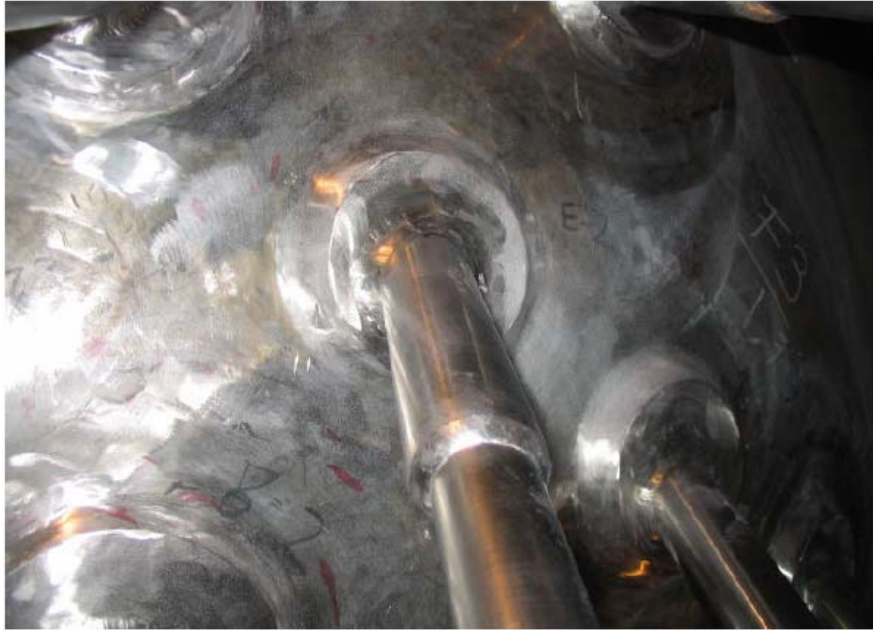
Photo 2: U3 Round Weld Pad

Improved tooling designs included the following: square weld pad (Photo: 3) machine versus the round weld pad (Photo: 2) machine, incorporation of engineering controls built into the tooling such as a containment and vacuum on the hydraulic mill (encapsulation tool) that reams out the old sleeve, and a redesign of the tool that severs the internal diameter of the sleeve using a “single point cutter” versus the “Hobby” tool.

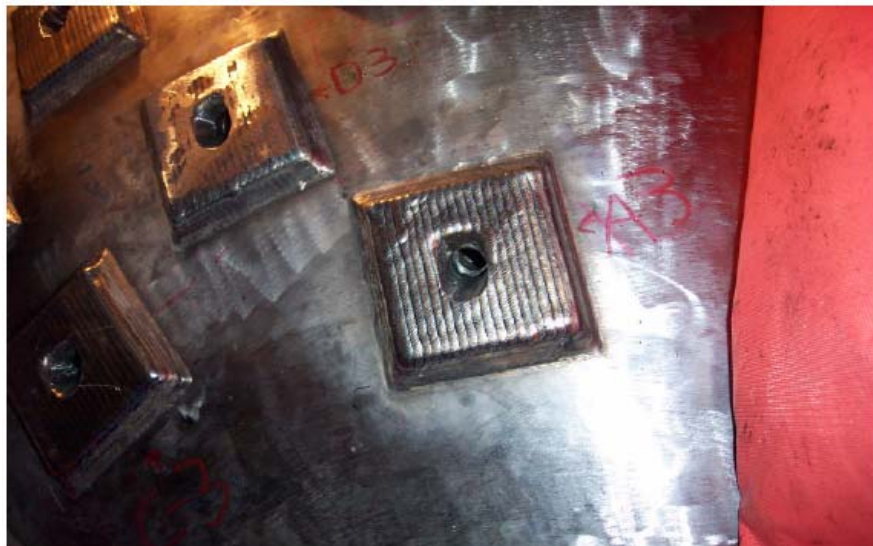
Photo 4: U2 Square Weld Pad

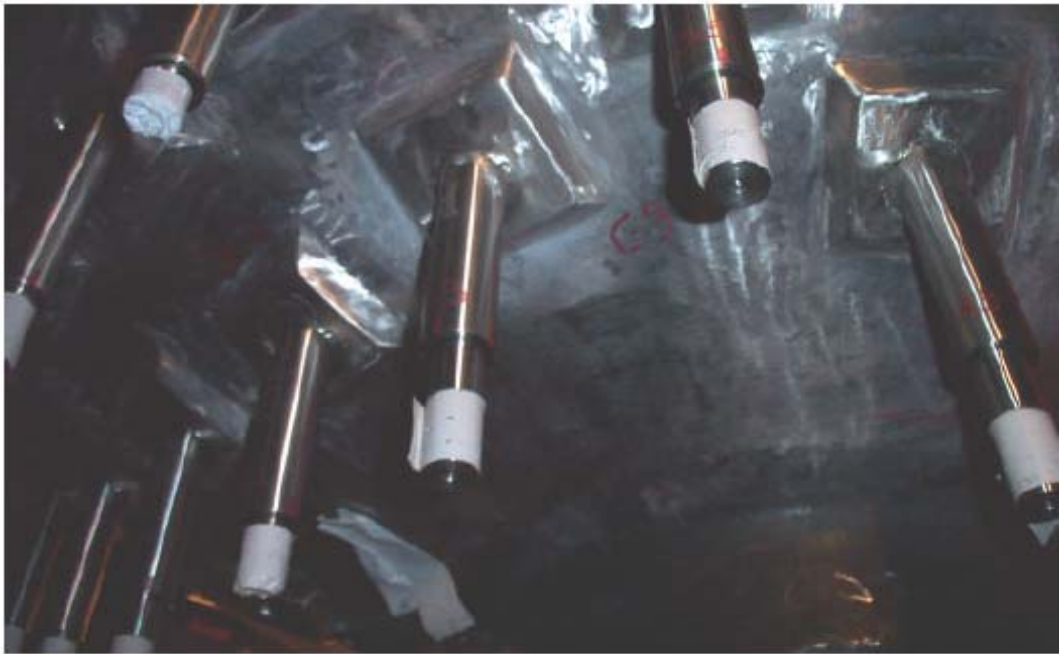
Photo 3: Pressurizer weld pads and new sleeves

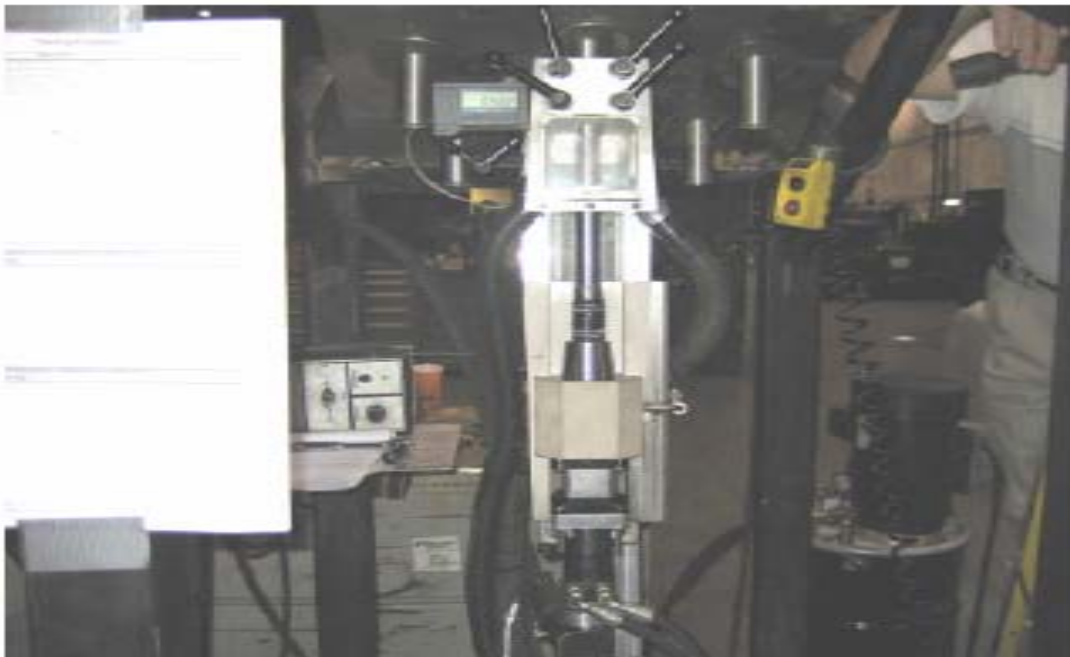
Photo 5: Encapsulation Tool (Reams out old sleeve)
