# Incident with exposure to high dose rate

When the RP tech's instrument is faulty

Johannes Isokivelä – Forsmark NPP

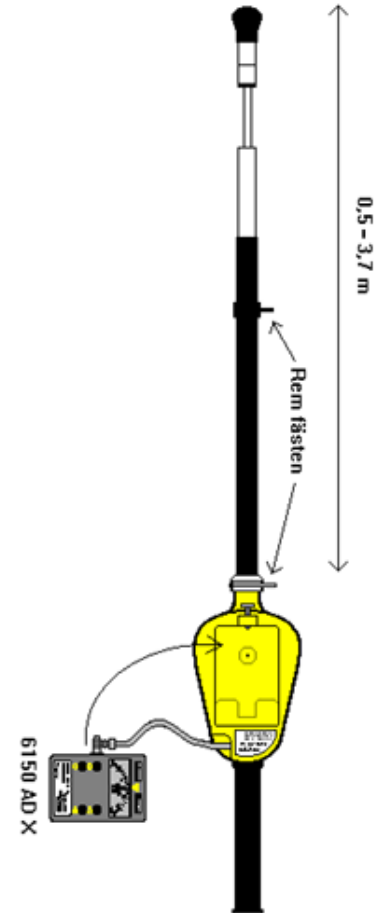
- Automess 6150 AD-t

- Function test before use, but only for the low dose rate tube
- We didn't have a source to do a function test of the high dose rate tube, that was a known problem for many years
- RP tech used the instrument without full understanding of its properties.

- Sources to do function tests of the high dose rate tube purchased
- Reinforced training for RP technicians
- Sorting out old instruments that often need repairs
- A comprehensive review of questions regarding radiation protection in pre job briefings

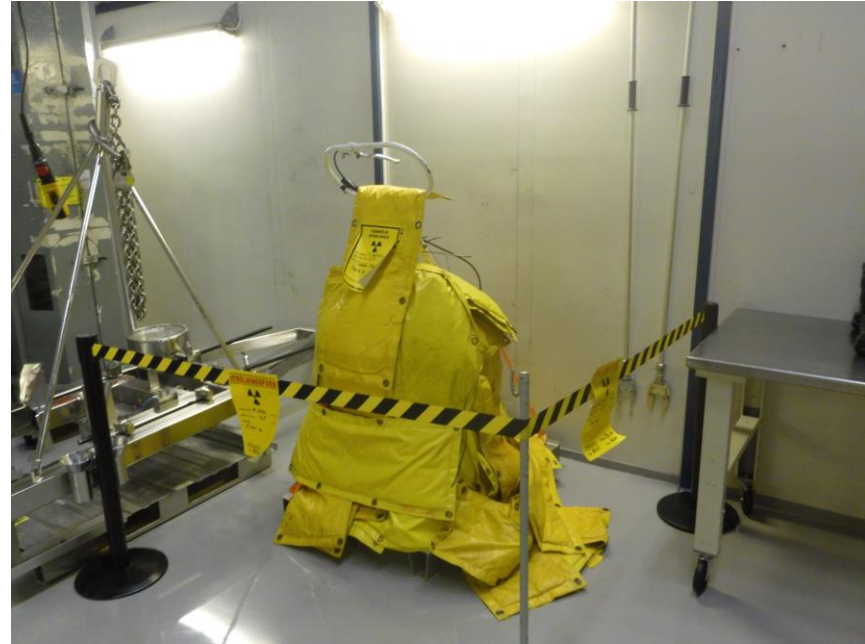
- Highest individual dose was 1,70 mSv, well under our yearly limit of 20 mSv. Verified by both EPD and TLD.
- The same person got exposed to a dose rate of 1,73 Sv/h (EPD).
- Incident classed as INES 1 according to both Forsmark and SSM.
- Gamma spectrometry showed that Co-60 was the main source.
