EPRI

Alloy 600 Inspection and Mitigation Dose Performance: 2008 Update

**ISOE North American ALARA
Symposium/EPRI Radiation Protection
Conference**

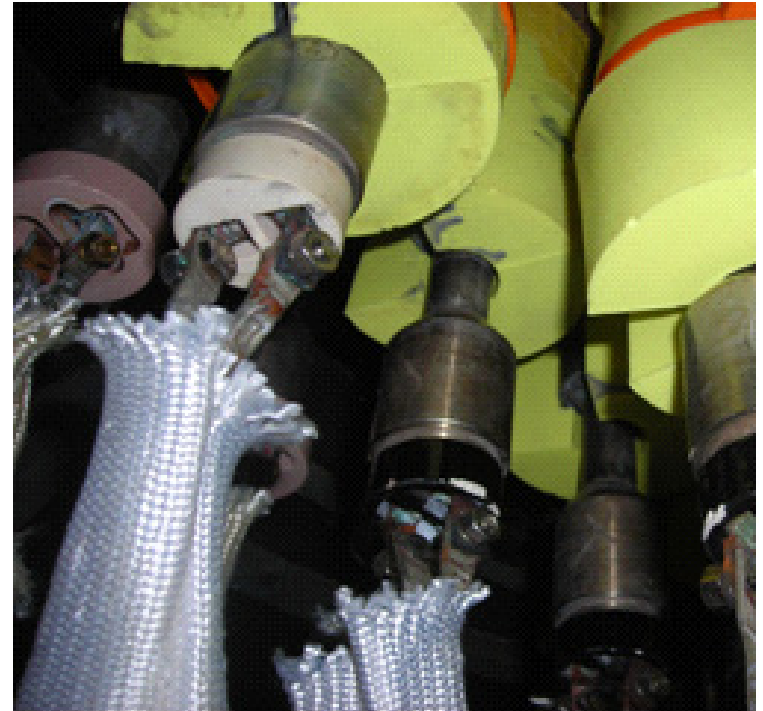
PZR Heater Penetration Sleeve
Shields

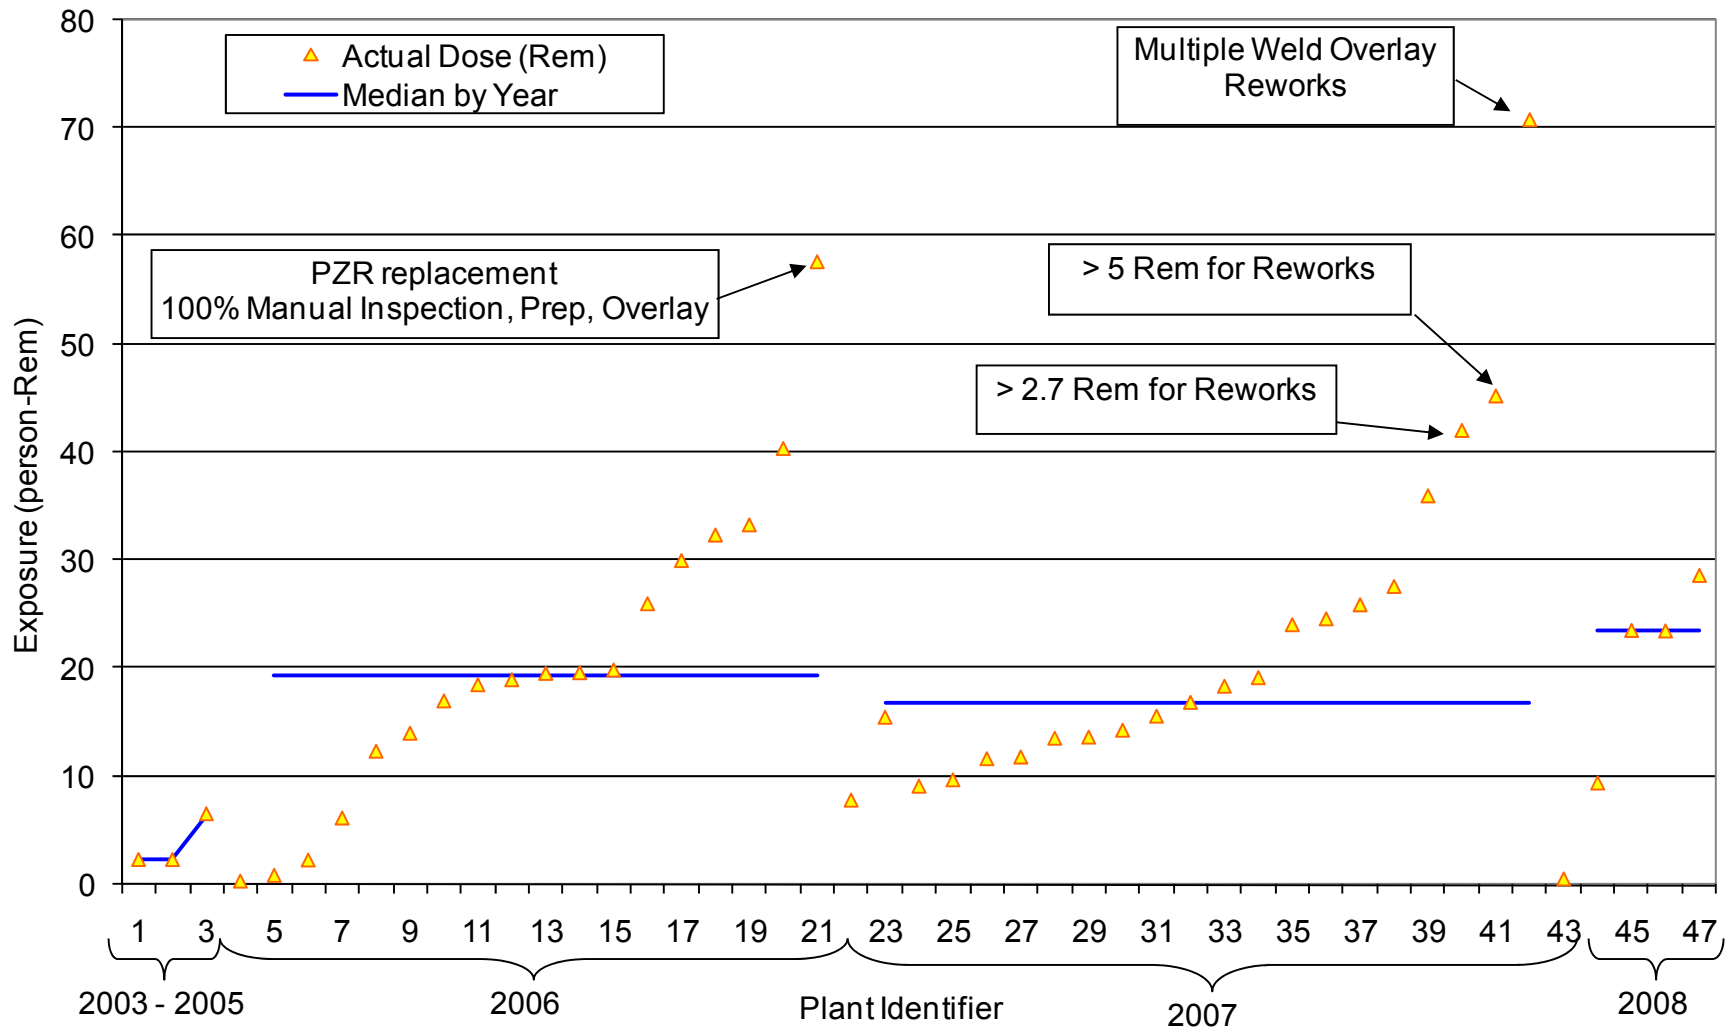
Benchmarking Alloy 600 Mitigation Exposure

Sorted by year, lowest to highest
