Rezoning for Bruce Power CANDU Reactors

2009 ISOE International ALARA Symposium 13-15 October 2009, IAEA HQ Vienna, Austria

Purpose

Share with the nuclear industry the development strategy and implementation of a major project devoted to further improving contamination control at Bruce Power.

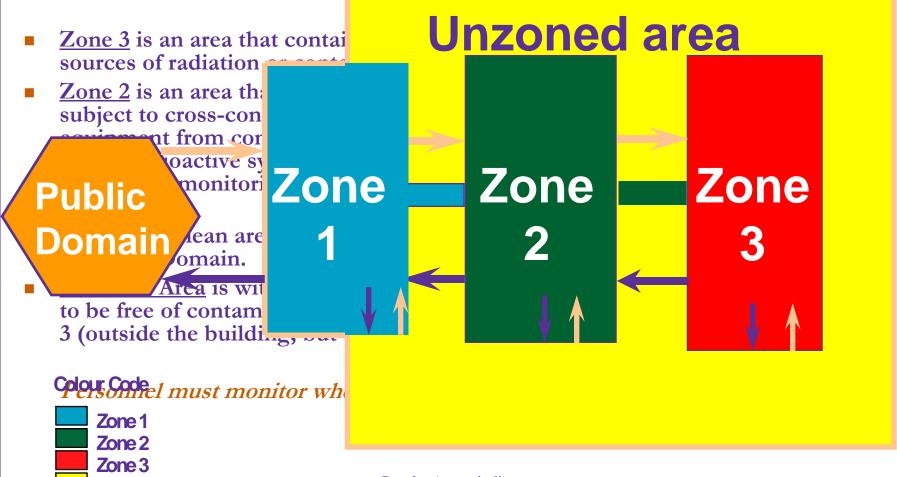
Station Layout

Each Station is laid out into 4 zoned areas.

Unzoned

Purple Arrow indicates that monitors is required.

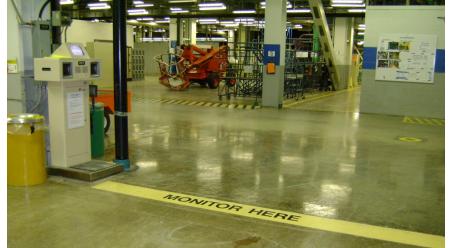
Zone 3 to 2 change

Zone Boundary -Prior to Change

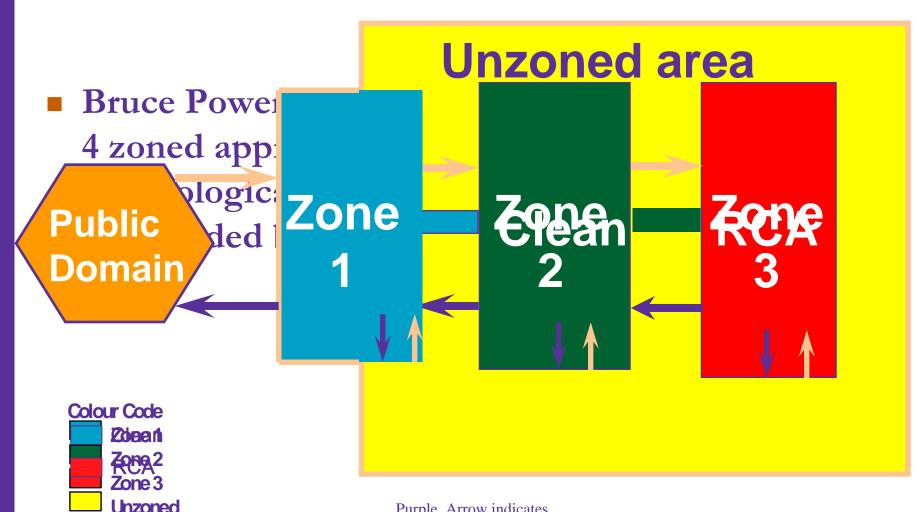
Vision of Rezoning

Purple Arrow indicates that monitors is required.

Two-phase solution

Phase 1

- Installation of new WBMs, barriers, and shielding
- Removal of obsolete monitoring devices (Hand and foot and older WBM)
- Introduction of new Personal Protective Equipment (PPE) and standards

■ Phase 2

- Formally rename the RCA
- Survey, and Verify Clean all surfaces outside the RCA
- Install new SAMs, Exit Monitors and Portal Monitors
- Introduce improved contamination control standards

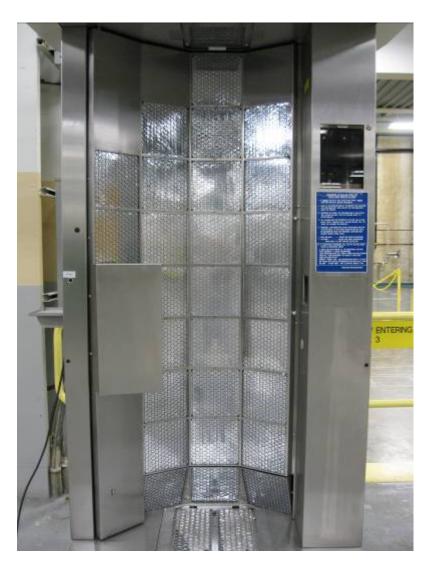
RADOS

- Gasless monitor.
- Comprehensive training for our staff.
- Advanced operating technology for easy maintenance.
- Must be robust to withstand high traffic.
- Quick detector repair/replacement, low cost.
- Superior geometry and body surface coverage.
- Be able to function from -10°C to 50°C (14°F to 122°F).
- Capability to be monitored remotely for maintenance and radiation protection purposes. (critical parameter).

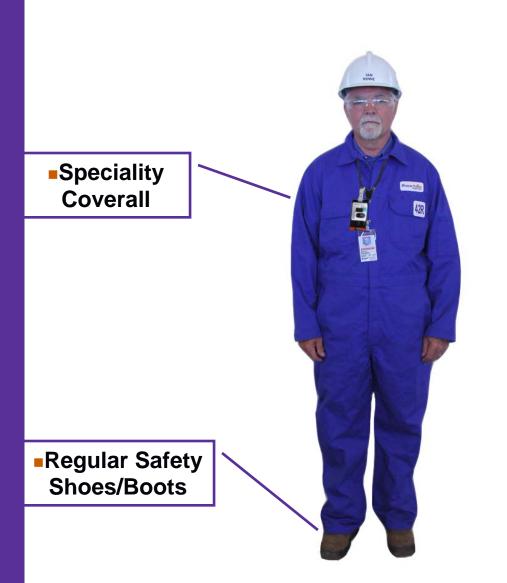
New "Specialty" PPE:

Must be worn:

- as a base garment when performing electrical work where FR rated coverall is required (arc flash protection)
- as a base garment under an Anti-C ensemble when performing contact contamination work
- as a base garment under a plastic suit

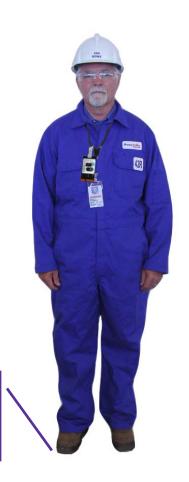
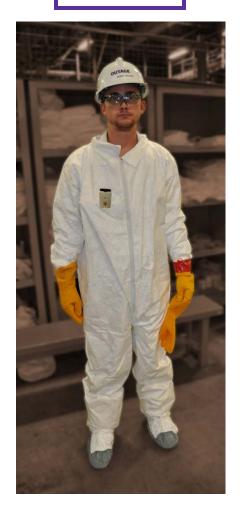
New Contact Contamination Work RPPE:

SpecialityCoverall

Anti-CEnsemble

RegularSafetyShoes/Boots

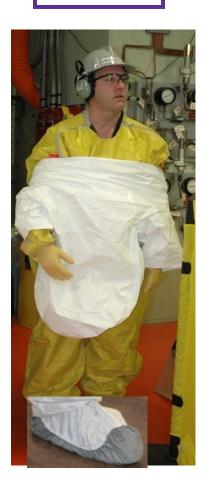
New Plastic Suit RPPE:

PlasticSuit

Regular
Safety
Shoes/Boots
