Advances in Radiation Instrumentation to Achieve Enhanced Characterization of Source Term Reduction Results

David W. Miller, PhD

Cook Nuclear Plant

ISOE International Symposium

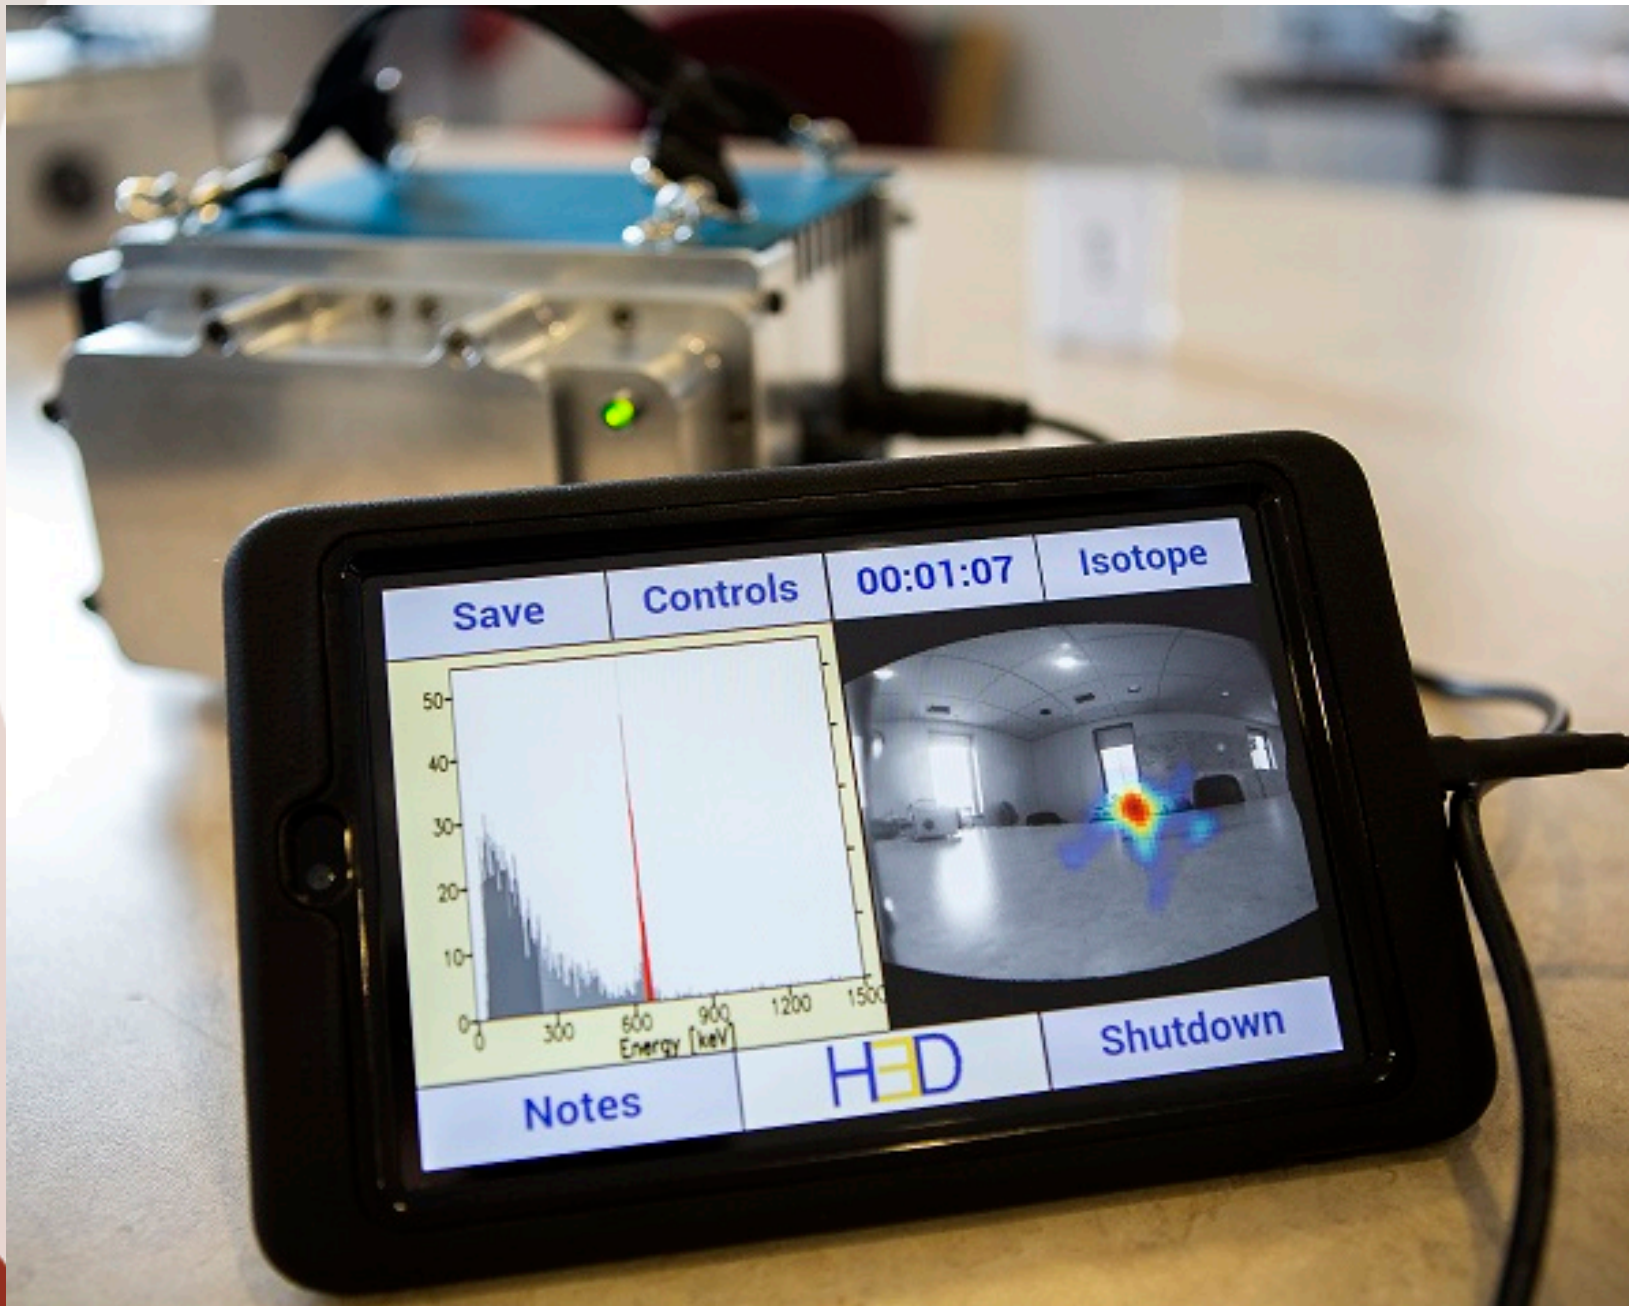
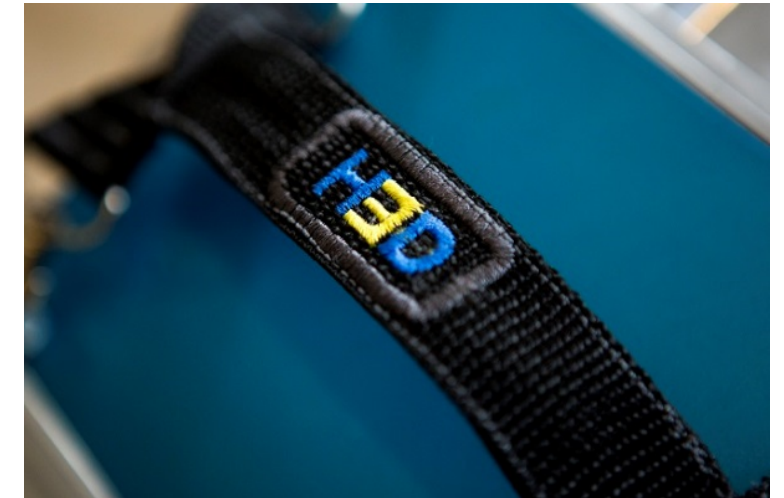
- 8.5 lbs
- Battery operated (5 hr)
- Washable for easy decontamination
- “Simple” user interface
- $\leq 1.1\%$ FWHM energy resolution at 662 keV
- Omnidirectional imaging

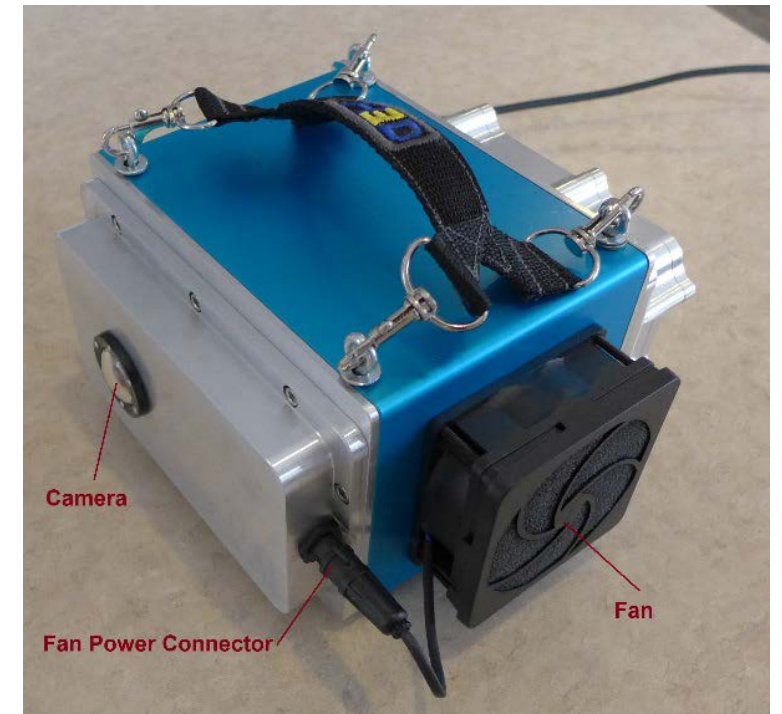
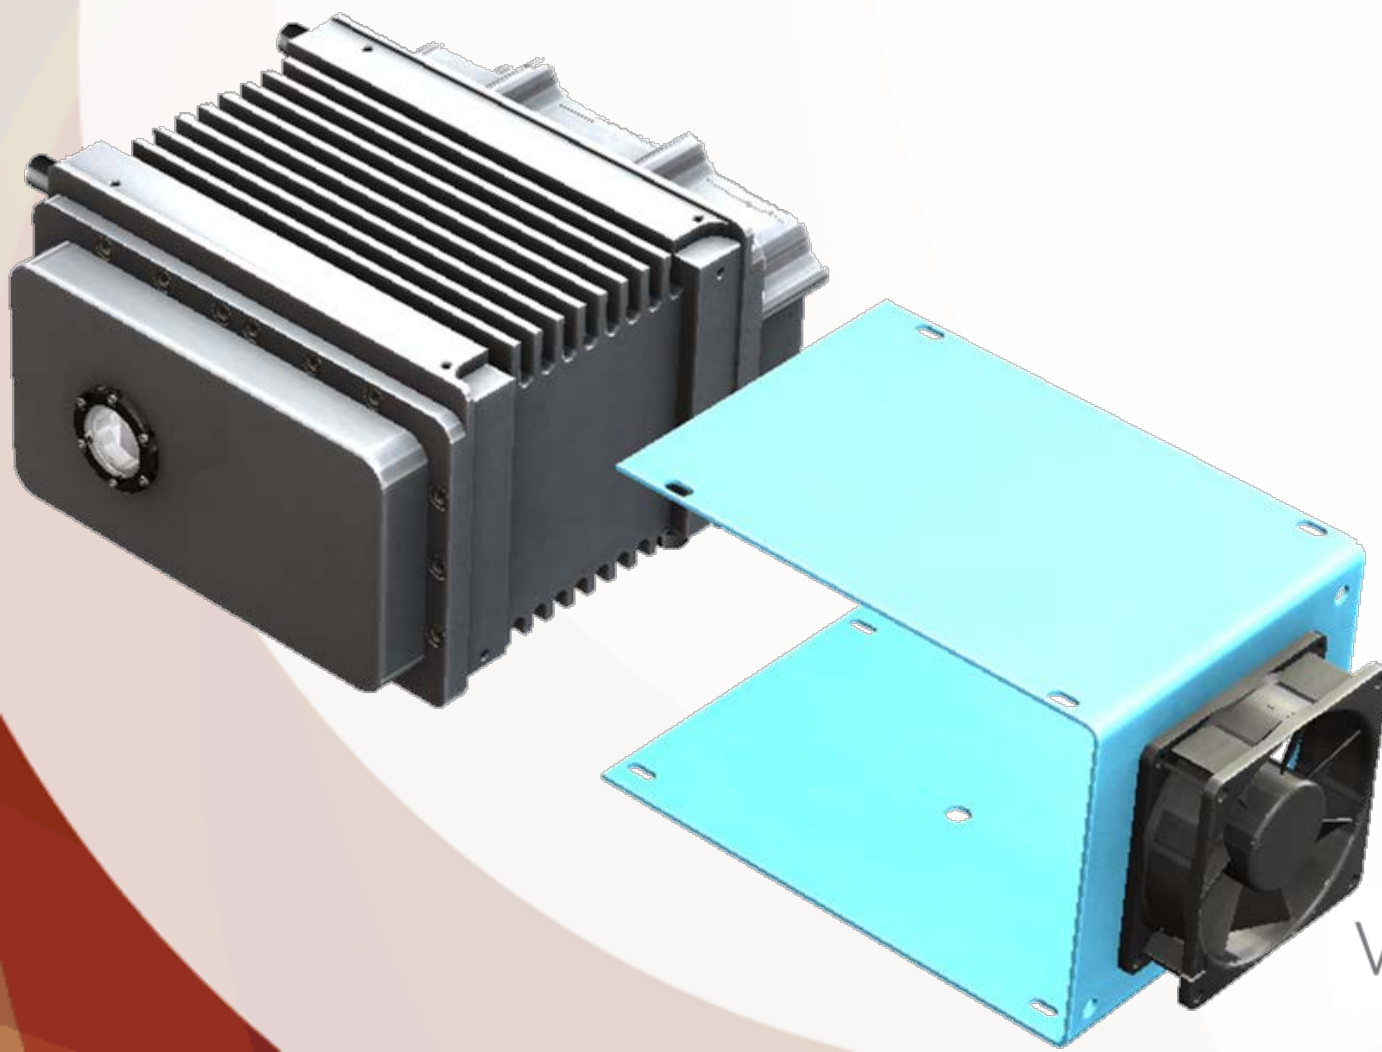
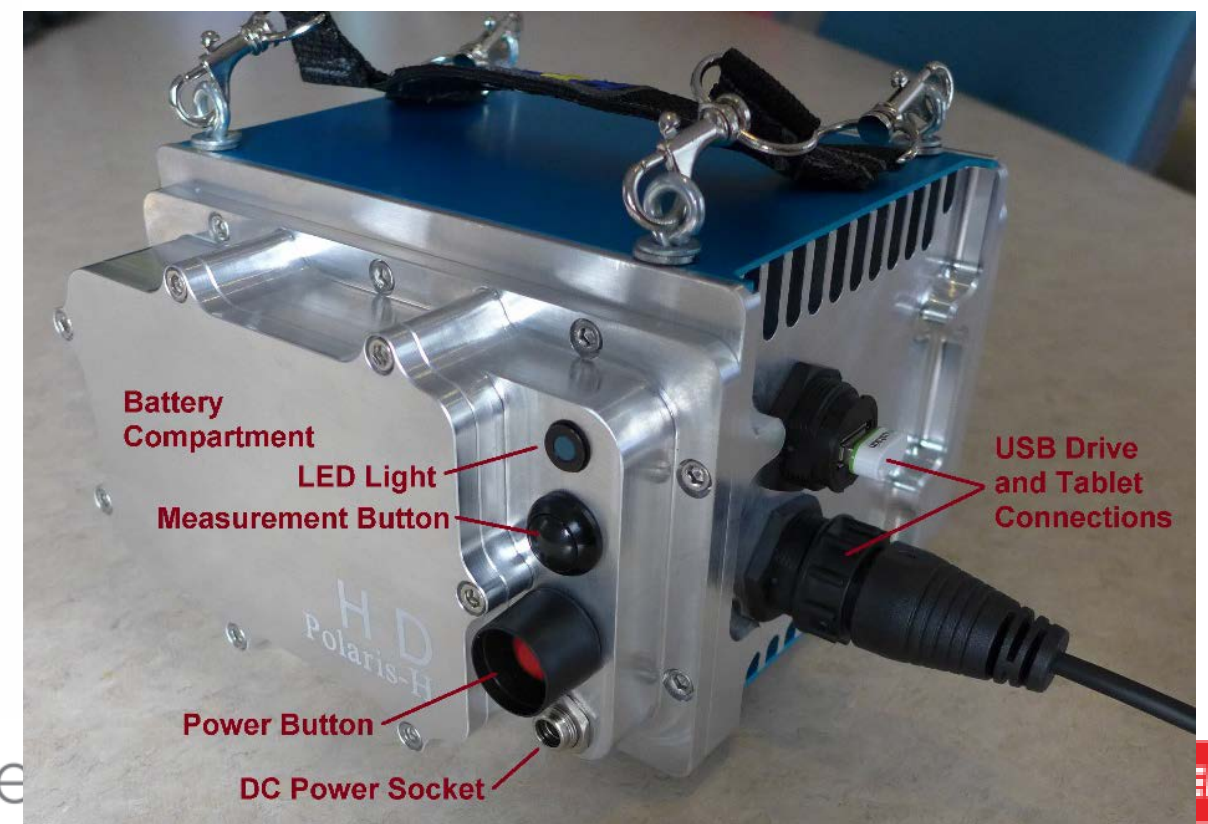
- $\sim 2\pi$ optical camera for overlay of radiation image
- Compton imaging ~ 250 keV to 3 MeV
- Communication with tablet display via Wi-Fi, Bluetooth, USB, or Ethernet to network
- Fan and external fins for temperature regulation

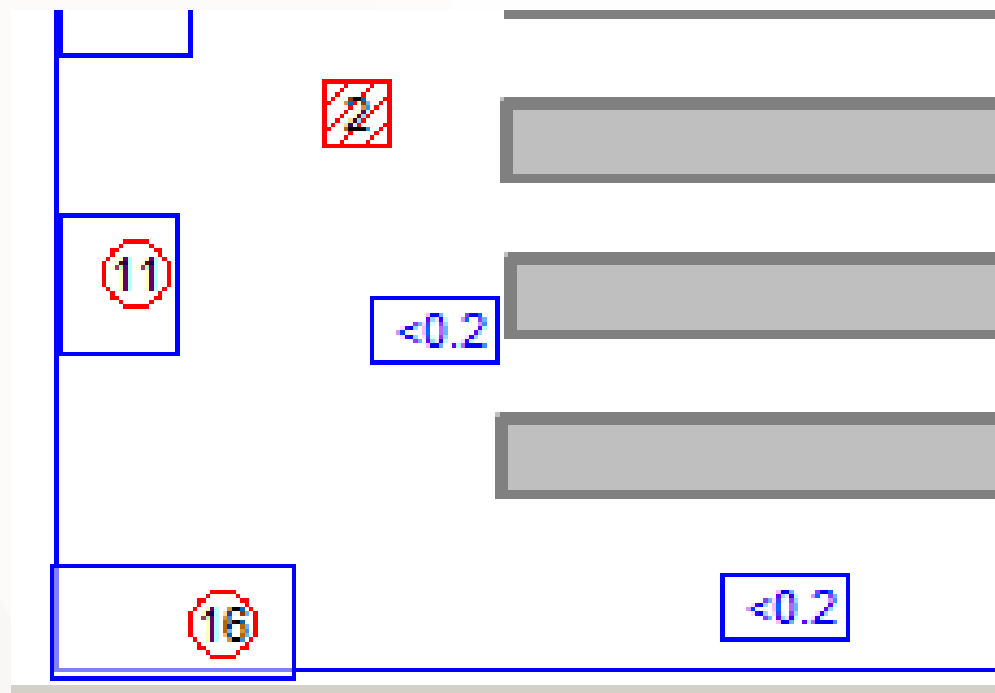
Typical Dose Rates

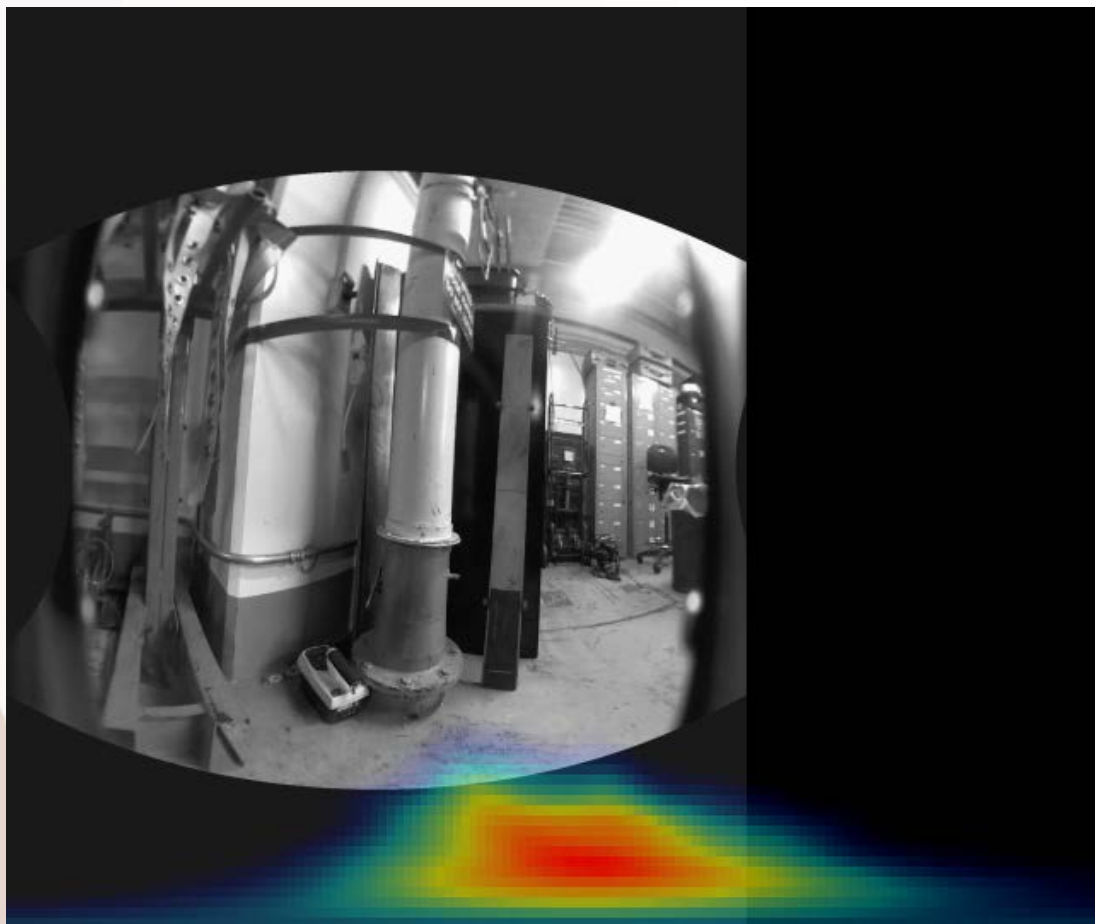
Image of Co-60:

- HTC Workers Instructed to avoid whole area near floor cover
- Increased Importance to Refill Demin prior to refueling outage
- Filled Demin decreased Dose Rates

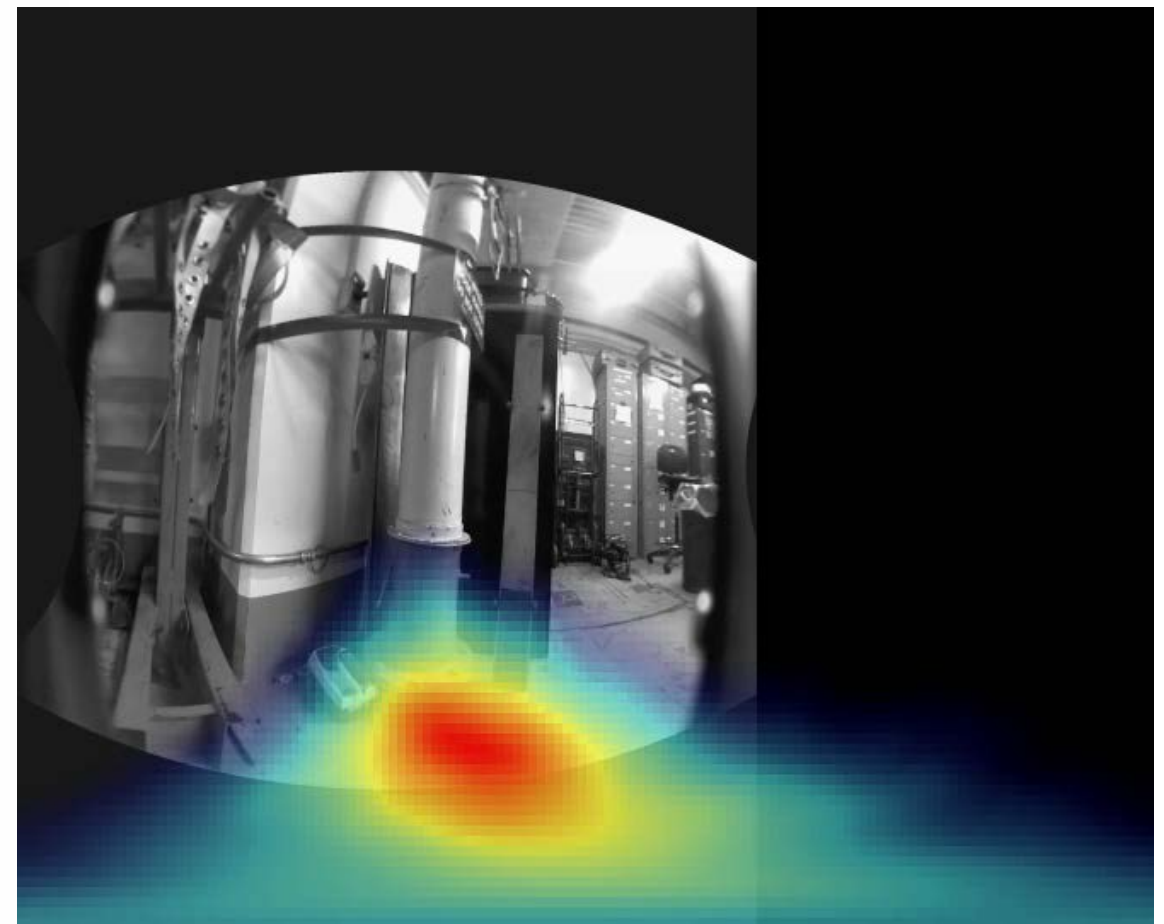
Image of Scatter:

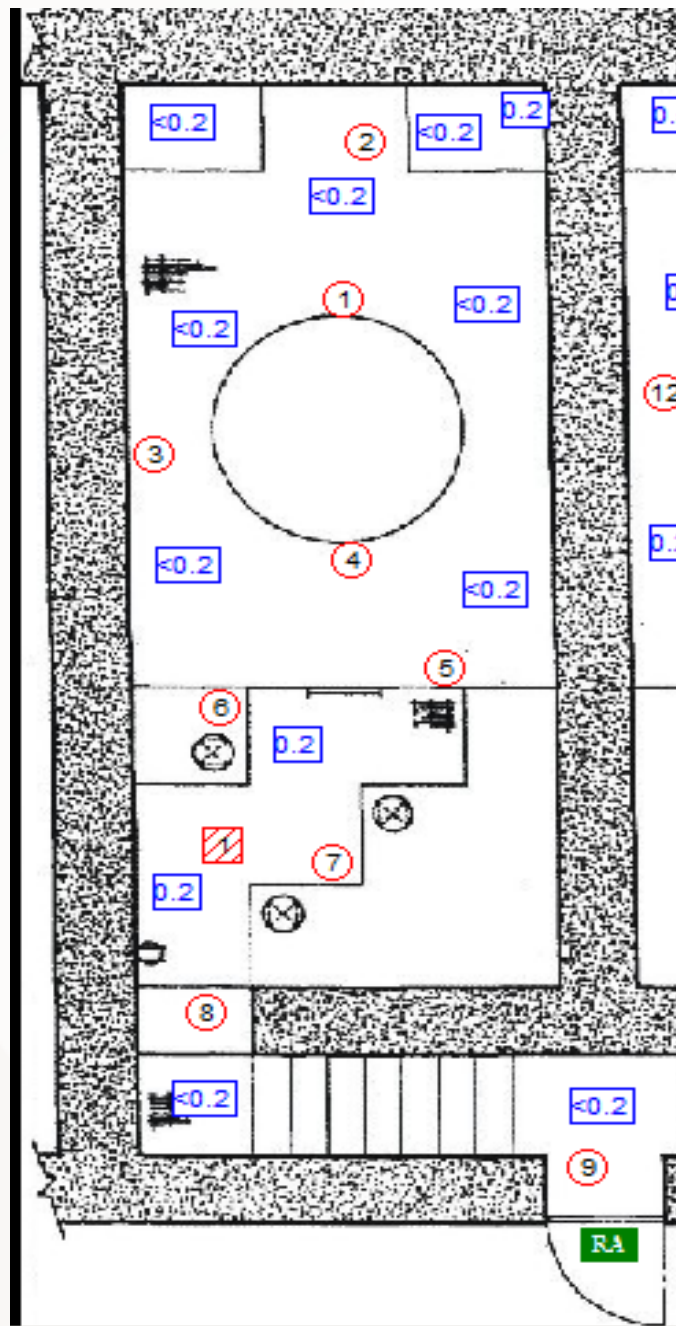
11/3 – Routine Survey

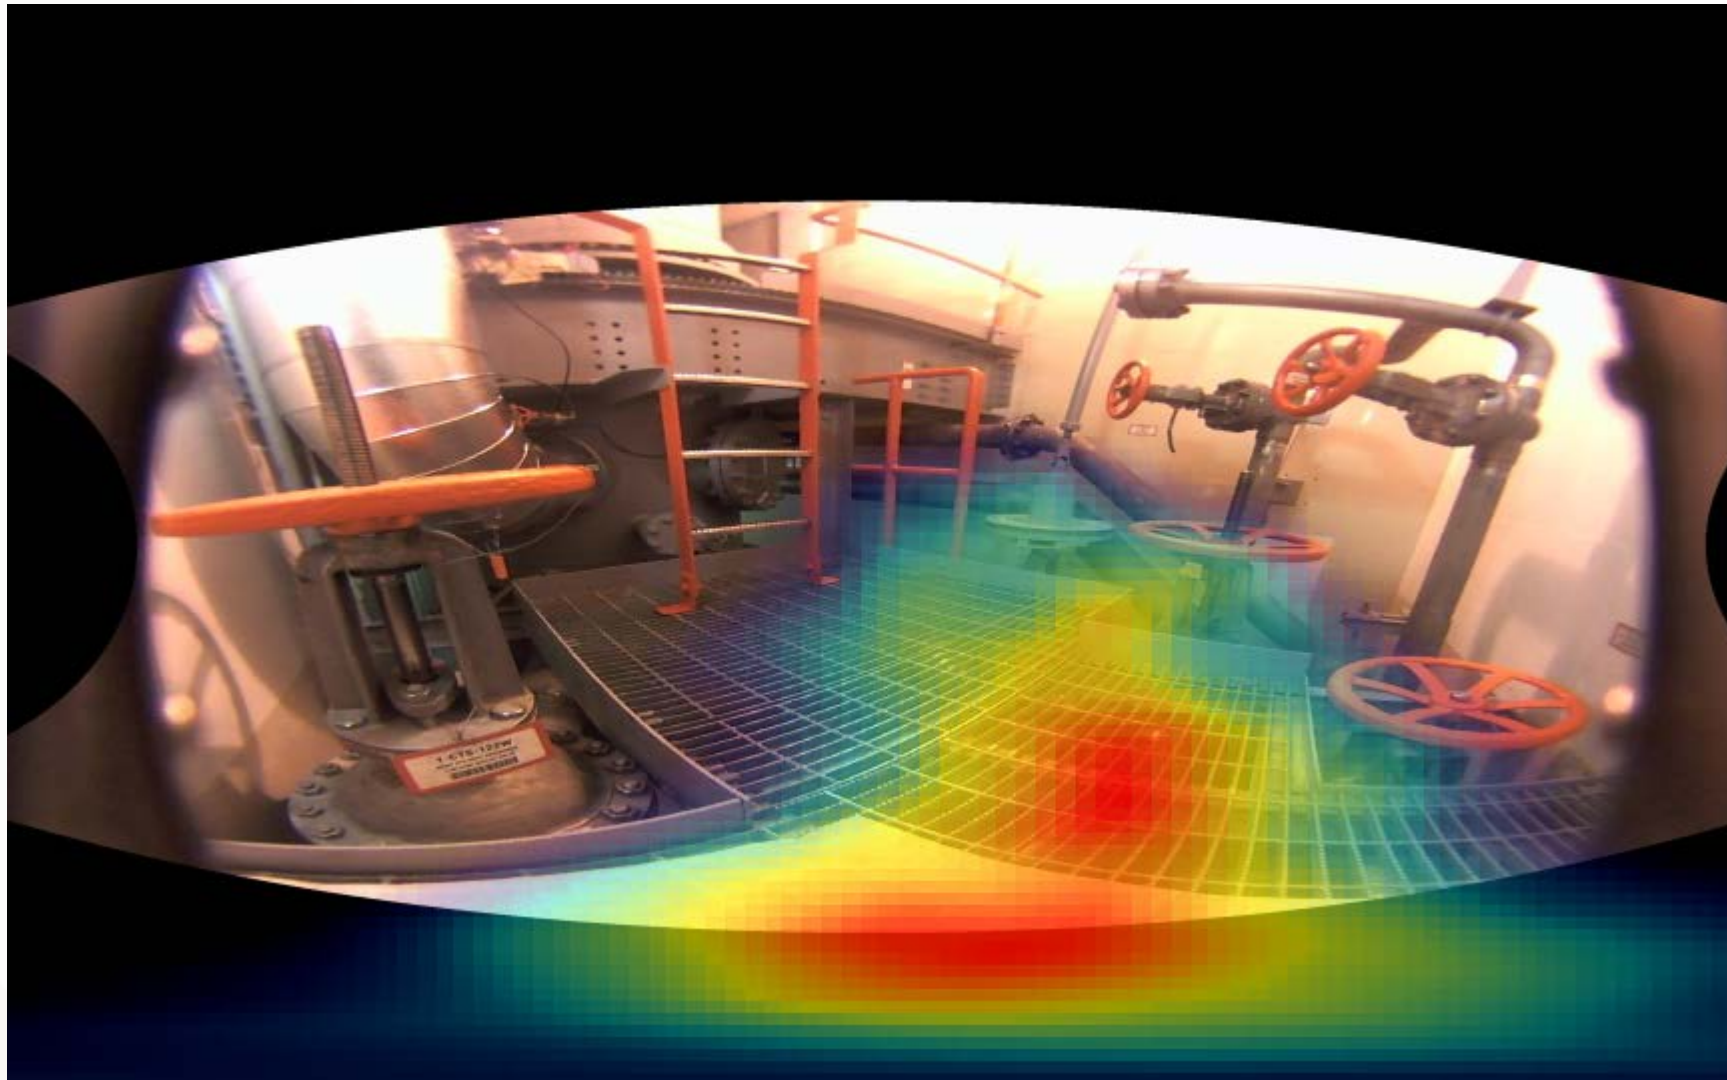
Co-58 – Highest contact DR: 2.1 mR/hr
– Highest GA DR: 0.5 mR/hr

- Co-58 was primary contributor to increased dose rates.
- Dose Rates coming from line used for leak test
- Recommendation was made to decay system instead of flush system.

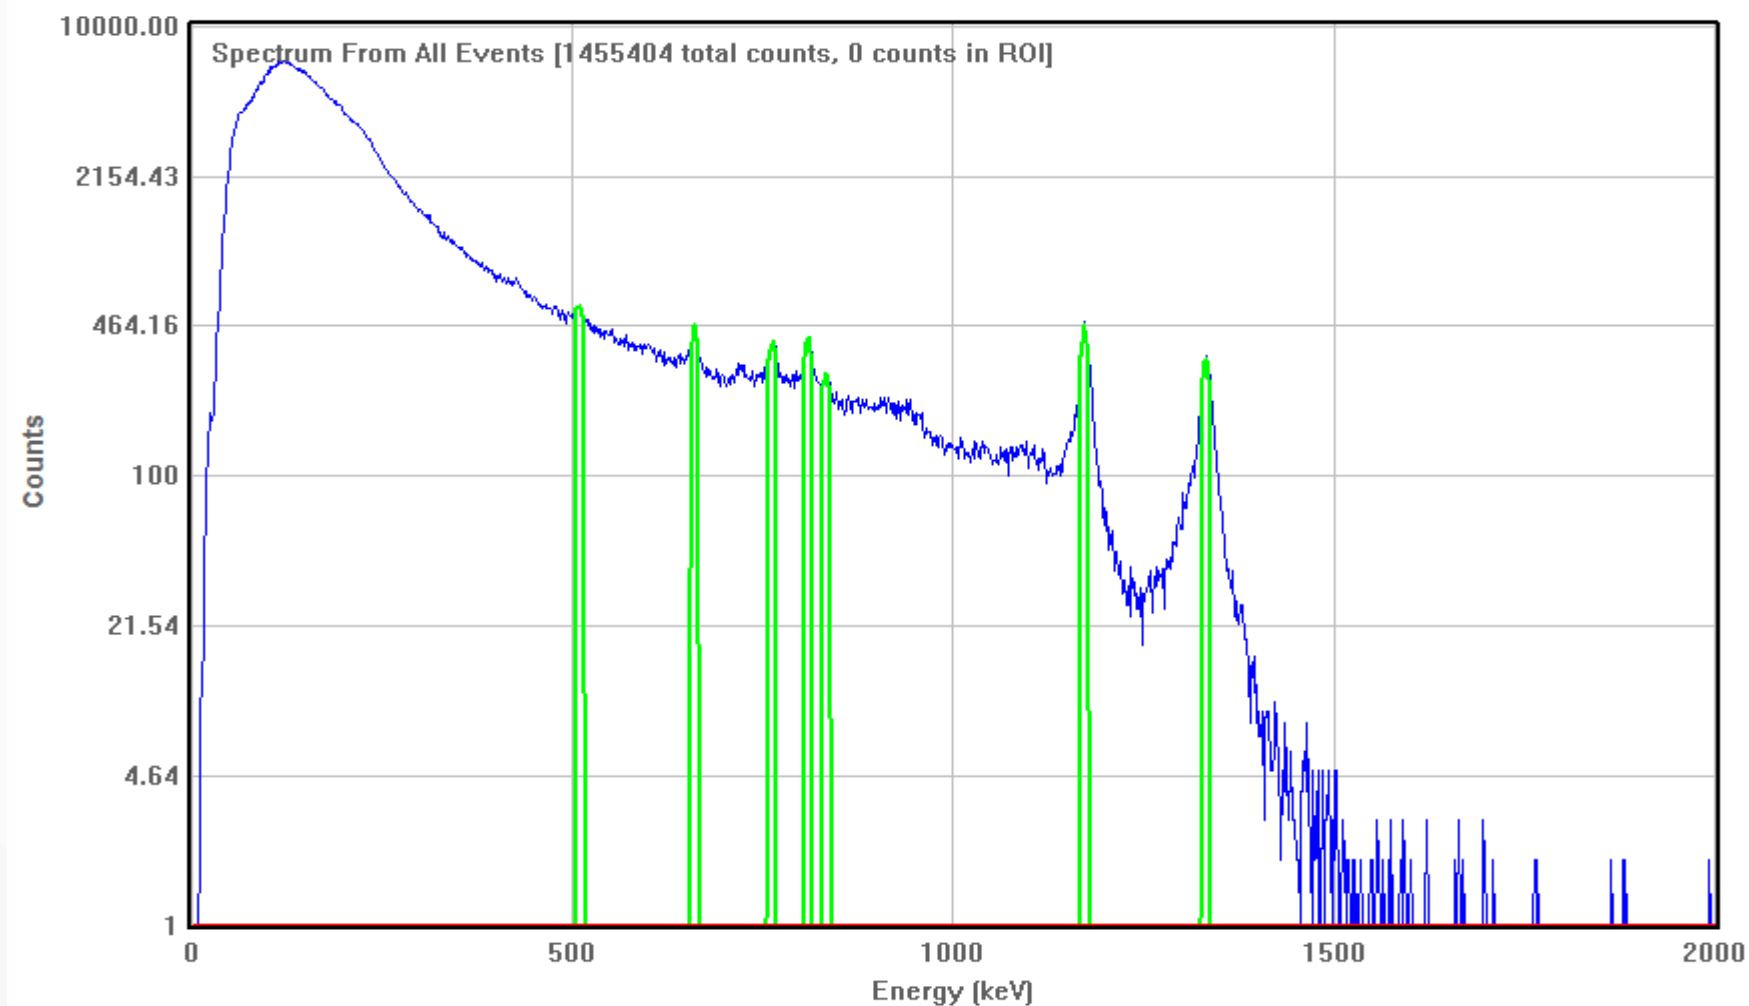
S. Waste Gas Compressor:
Co-58, Co-60, Cs-137, Mn-54, Nb-95

- When the spent resin storage tank was filled water solid, the vent path allowed water to enter the plant vent header.
- This water cleared out particles entrained in the piping and flowed down to the drain tank.
- The gas / vapor with the radioactive particles was drawn into the south compressor suction.

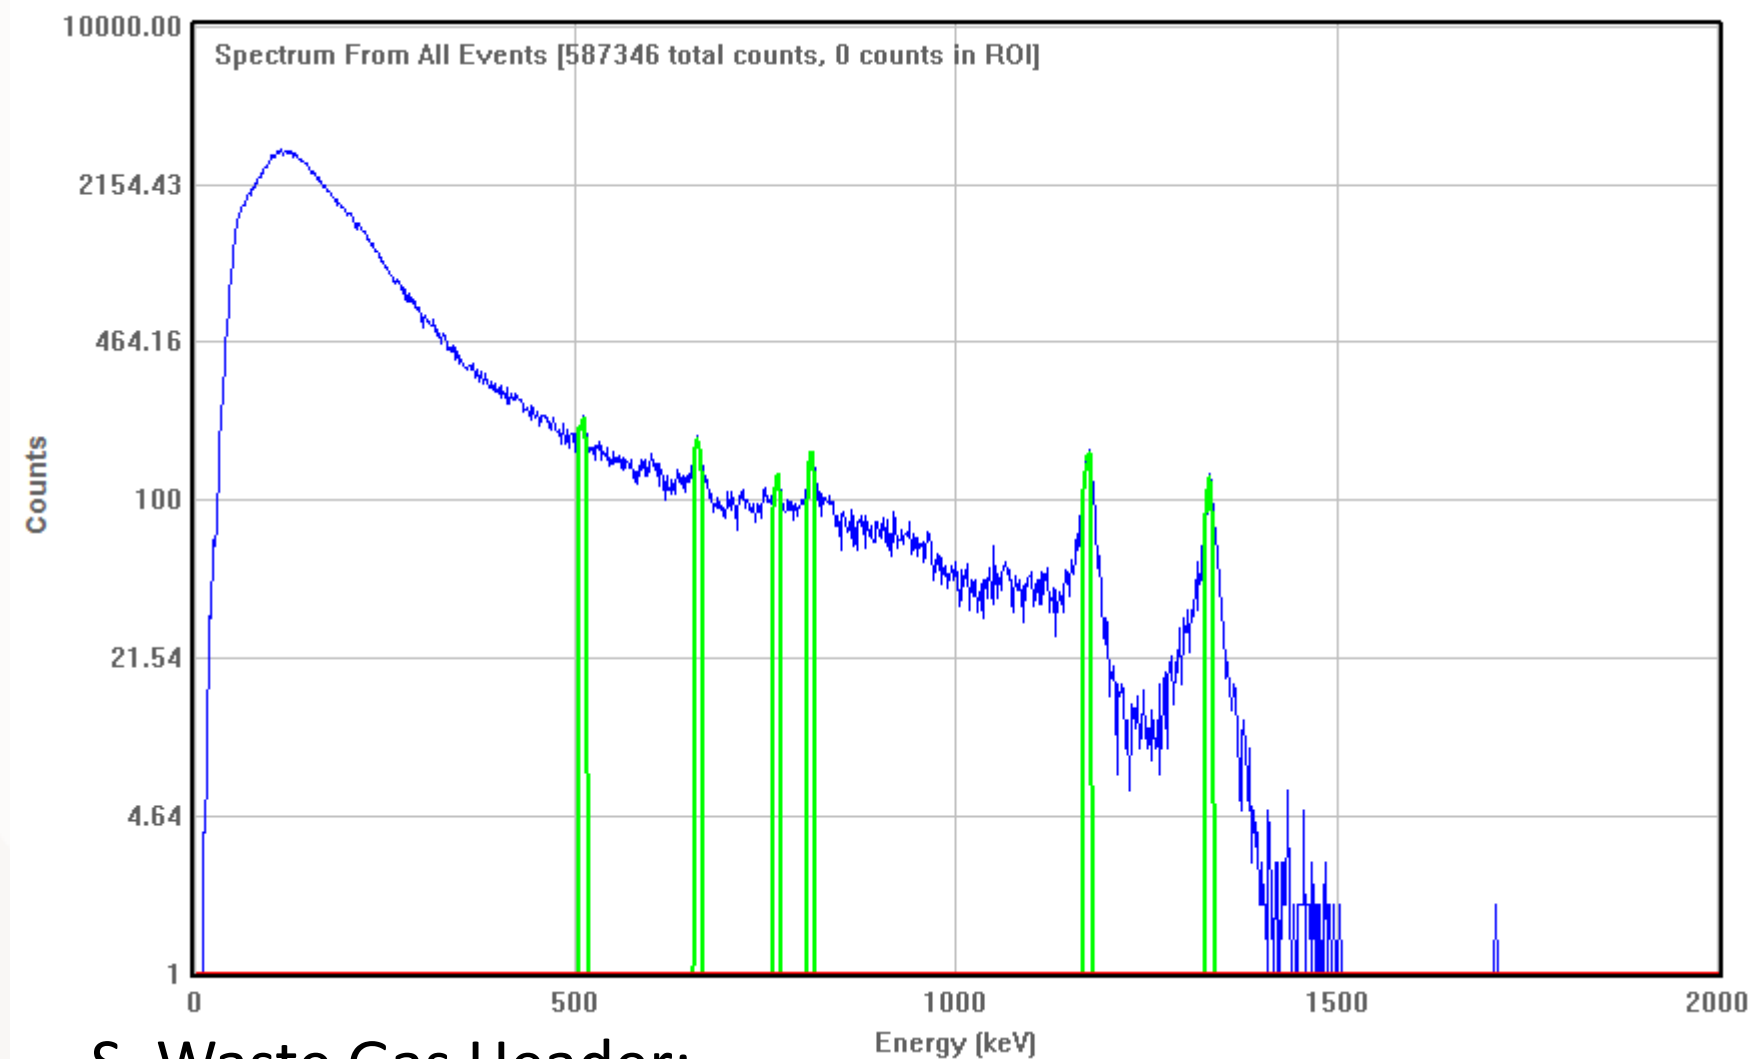
S. Waste Gas Header:
Co-58, Co-60, Cs-137, Nb-95

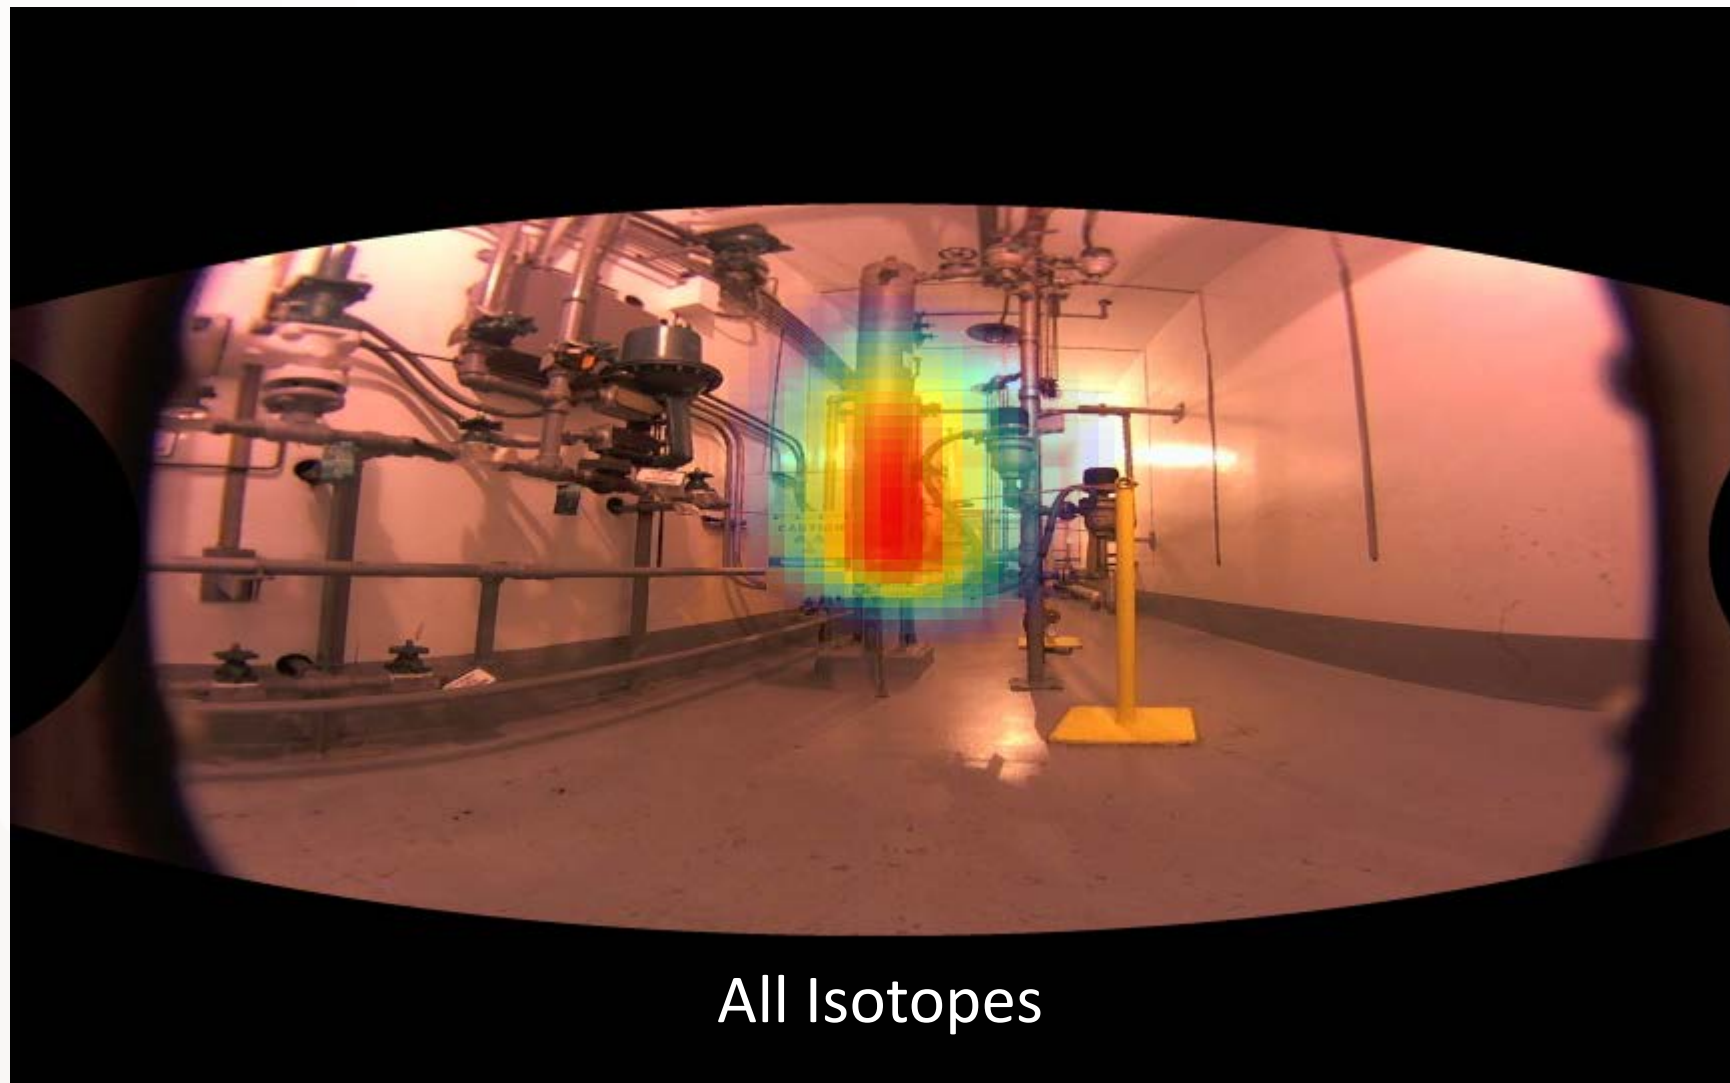
All Isotopes

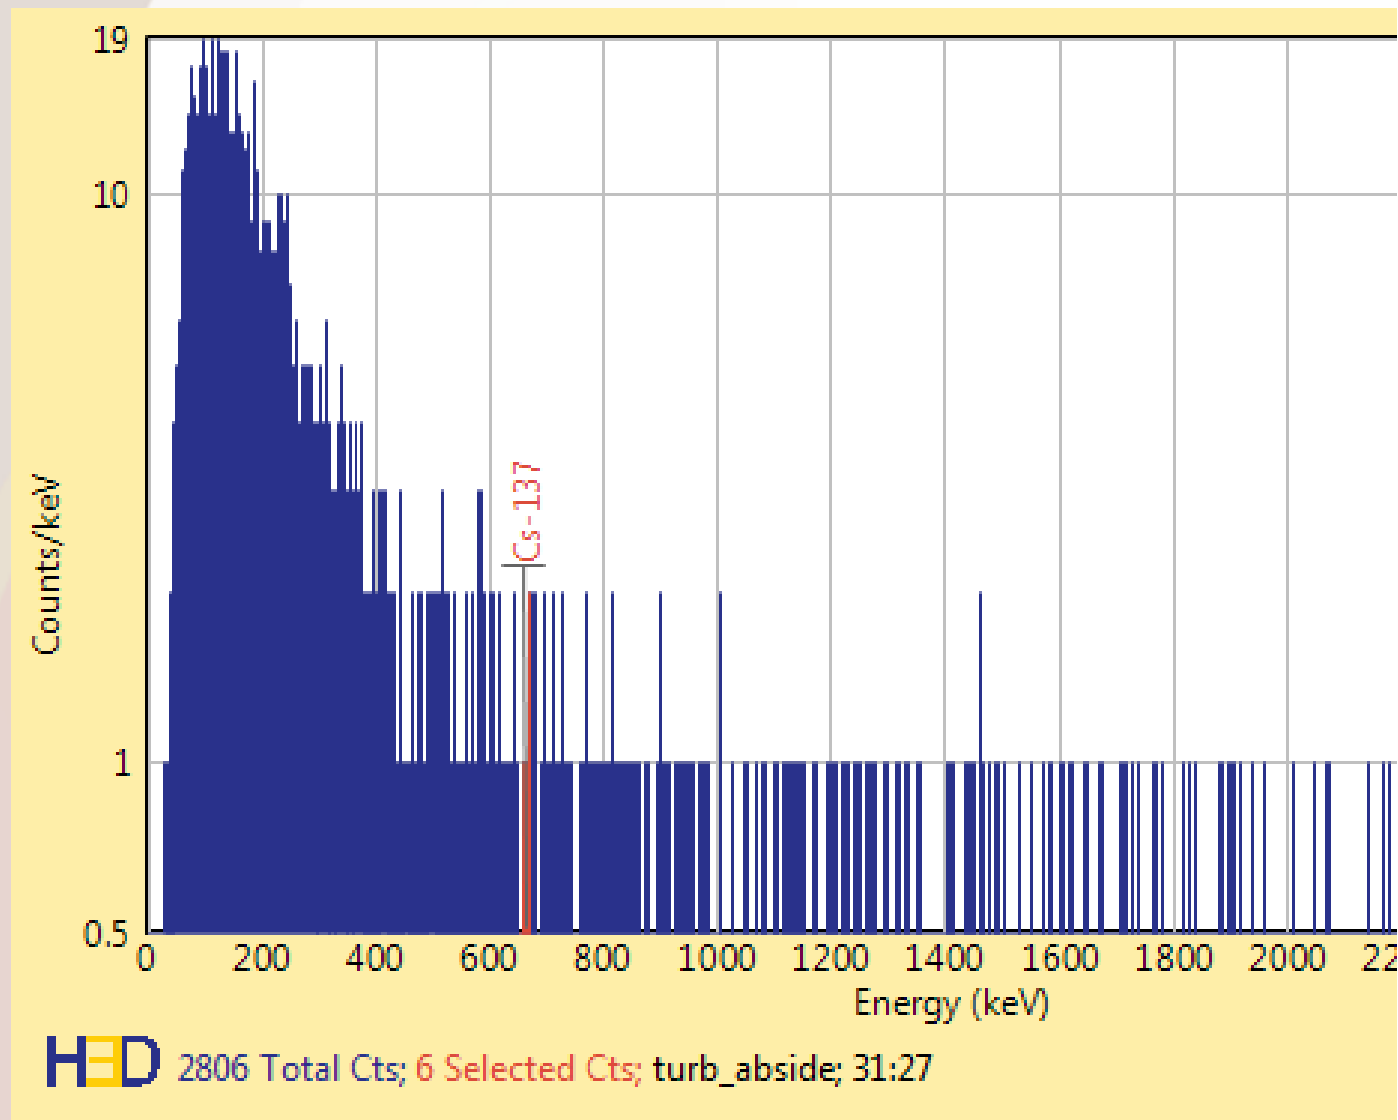
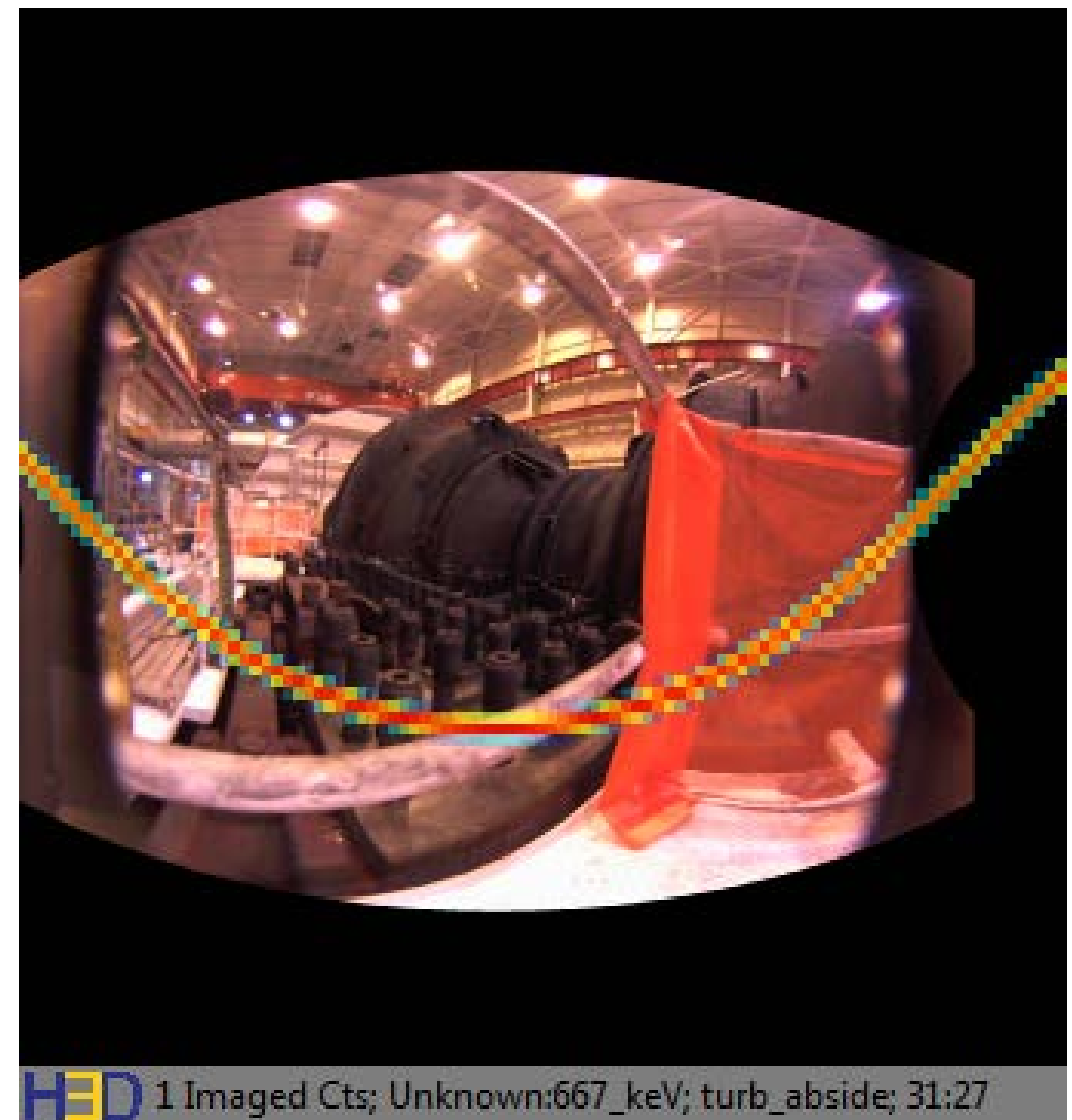
LPT 'B' O/S of Inner Cover

2 CPS – No noticed contamination. It's a good zero!

Something needs to be selected. Cs-137
most probable isotope, nothing above bkgd

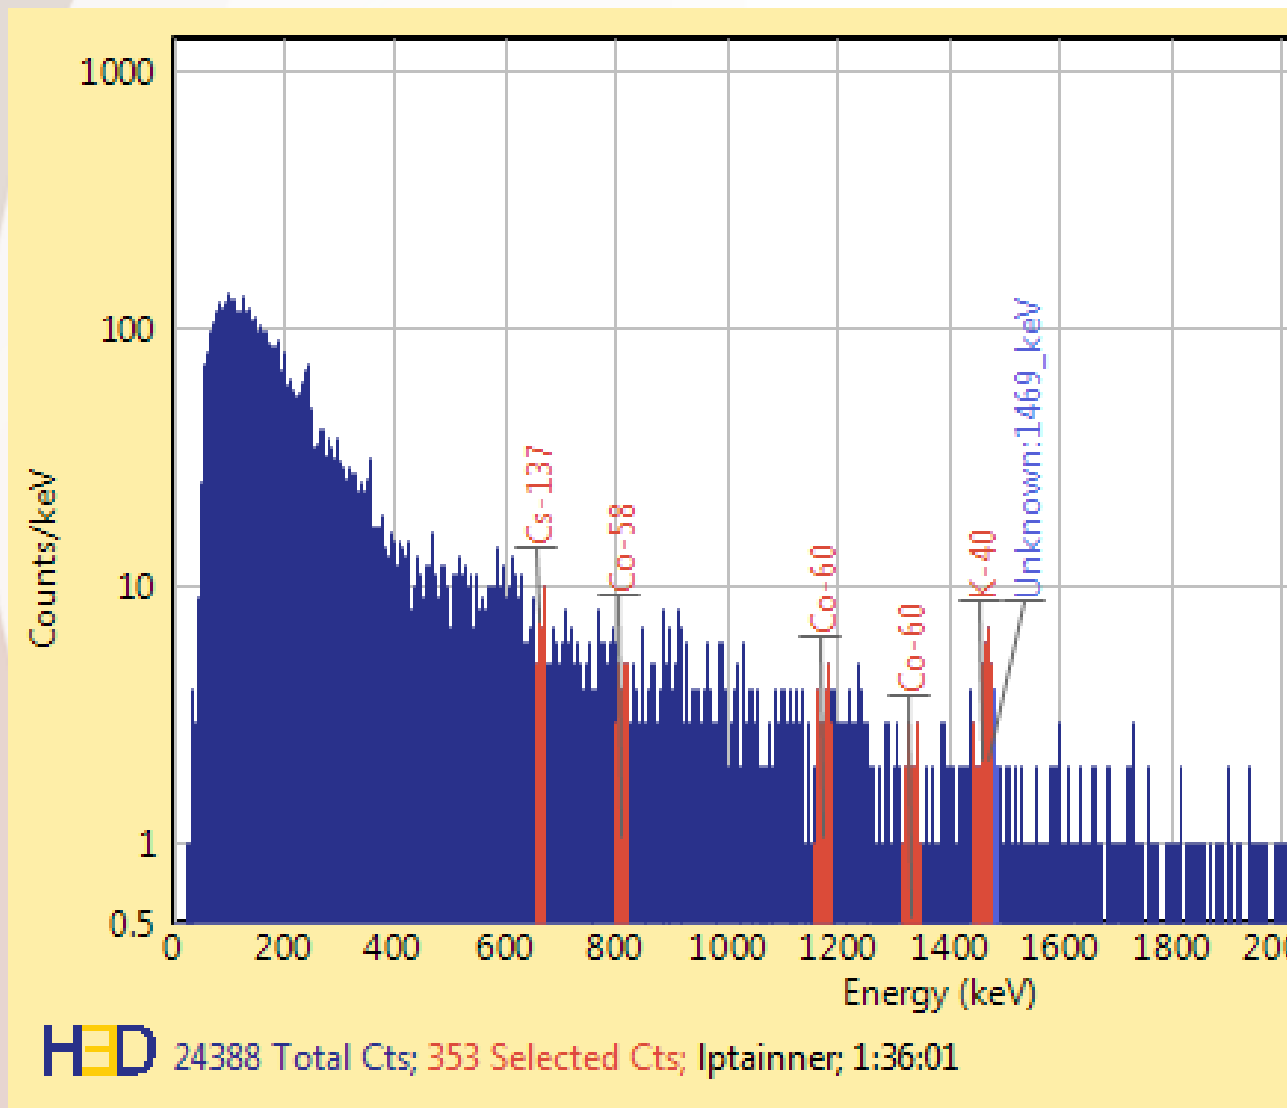
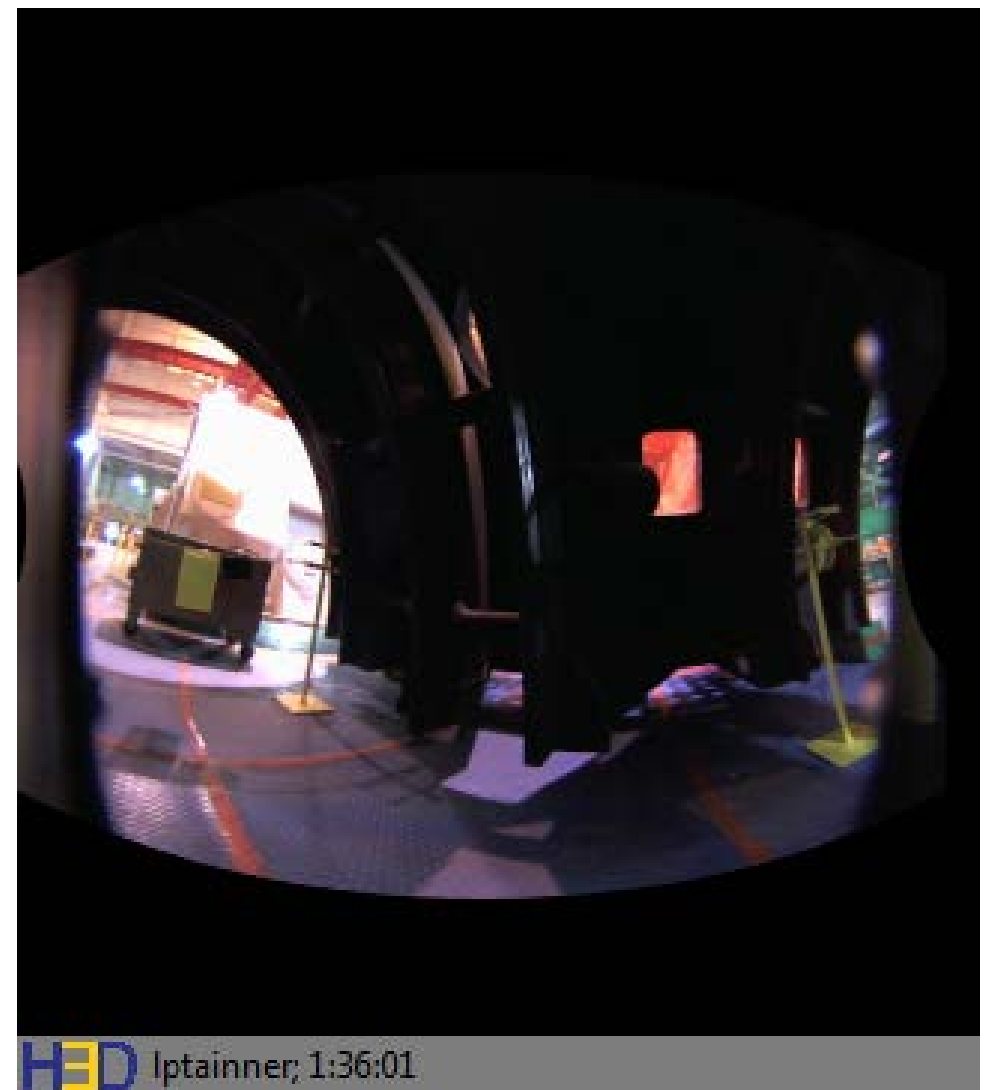
LPT 'A' – I/S Inner Cover (Posted Restricted Area from Survey)

1 hour 30 minute measurement – No plant identified peaks

Unknown Peak is K-40 – Software misidentification. Only noted peak on spectrum.
Other isotopes selected as reference
