Advances in Radiation Instrumentation to Achieve Enhanced Characterization of Source Term Reduction Results

David W. Miller, PhD

Cook Nuclear Plant

ISOE International Symposium

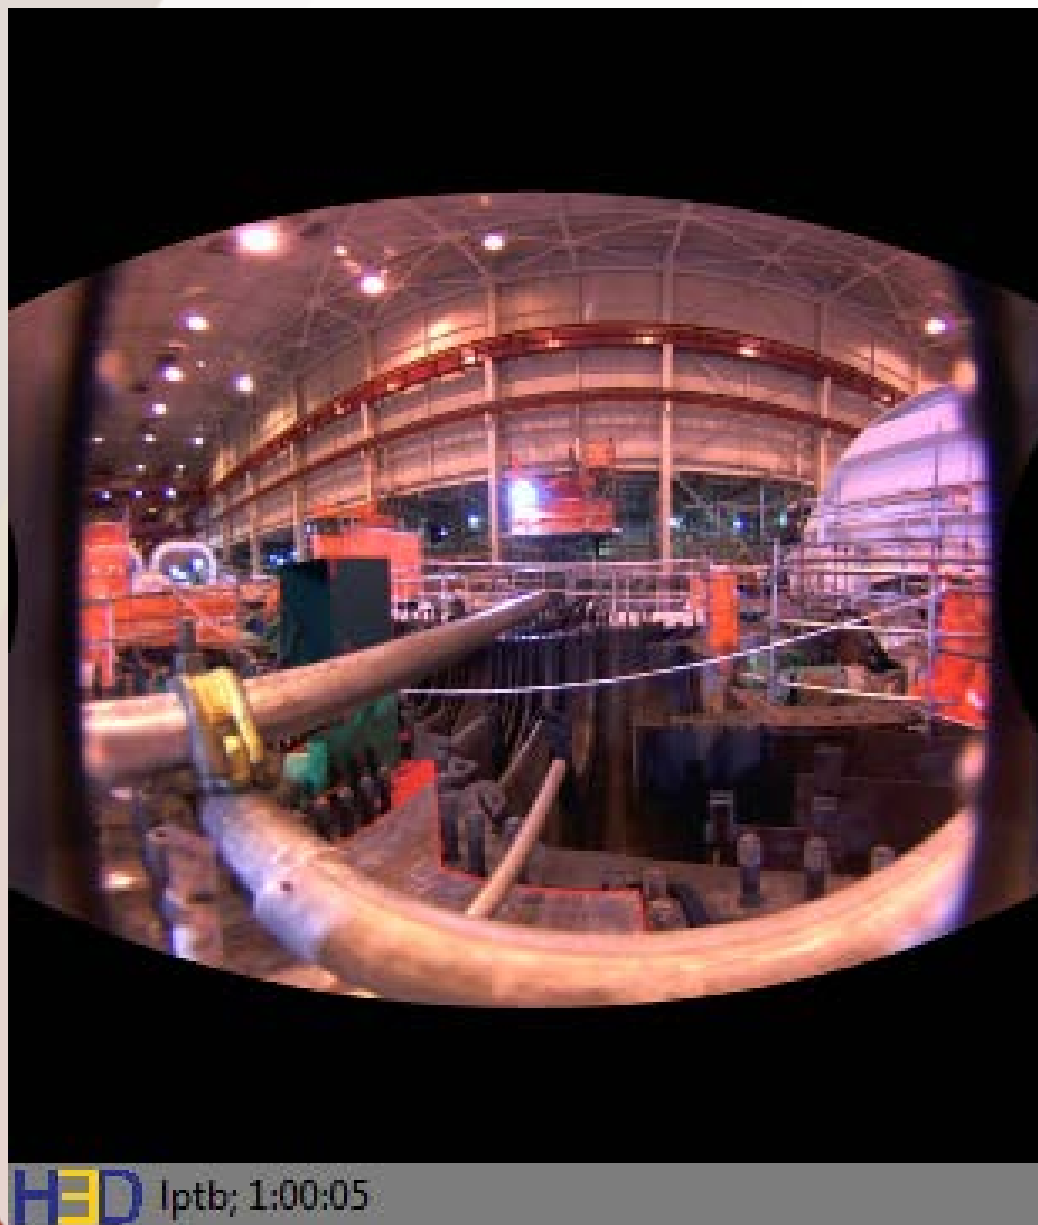
HED lptb; 1:00:05

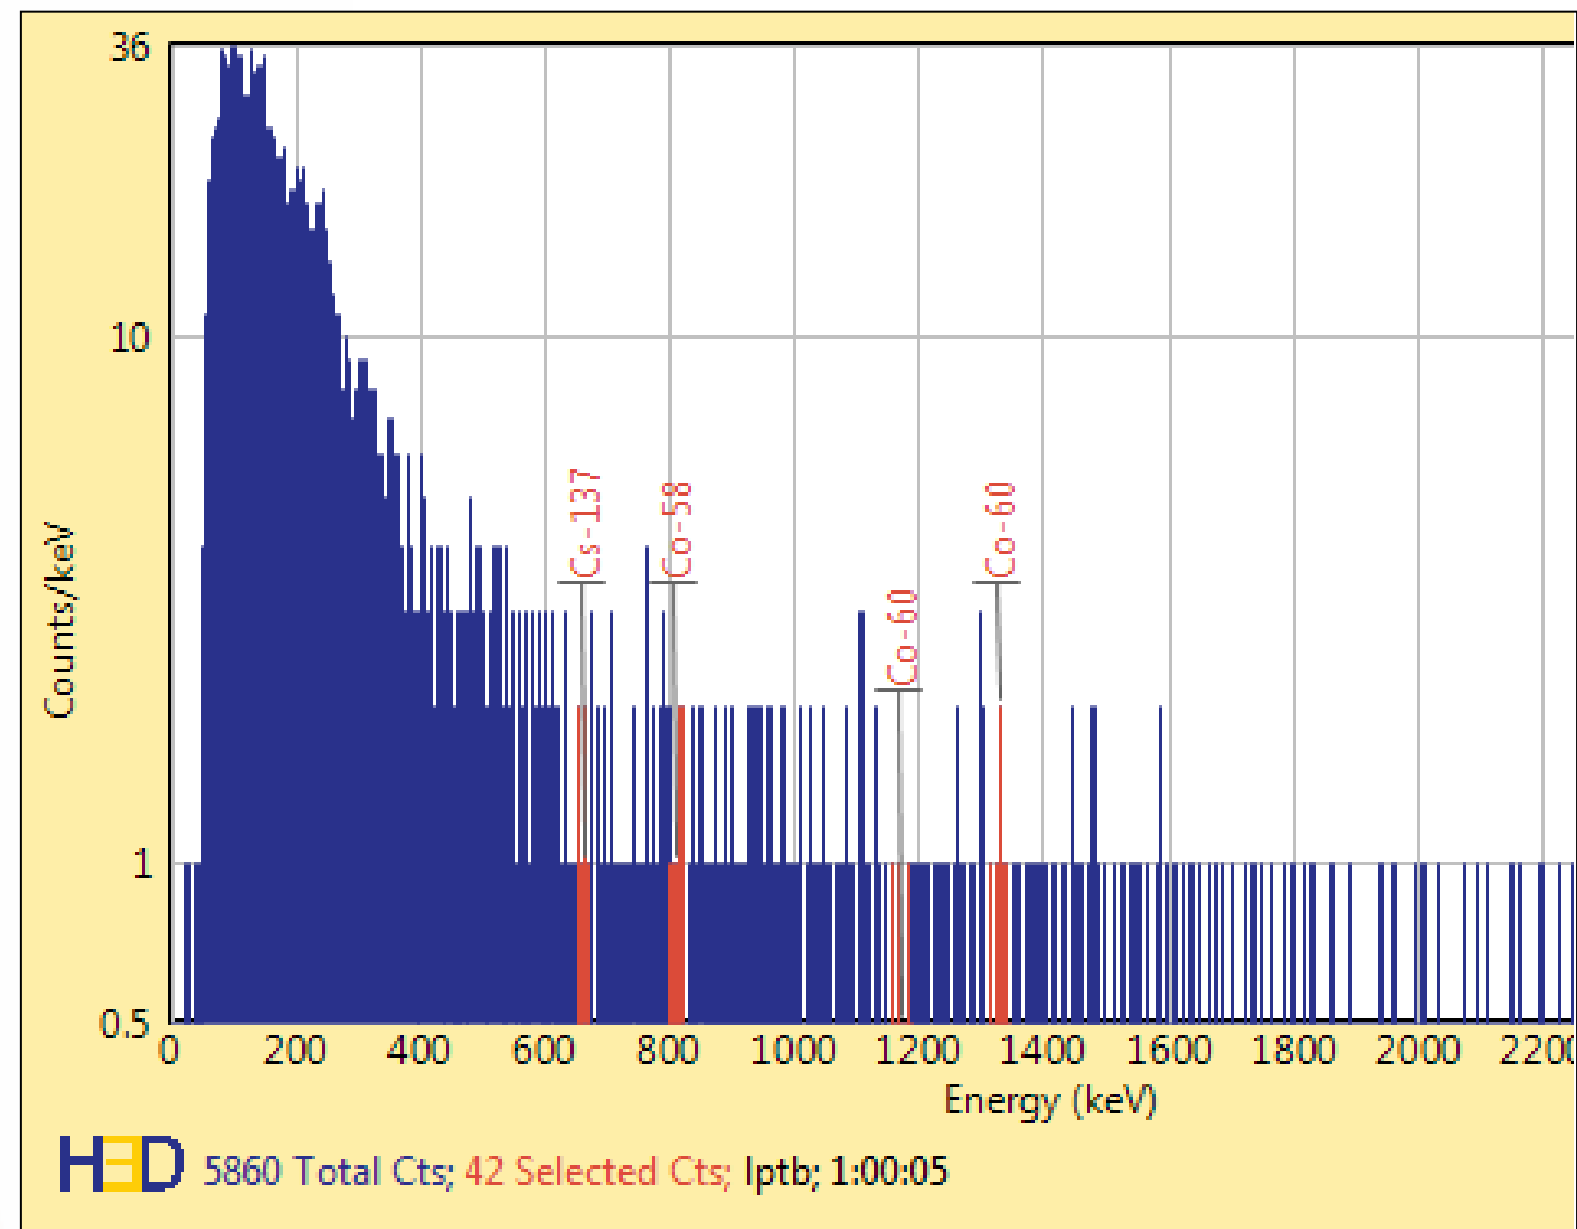
“Co-58” – 3 imaged counts

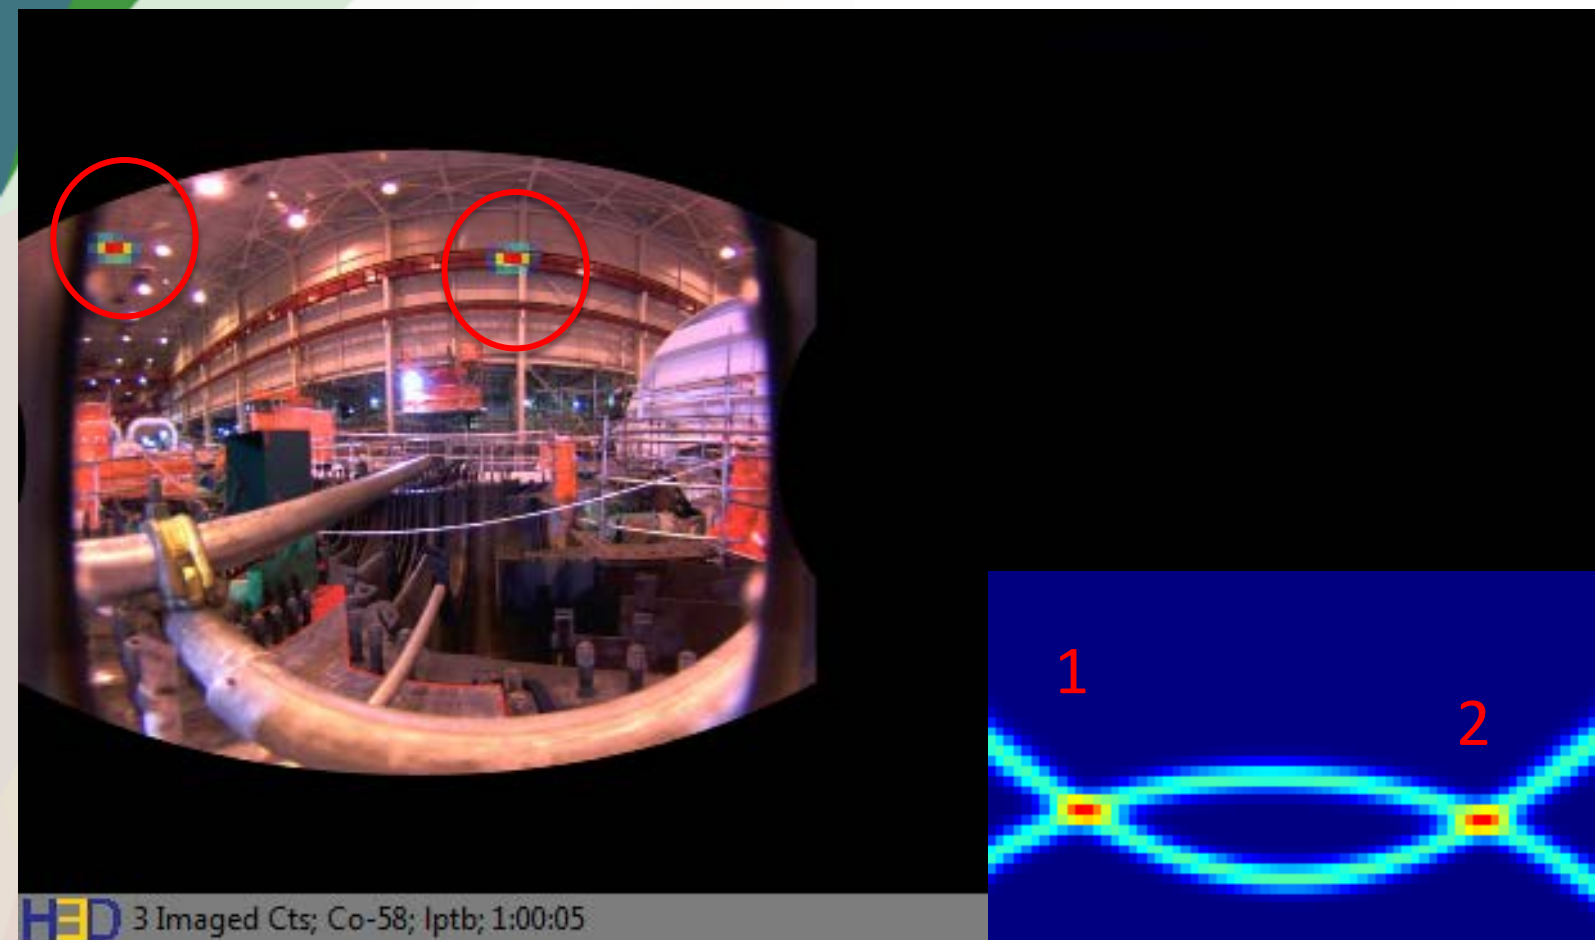
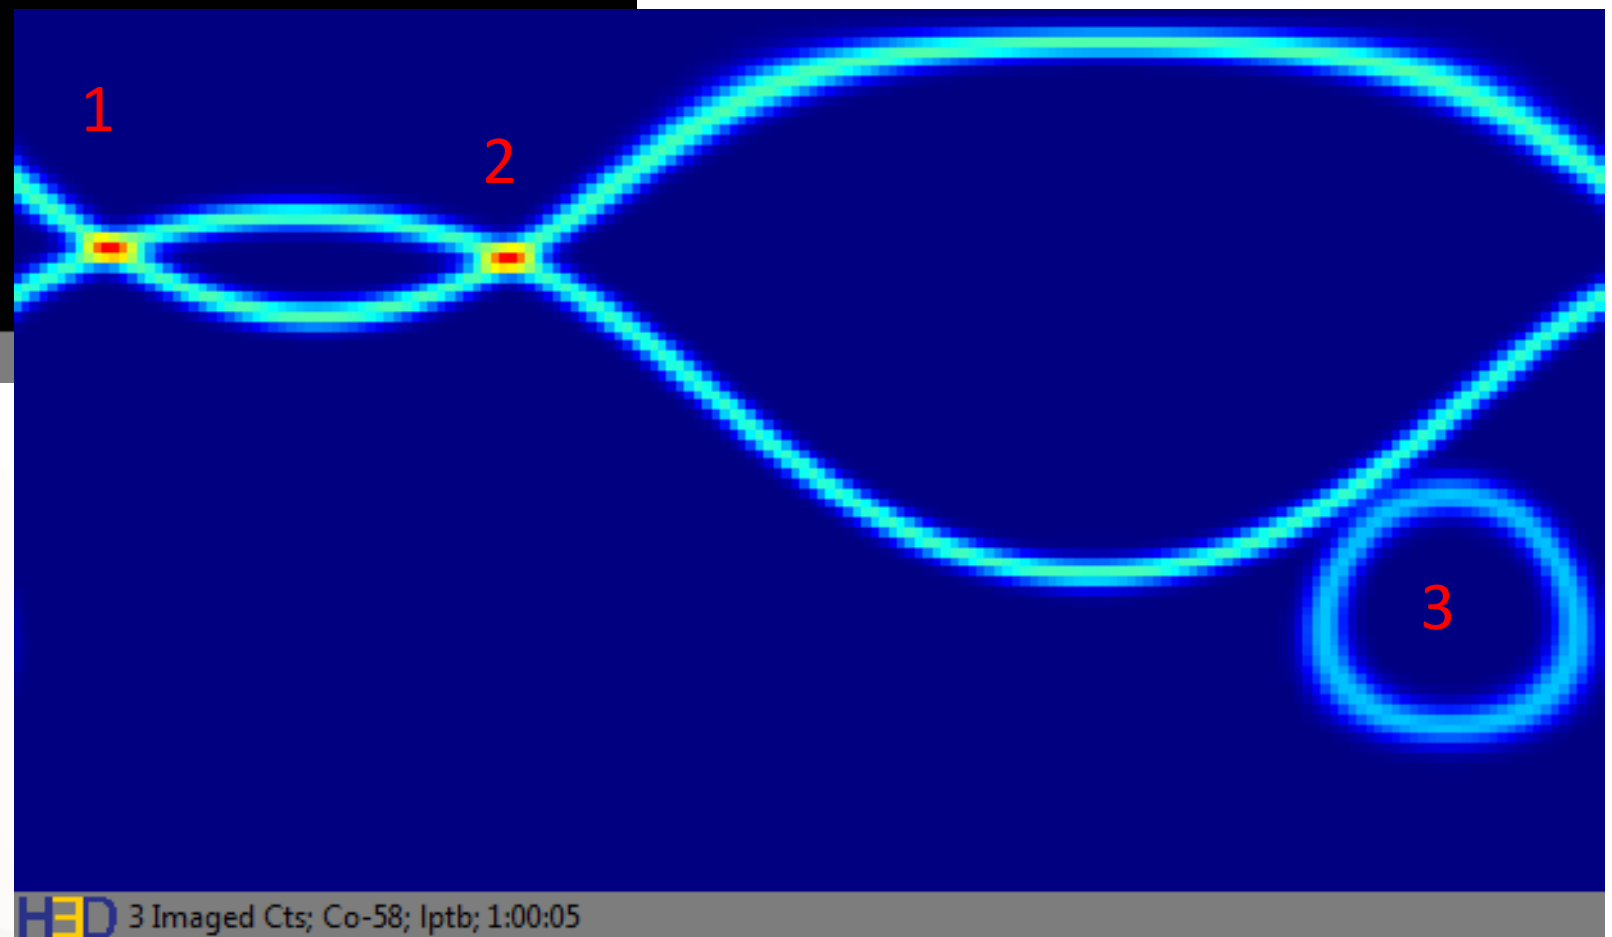
Image is not resolved. The system will image any energy range (>250 keV) programmed regardless of background in the area and whether the isotope is actually present.

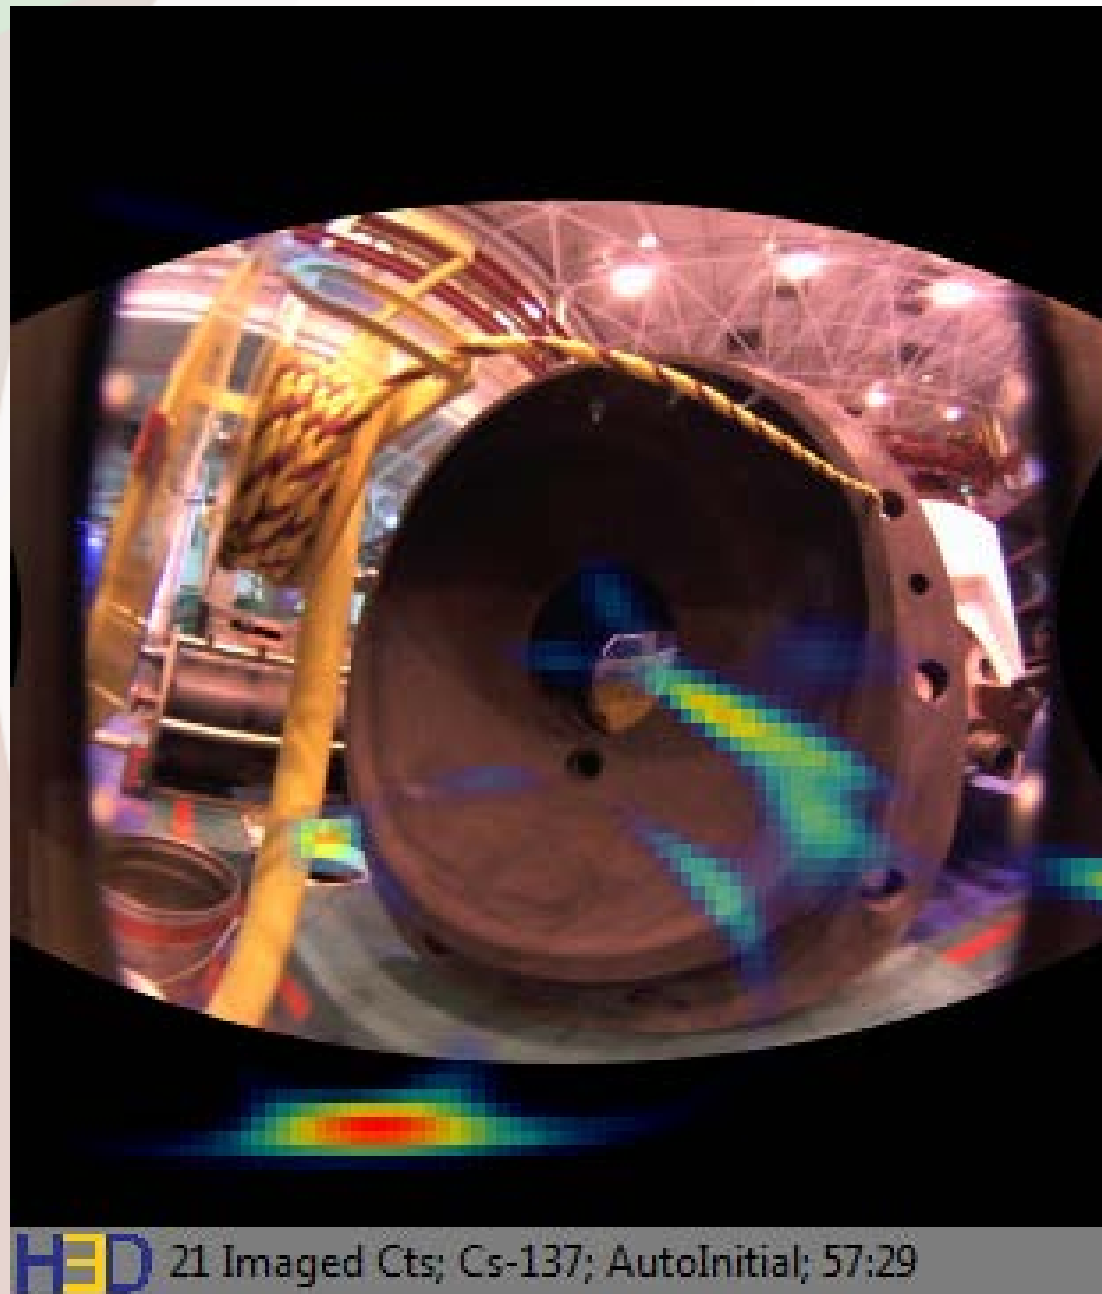
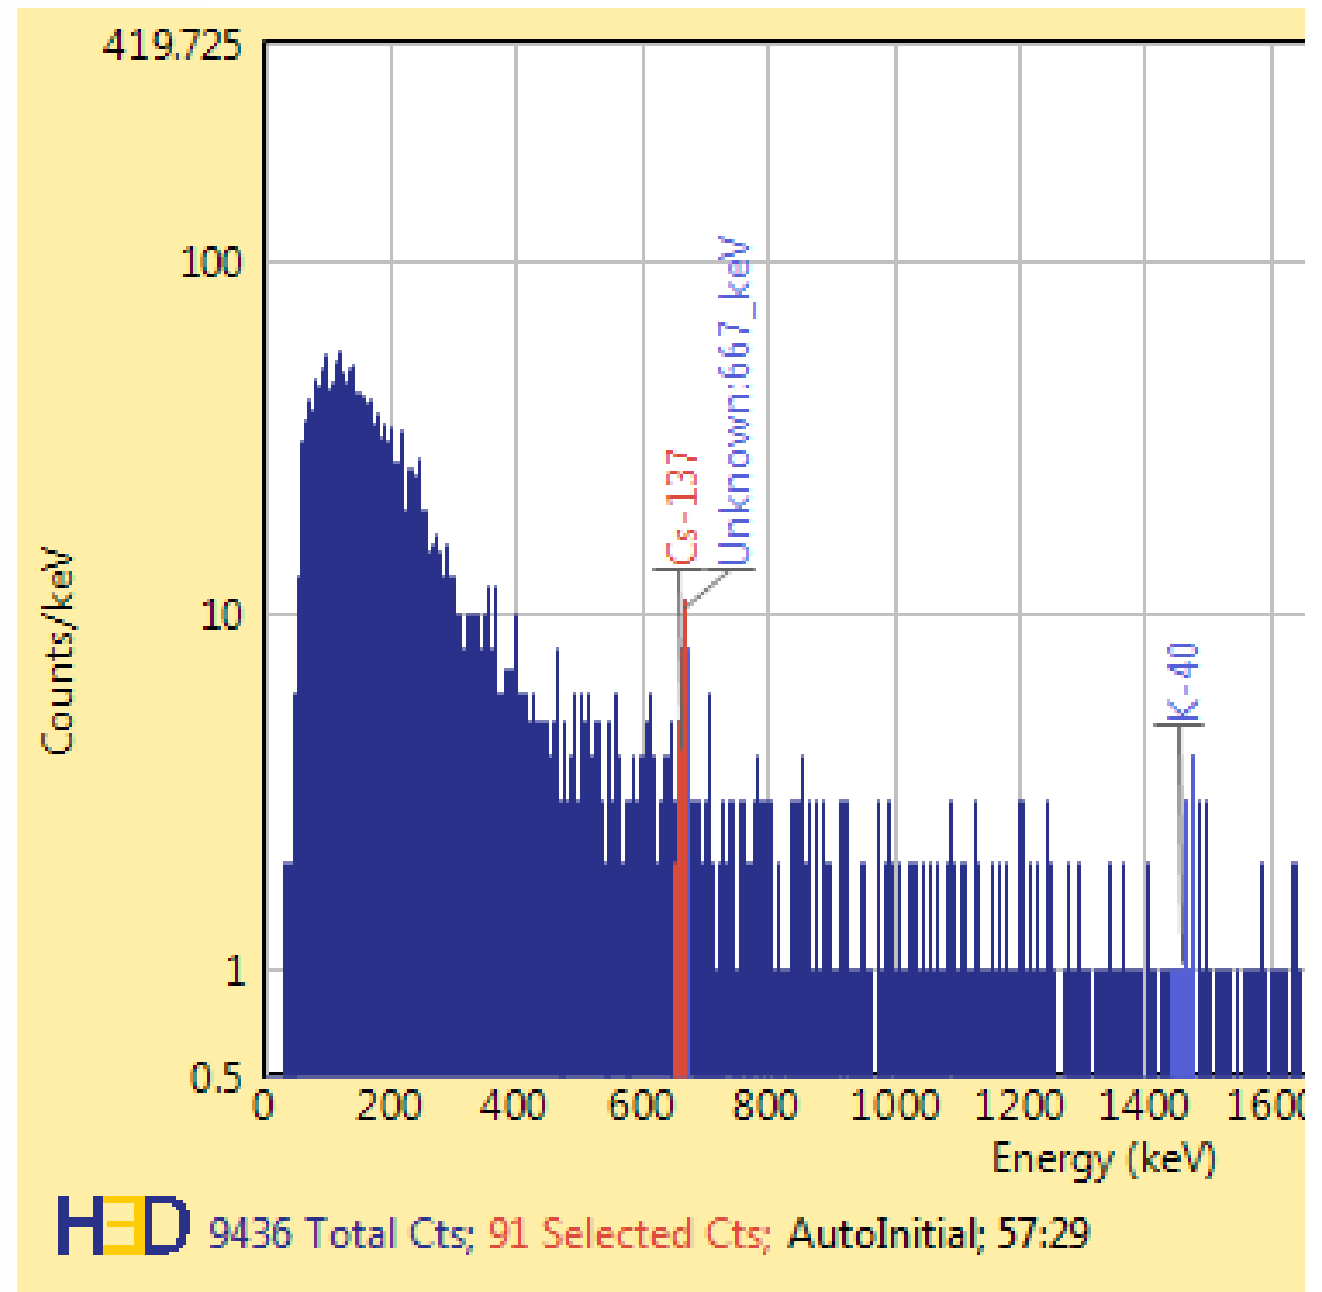
Turbine Stop Valve – Positive Cs-137

Count Rate of 3 CPS for 58 minutes. Image is not fully resolved to show contamination location. Verification of plant generated isotopes on fixed contamination.

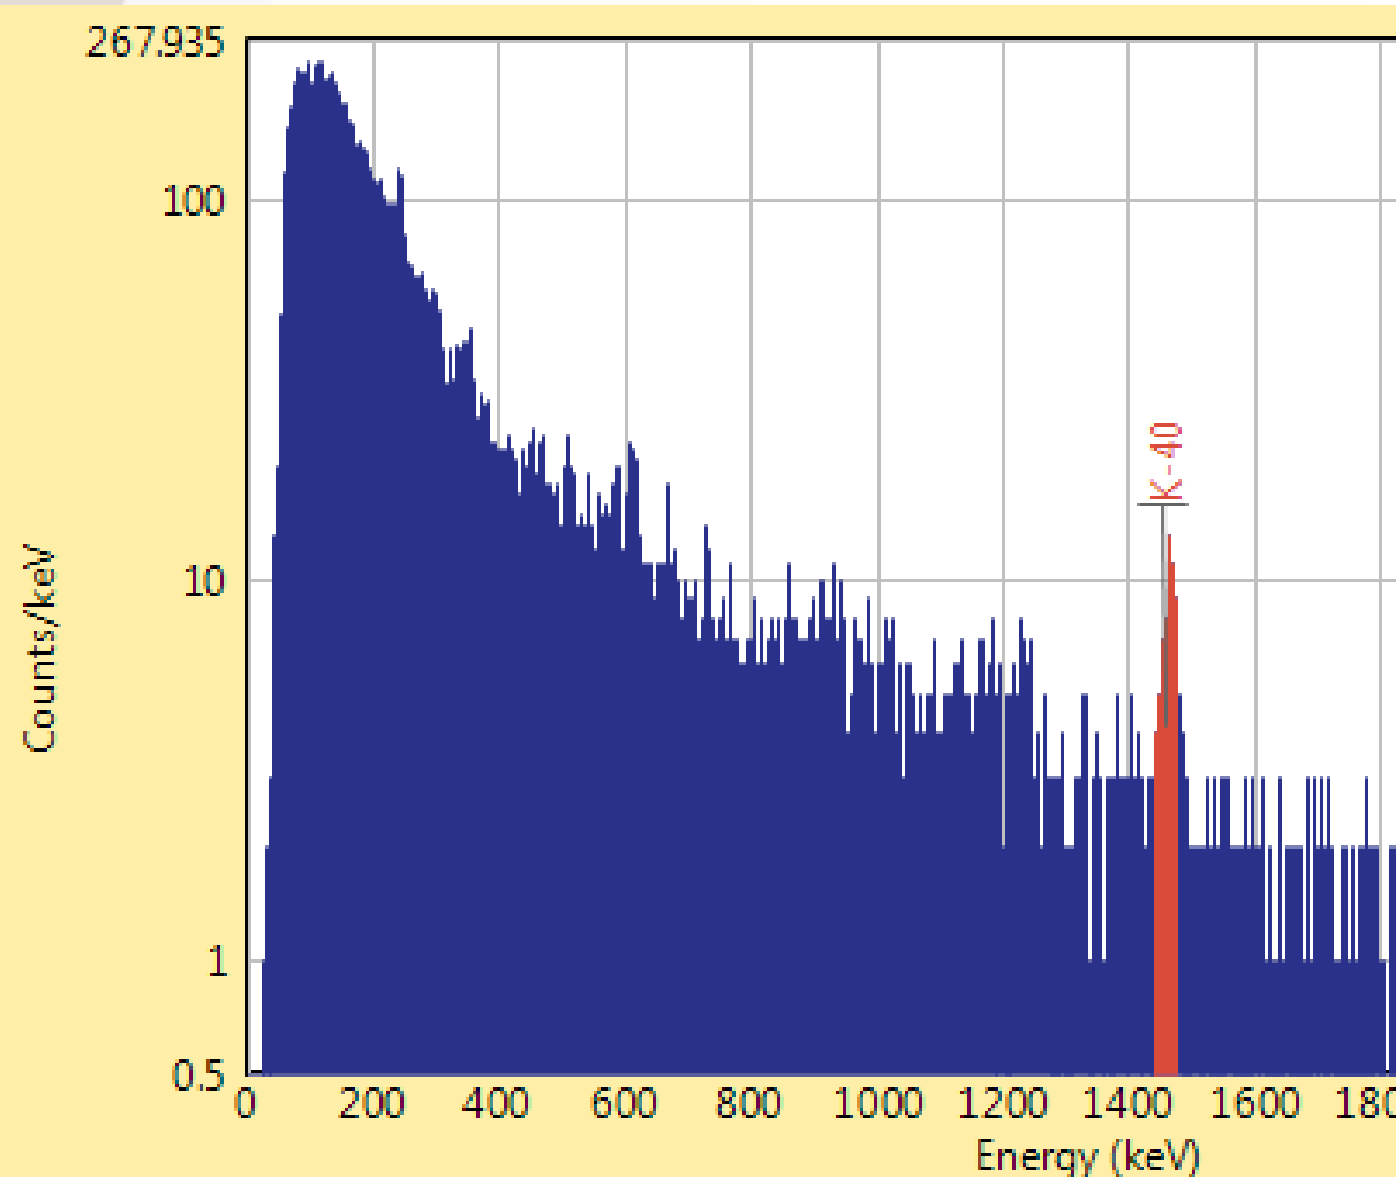
Auxiliary Feedwater Pump Seal

HED 44097 Total Cts; 199 Selected Cts; mfp_parts; 2:43:34

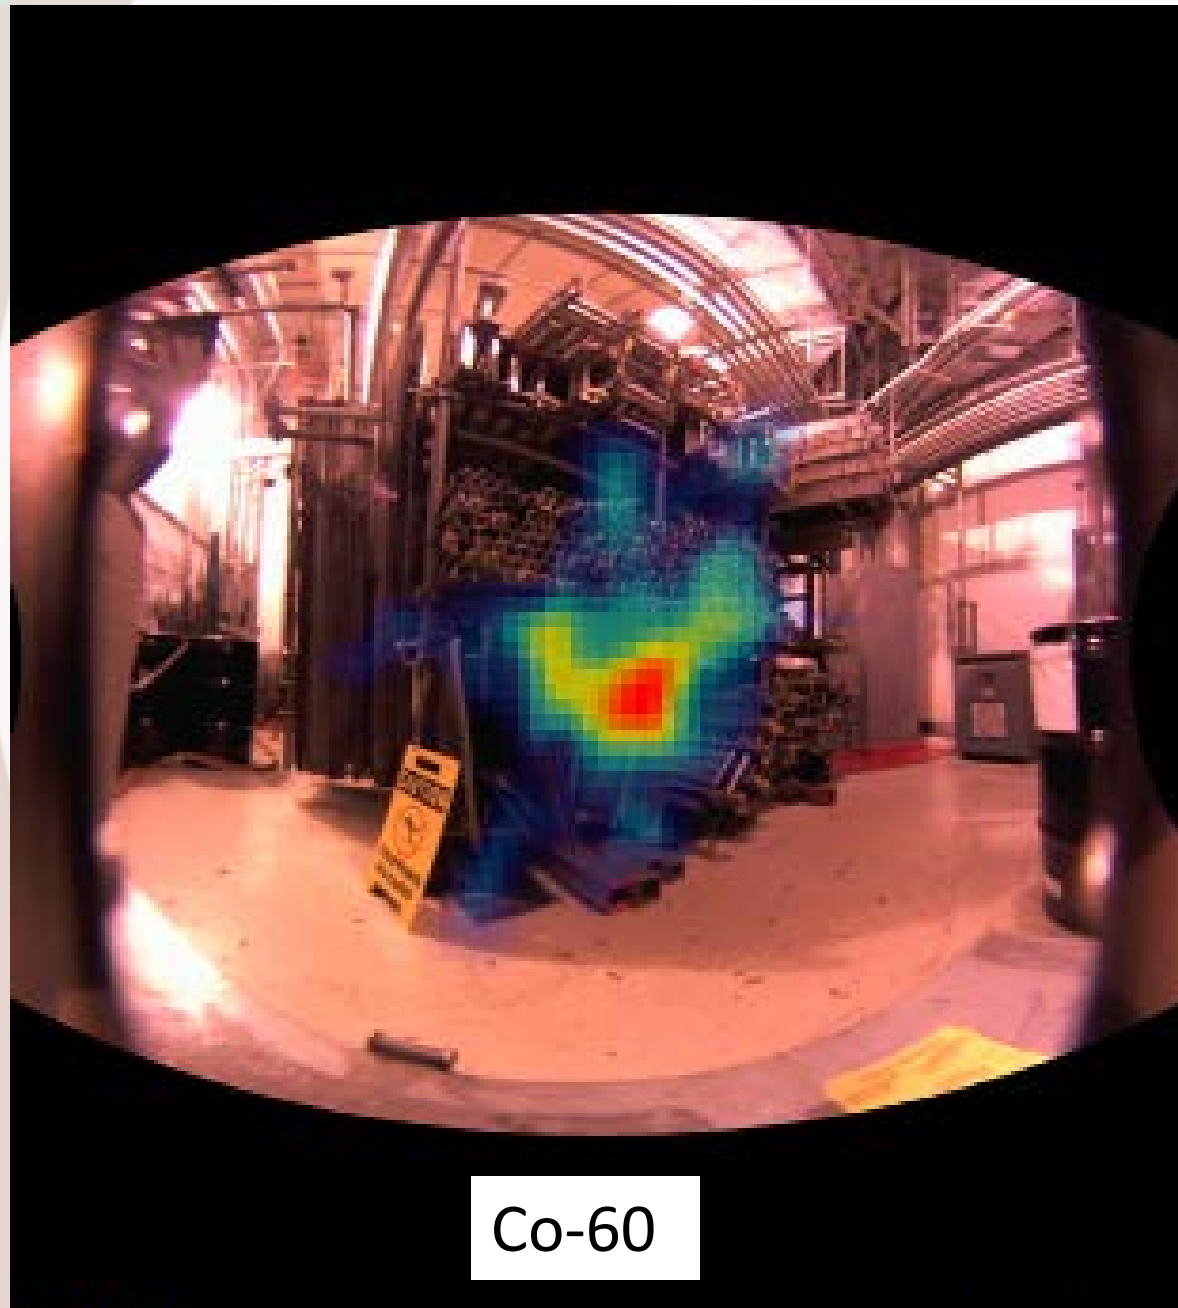
Co-60

HED 209 Imaged Cts; Co-60; cook_unit_2_609_scaffolding

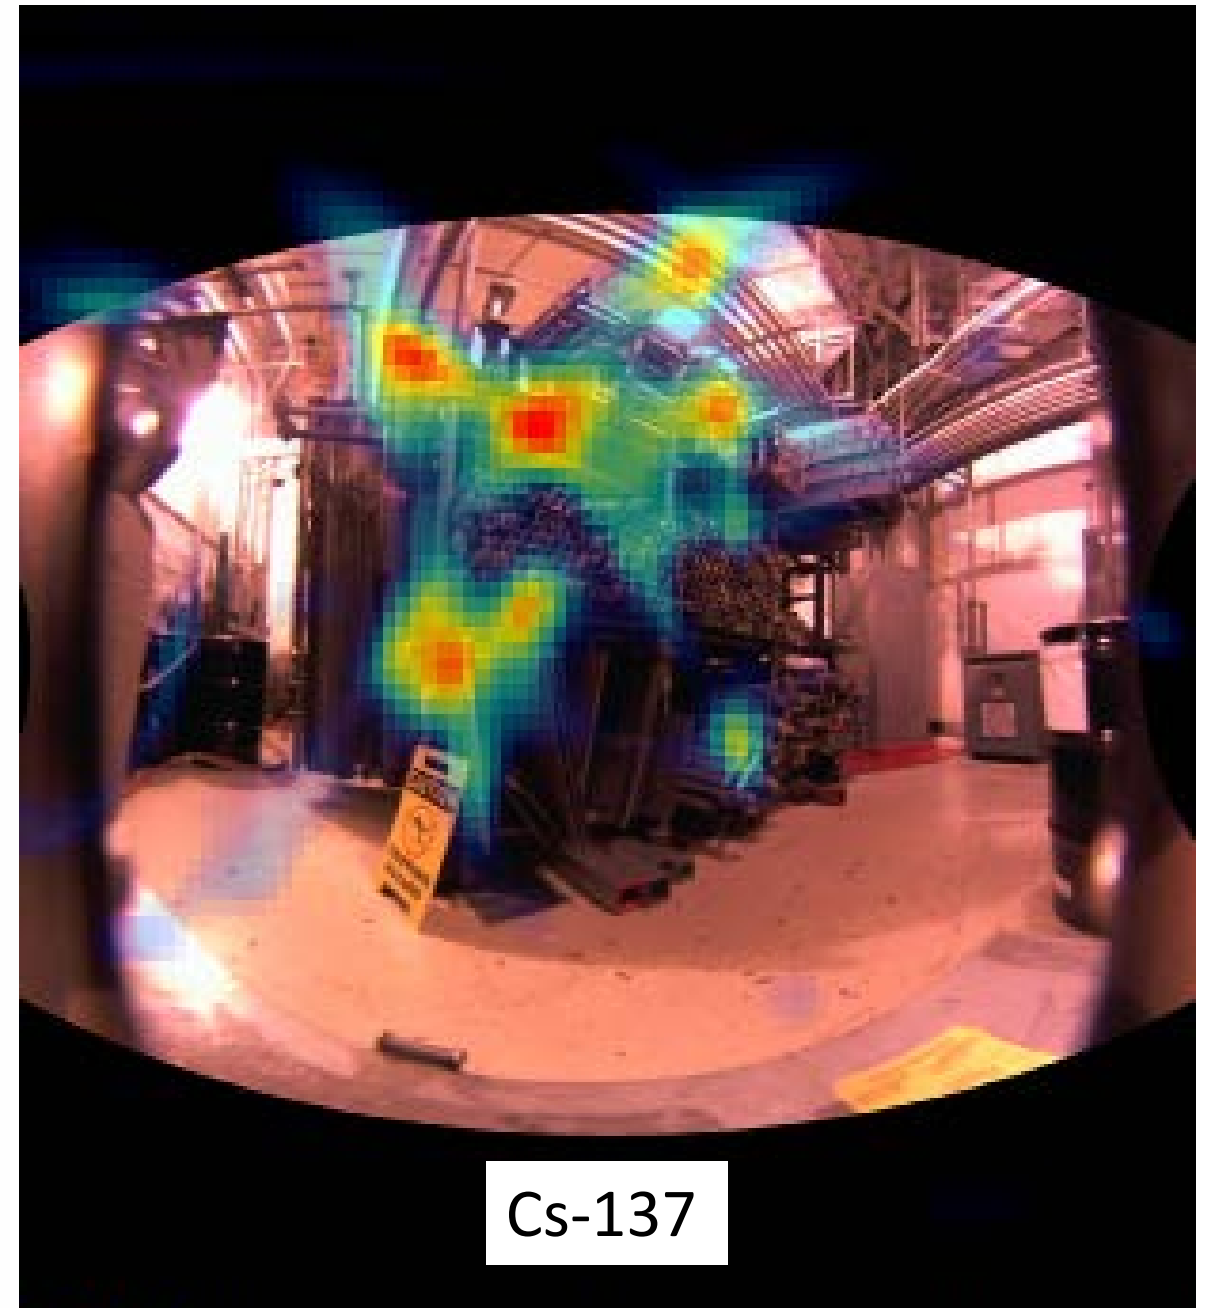
Cs-137

HED 249 Imaged Cts; Cs-137; cook_unit_2_609_scaffolding

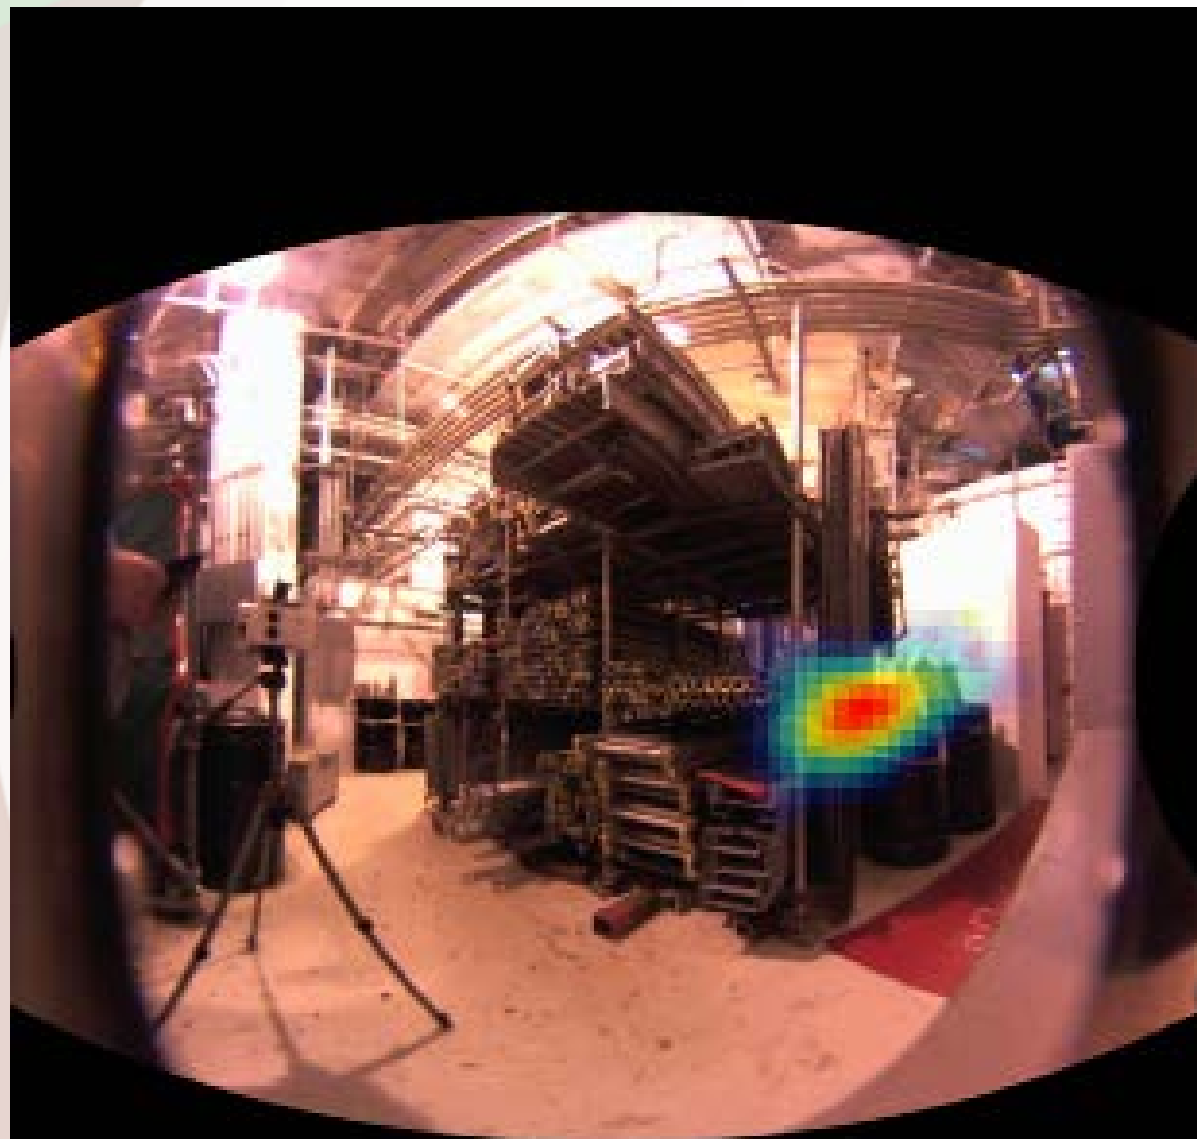
Co-60

HED 369 Imaged Cts; Co-60; 603_aux_unit_2_scaffolding

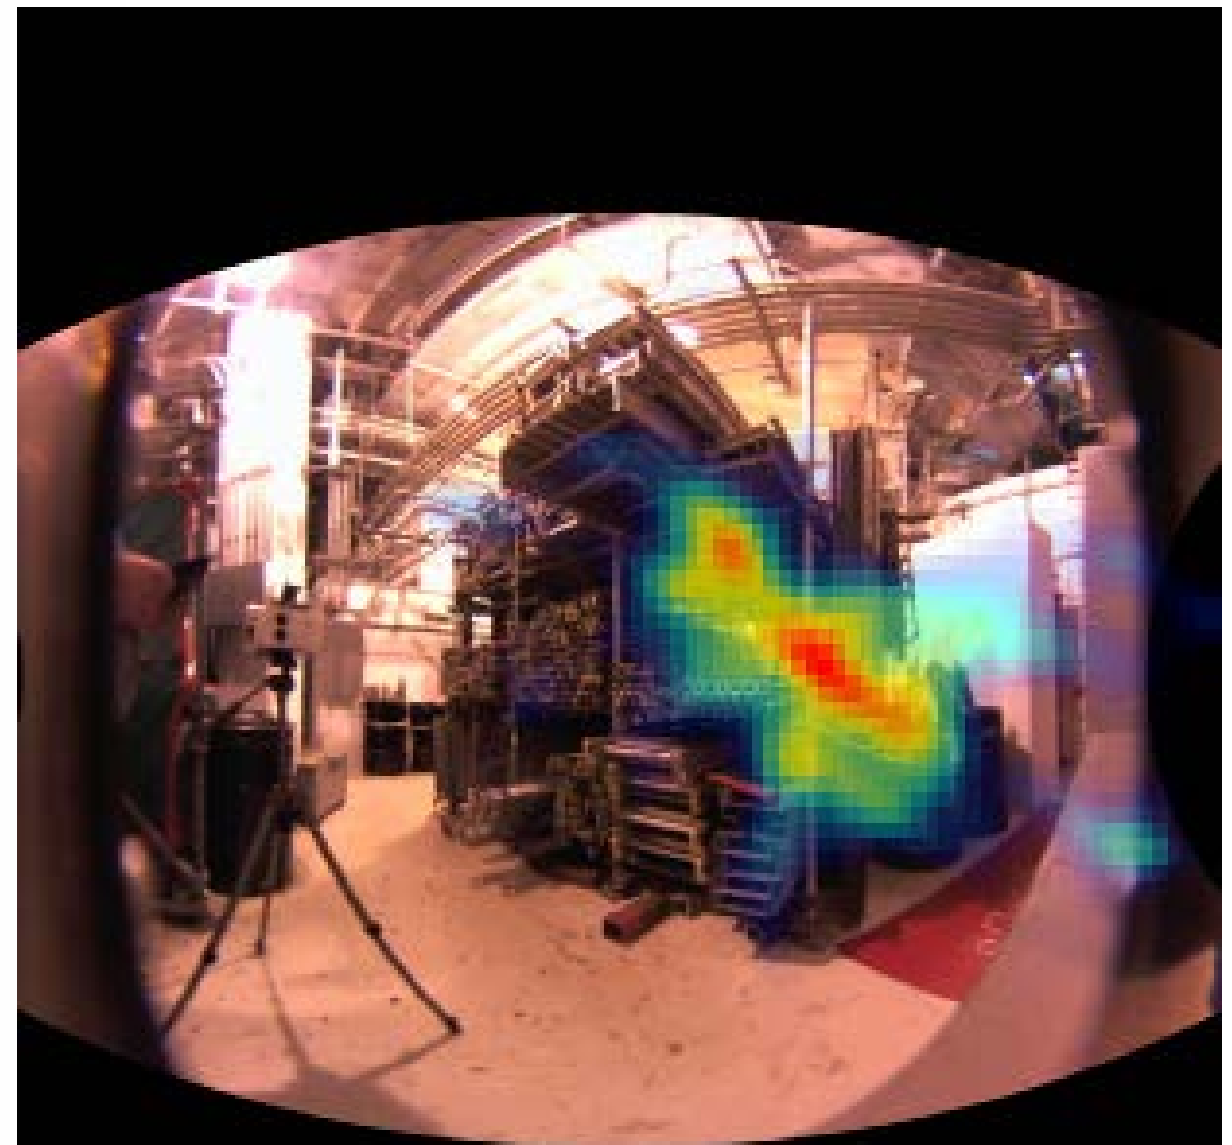
Cs-137

HED 217 Imaged Cts; Cs-137; 603_aux_unit_2_scaffolding

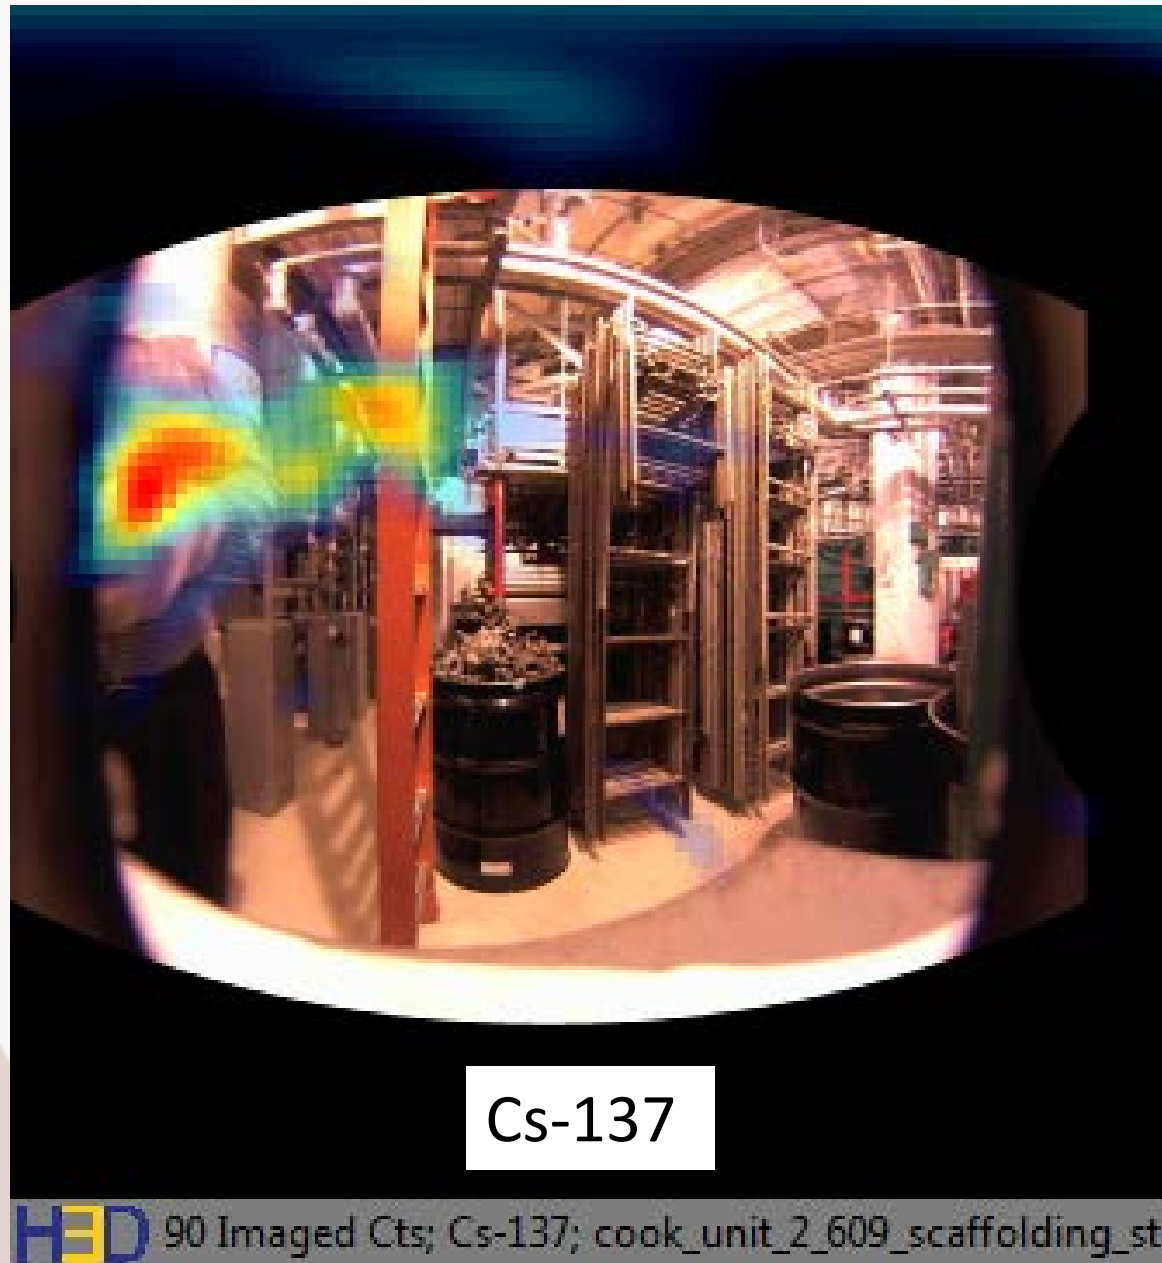
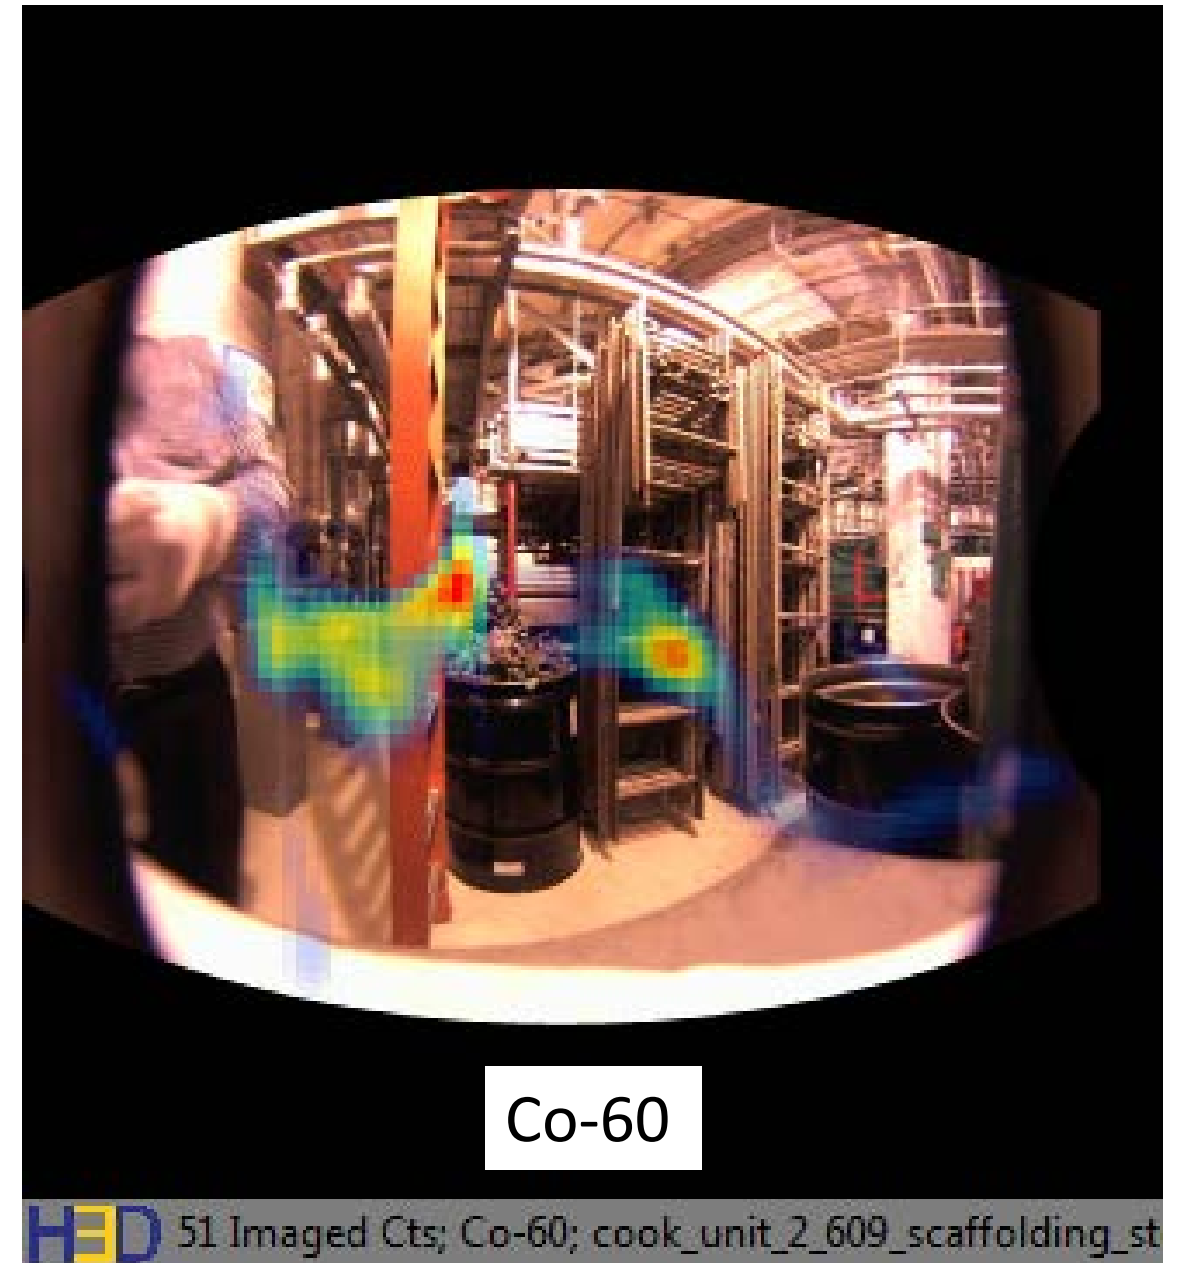
Scaffold Rack Contamination – Behind Scaffold

10.4 mR/hr contact w/Ion Chamber –
Lowest recorded dose rate

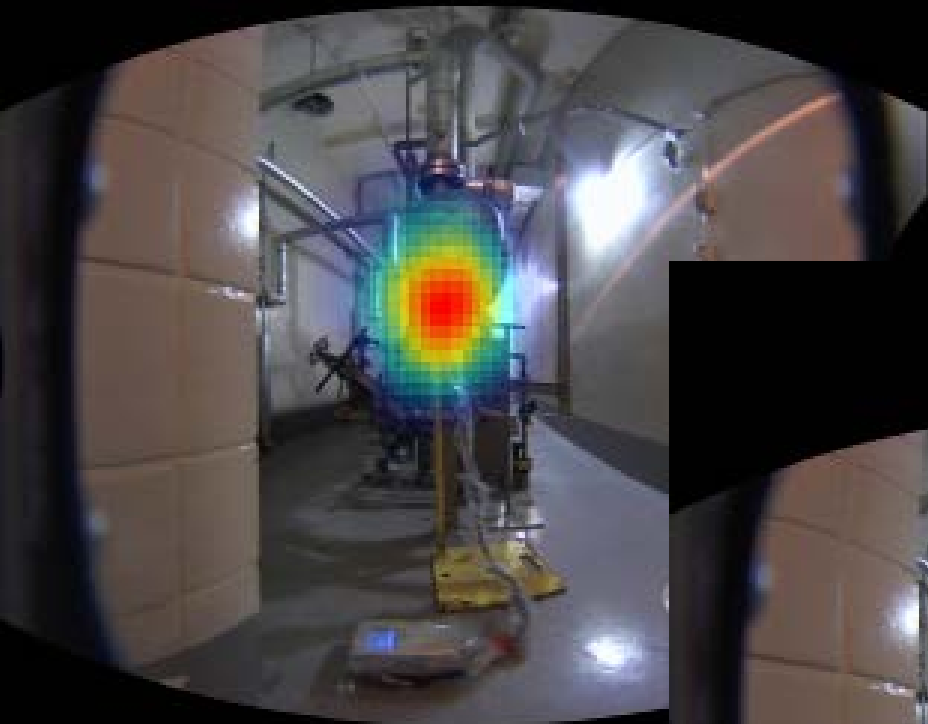
Sb-124

HED 6181 Imaged Cts; Sb-124; letdownend; 15:03

~10 mR/hr on platform, 28 mR/hr contact

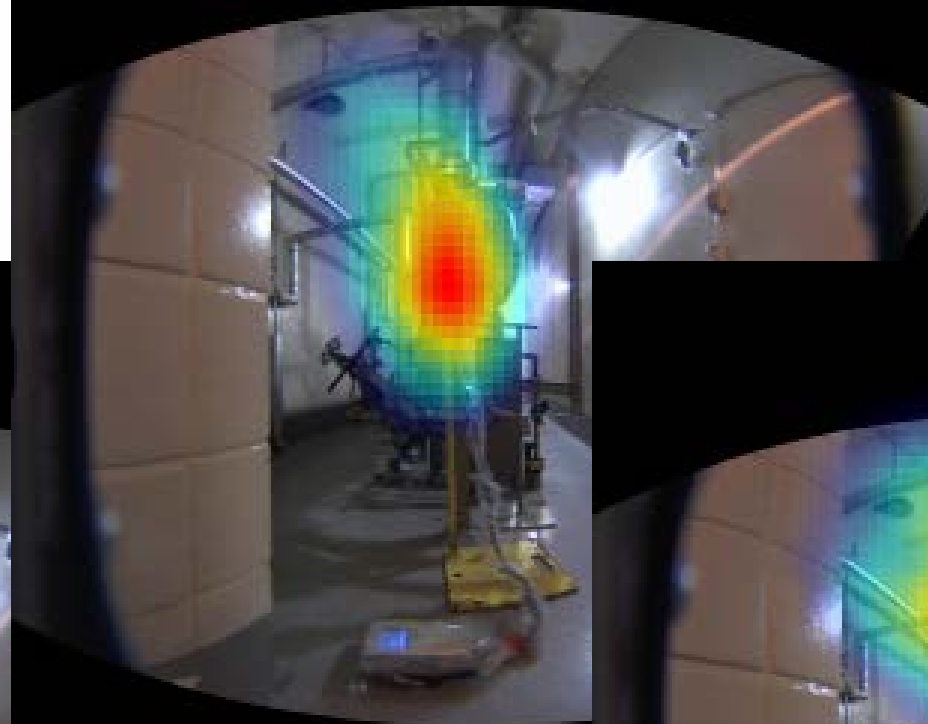
Co-60

HED 7156 Imaged Cts; Co-60; letdownend; 15:03

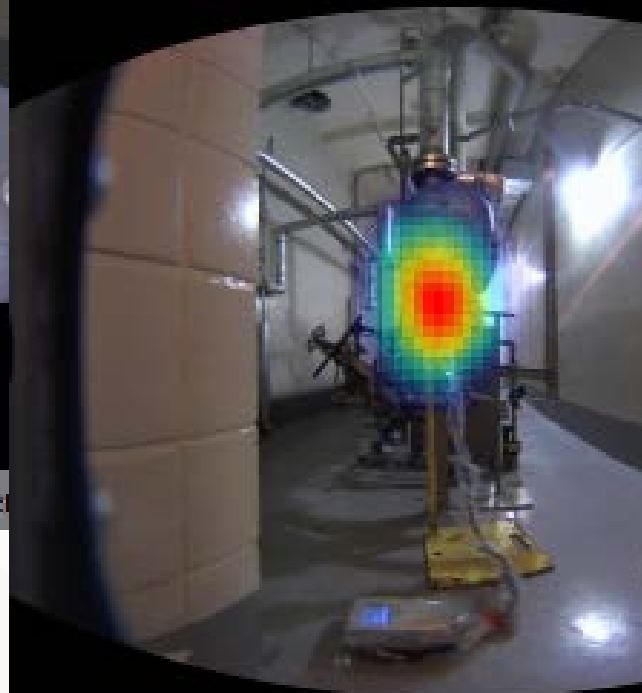
Nb-95

HED 5998 Imaged Cts; Nb-95; letdownend; 15:03

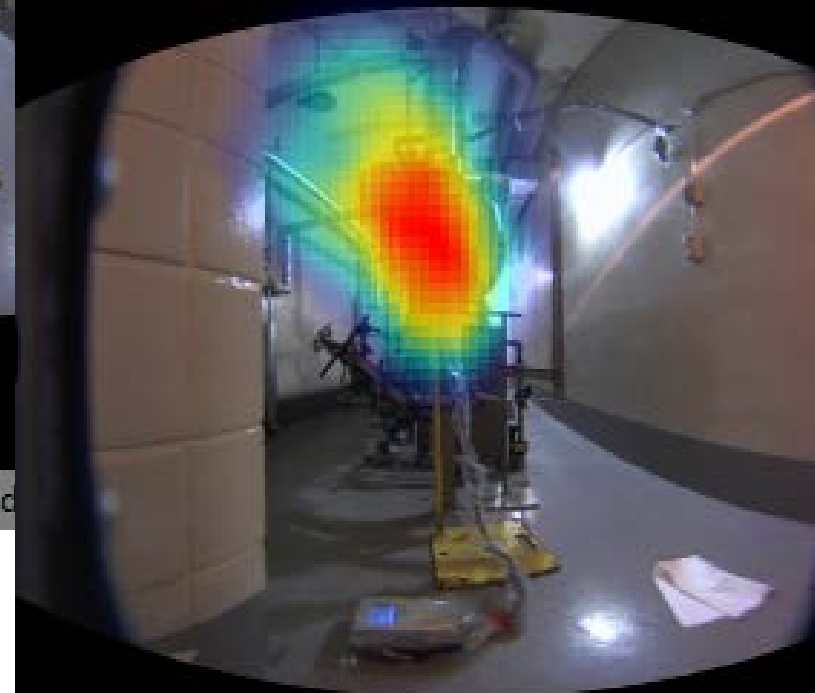
Co-58

HED 4874 Imaged Cts; Co-58; letdownend; 15:03
