Advances in Radiation Instrumentation to Achieve Enhanced Characterization of Source Term Reduction Results

David W. Miller, PhD

Cook Nuclear Plant

ISOE International Symposium

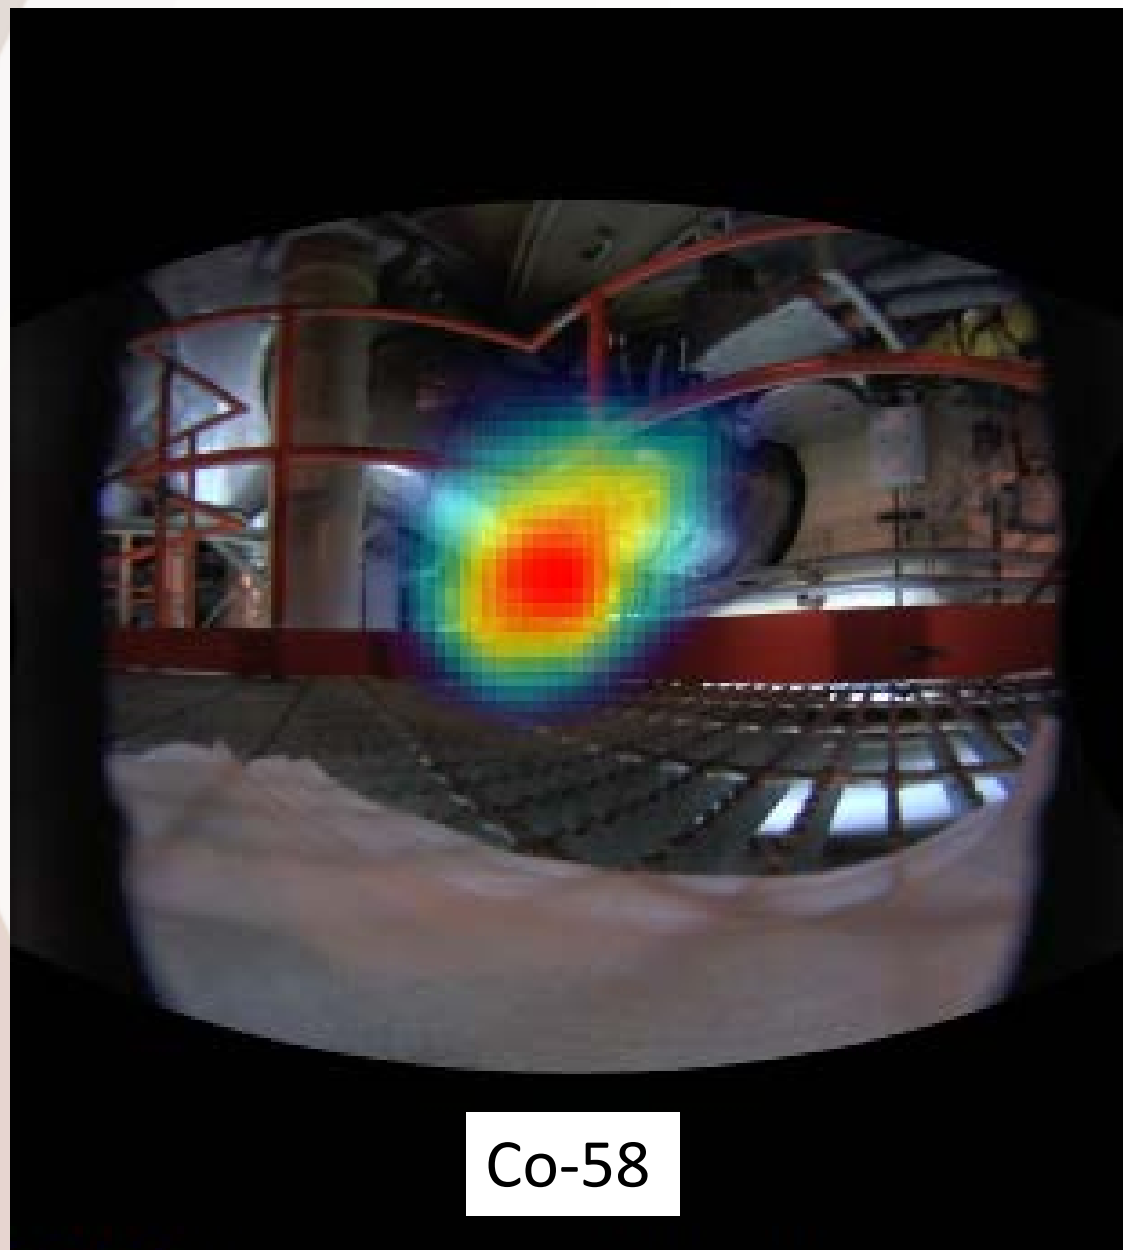
Co-58

HED 18096 Imaged Cts; Co-58; hl24; 24:28

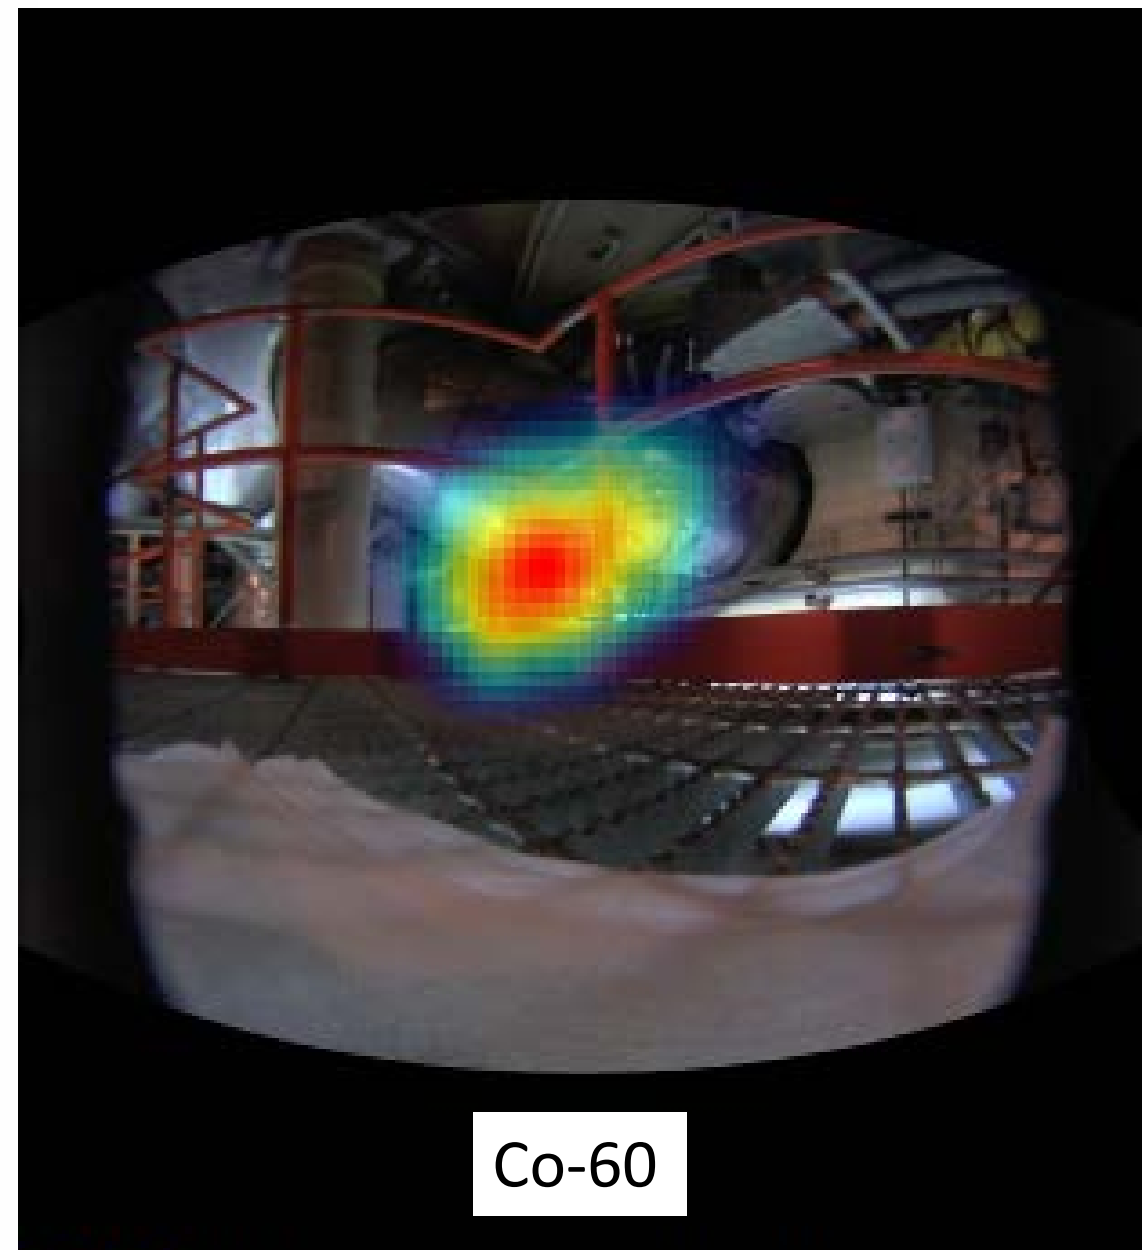
Co-60

HED 18171 Imaged Cts; Co-60; hl24; 24:28

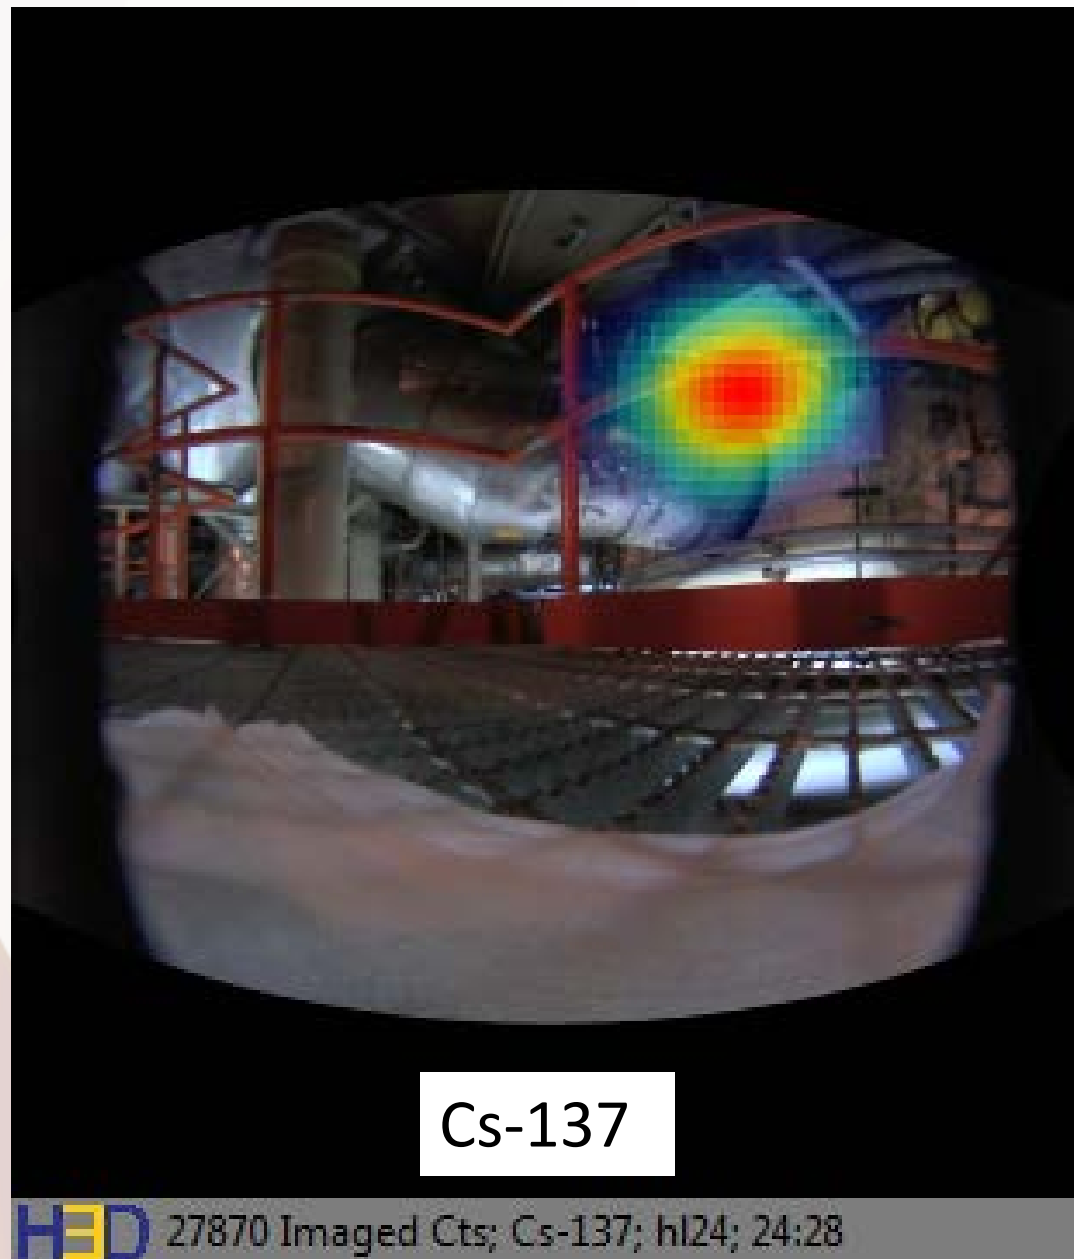
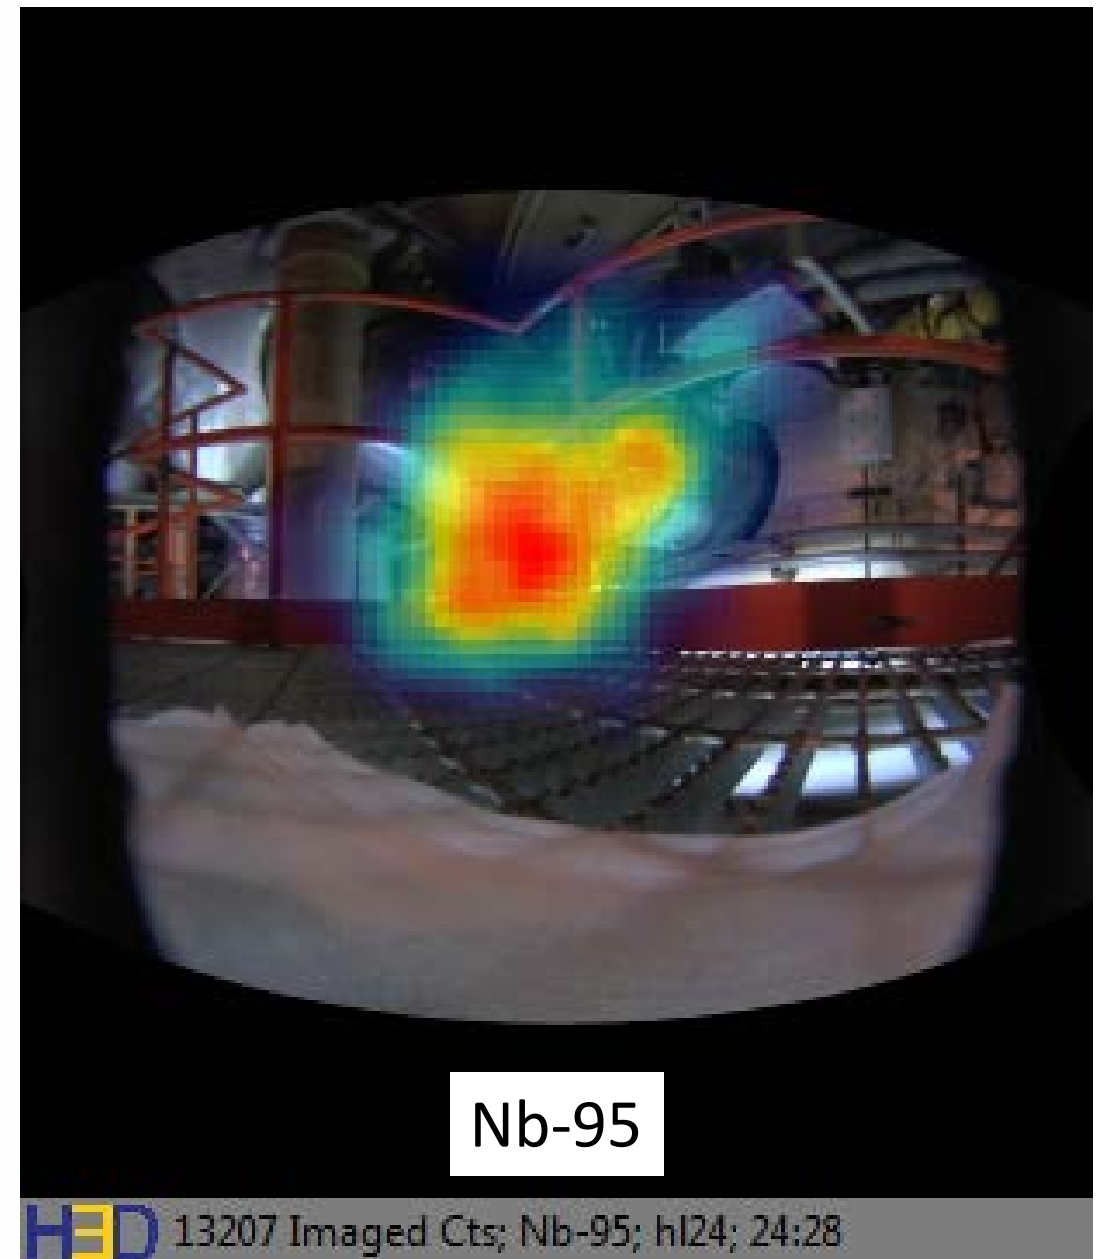
Note: 30 minute count imaged 100 counts. For good resolution, distributed contamination should have minimum 1000 counts (5 hour image).

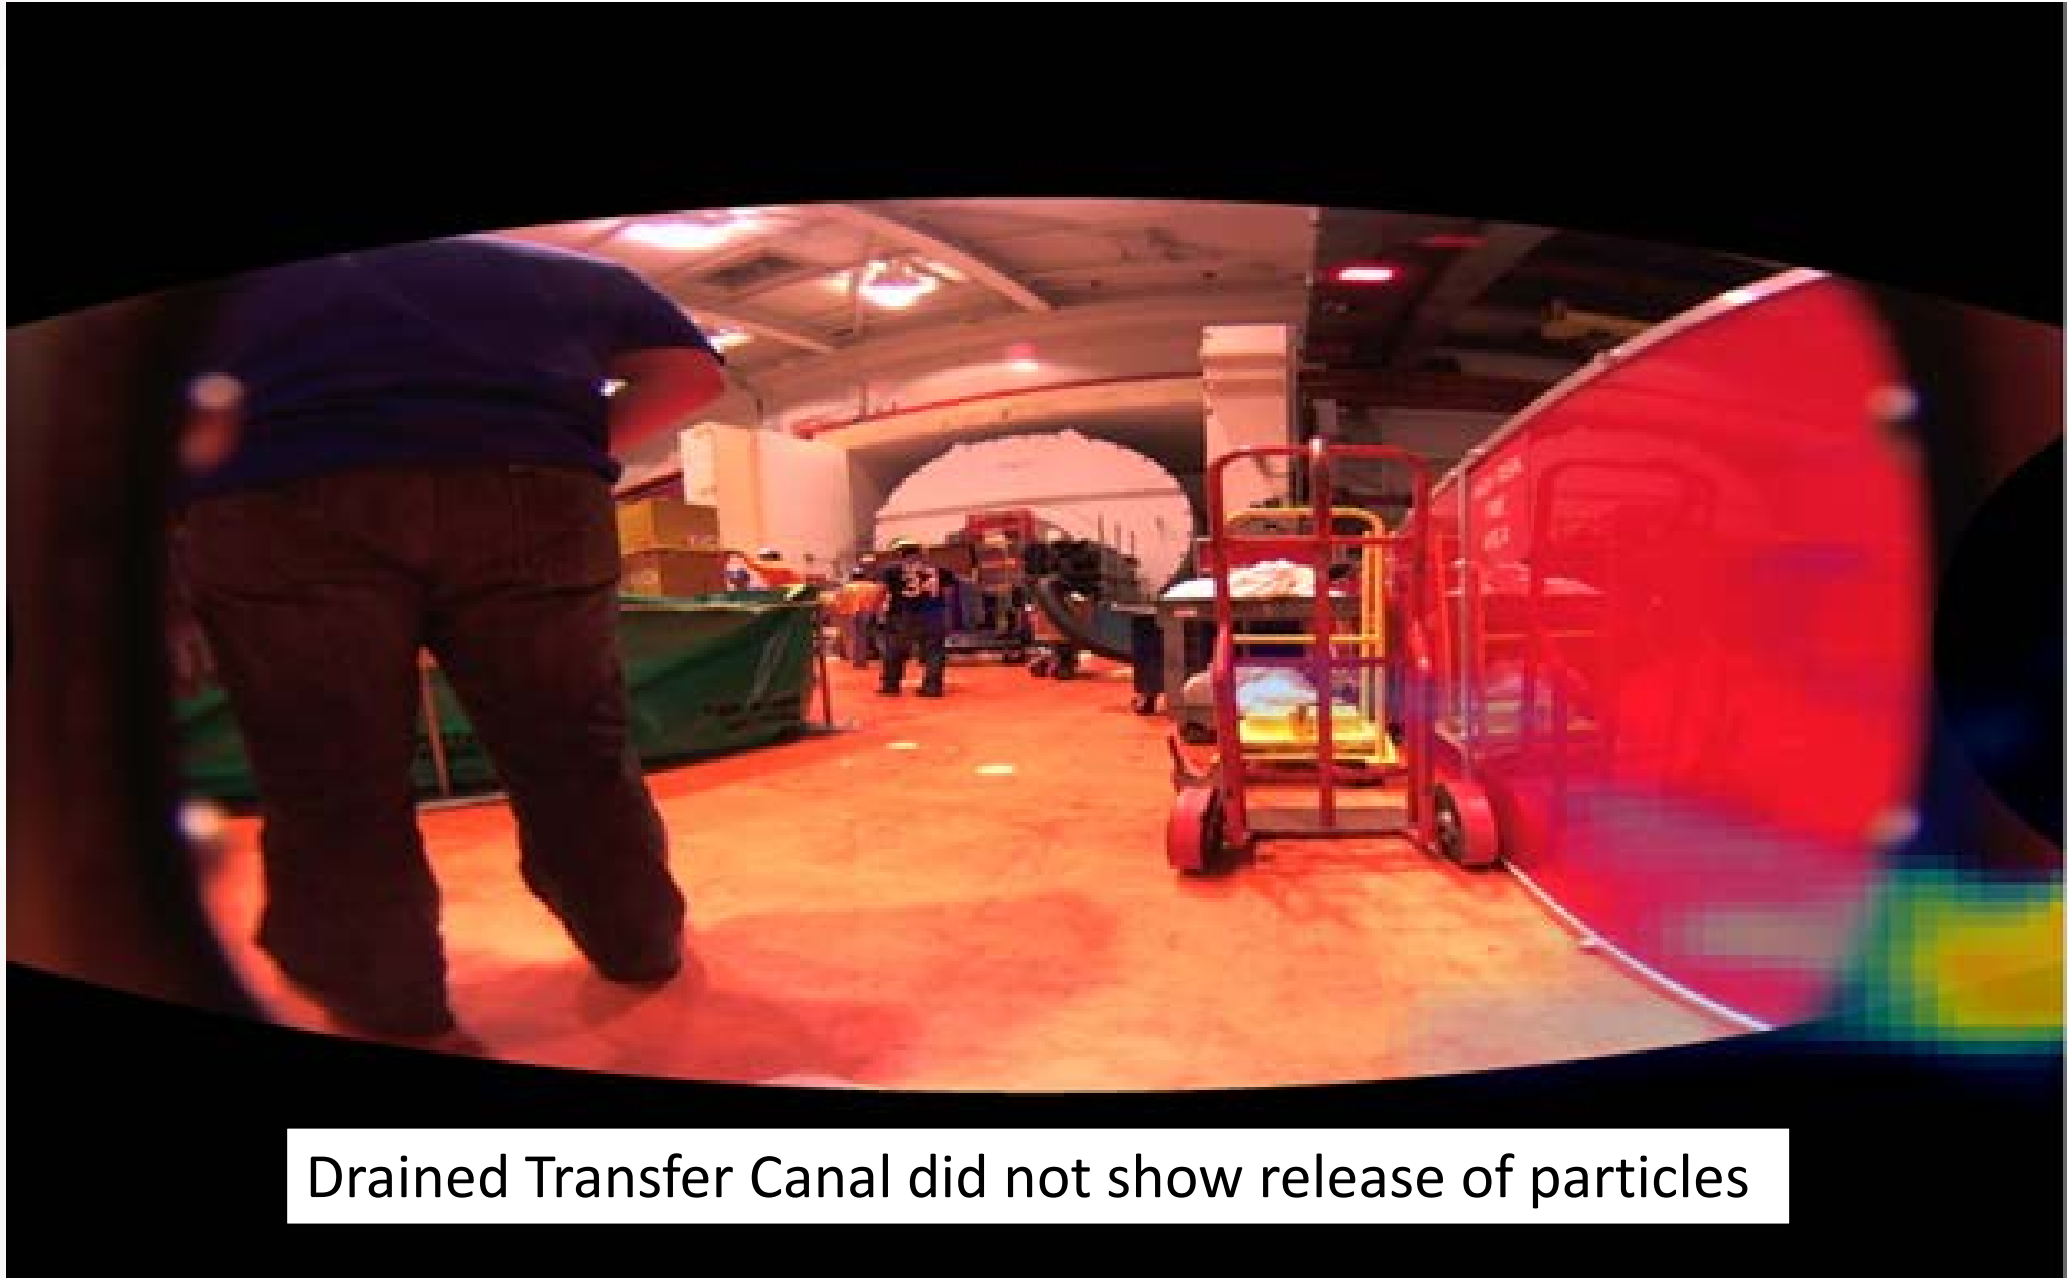
Drained Transfer Canal did not show release of particles
