Isotopic Mapping Program at Prairie Island Nuclear Plant

Brad Boyer,
Radiation Protection Manager
Prairie Island Nuclear Plant

Background to Isotopic Mapping Program at Prairie Island Nuclear Plant

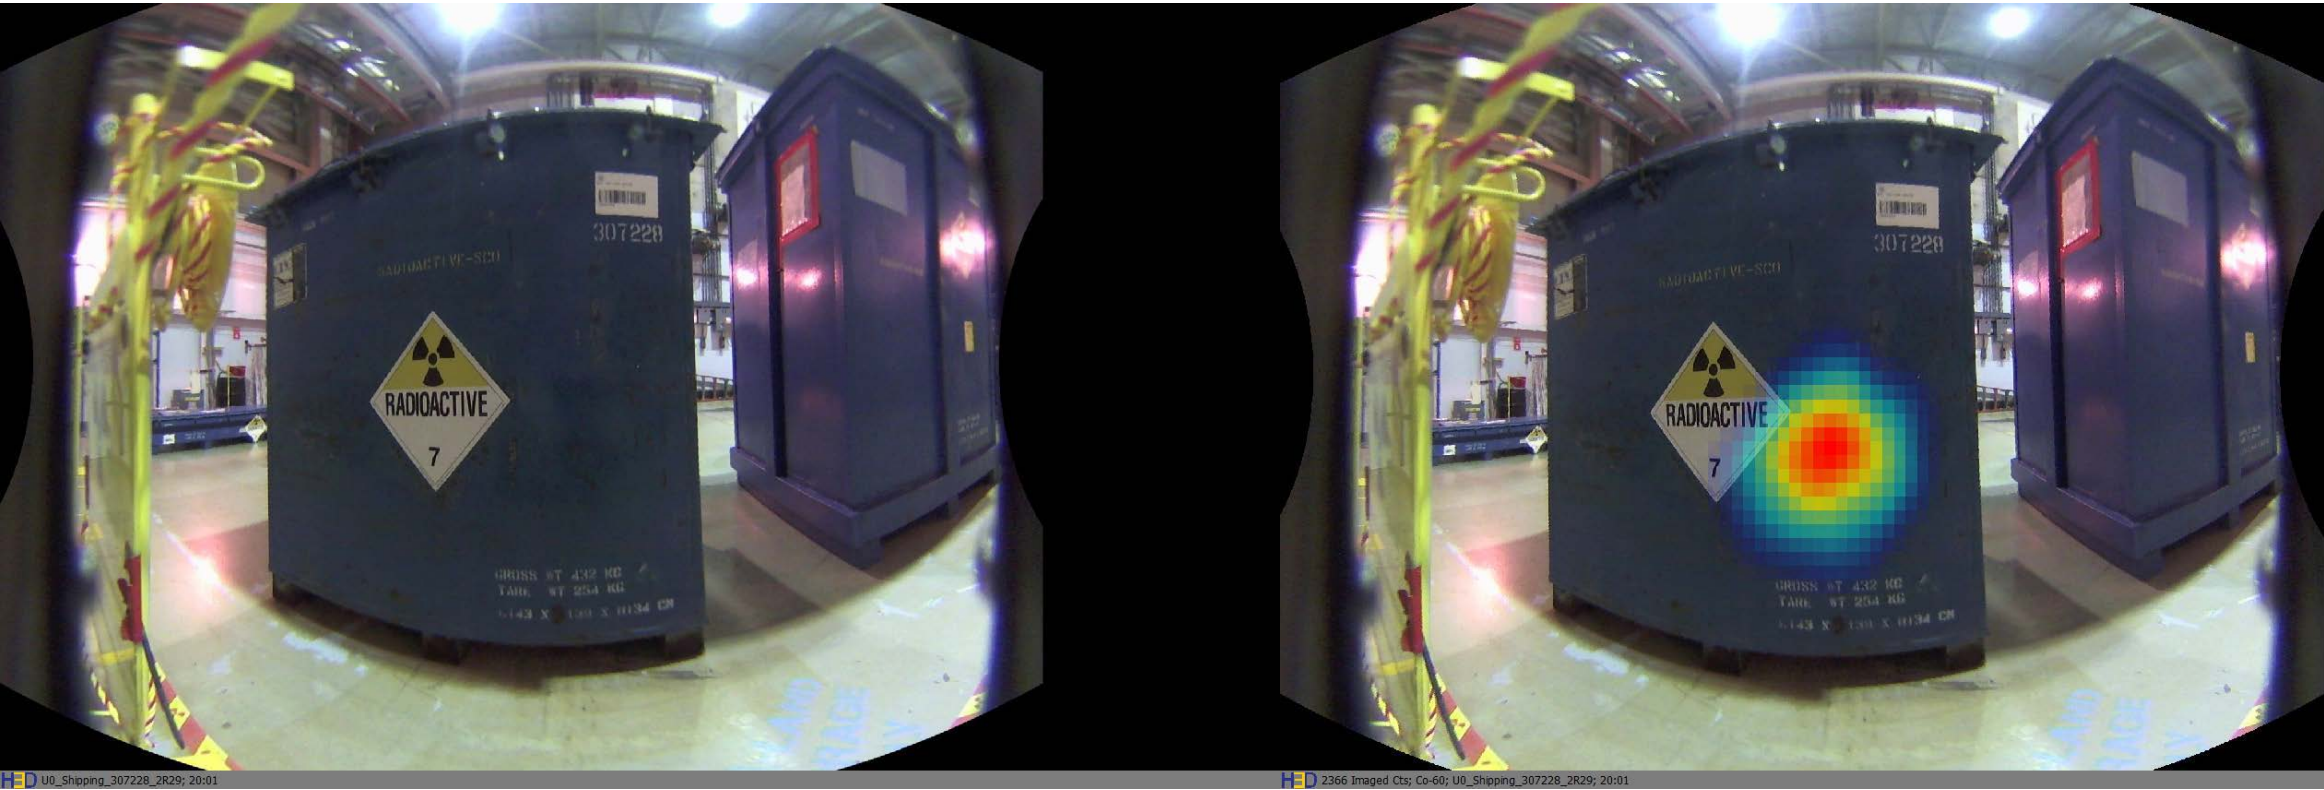
Shipping Container

The image on the left shows just the camera image of a RAM shipping container. On the right, the image shows the area with the highest concentrated activity of Co-60.

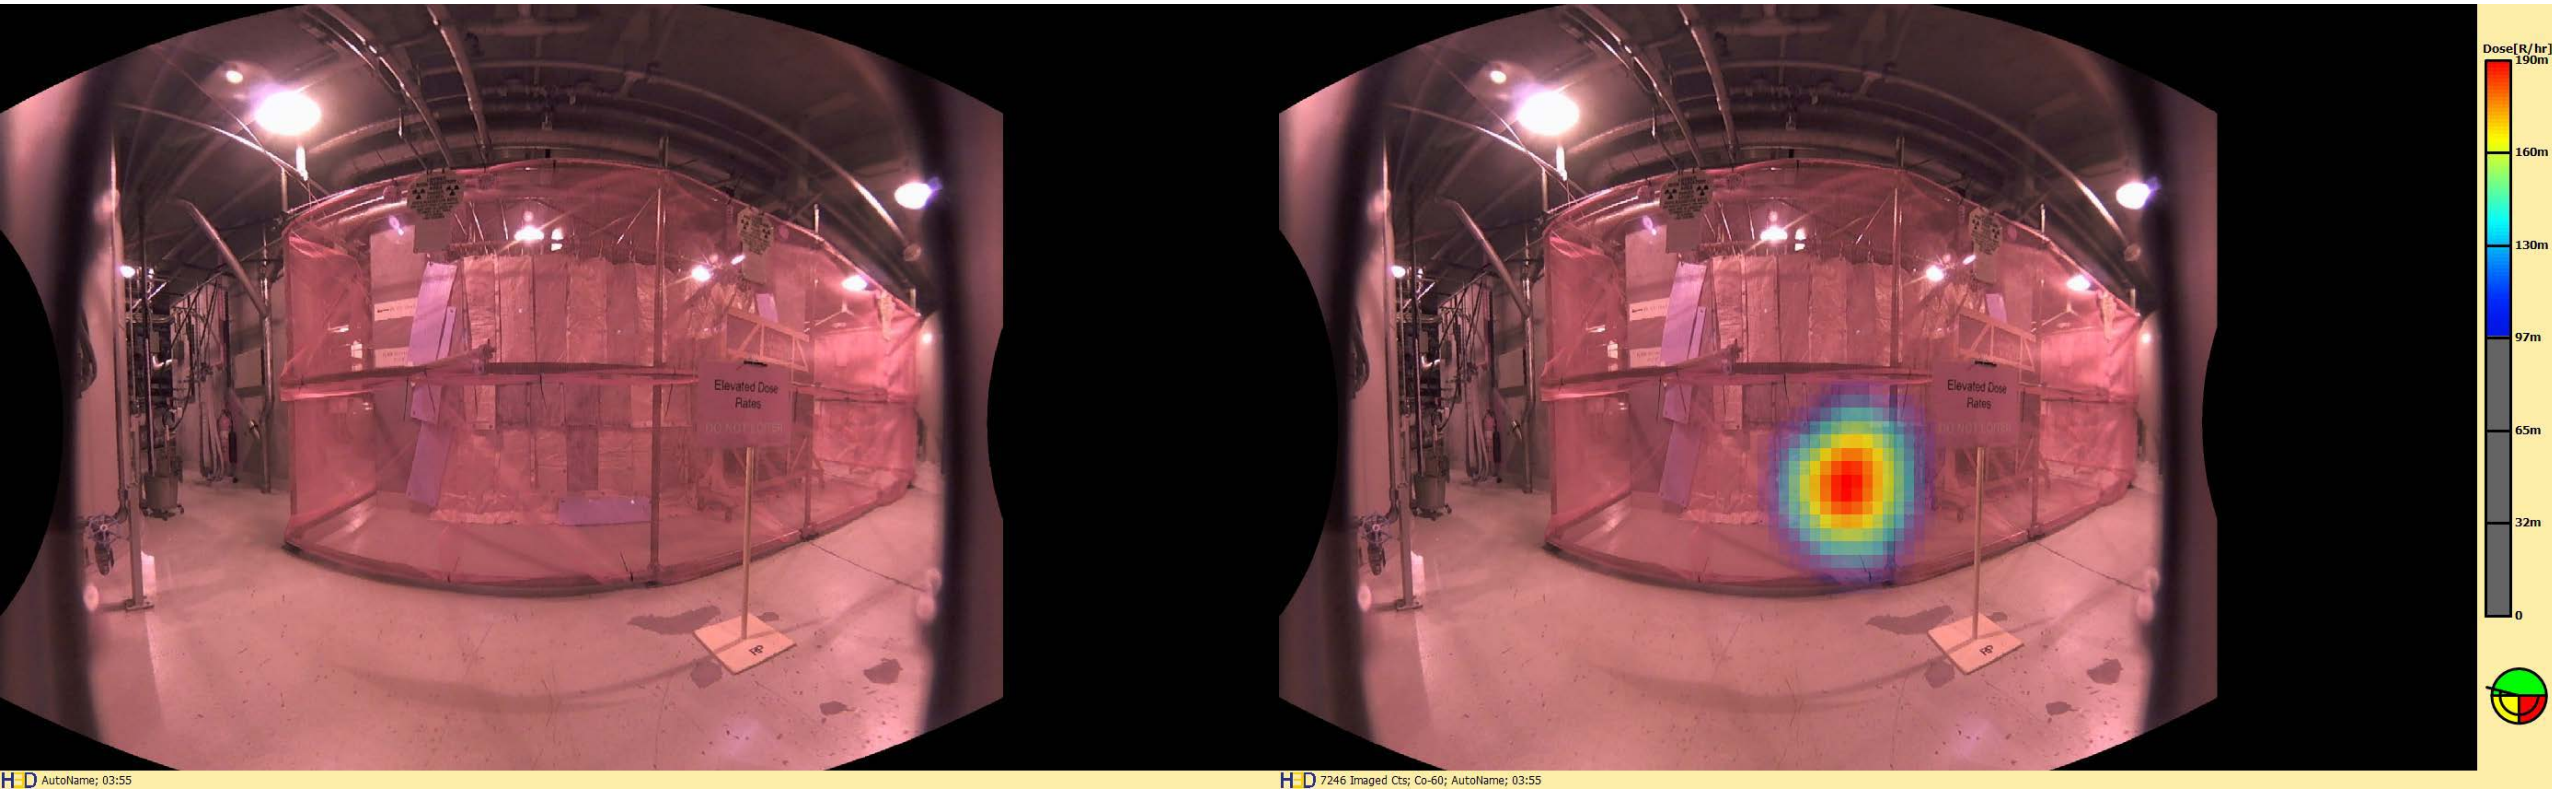
Shielding Verification

The image on the left shows just the camera image of the Sump C shielding package. On the right, the image shows the area with the highest concentrated activity of Co-60. There is no identified streaming in this image, and additional shielding was placed in the colored area.

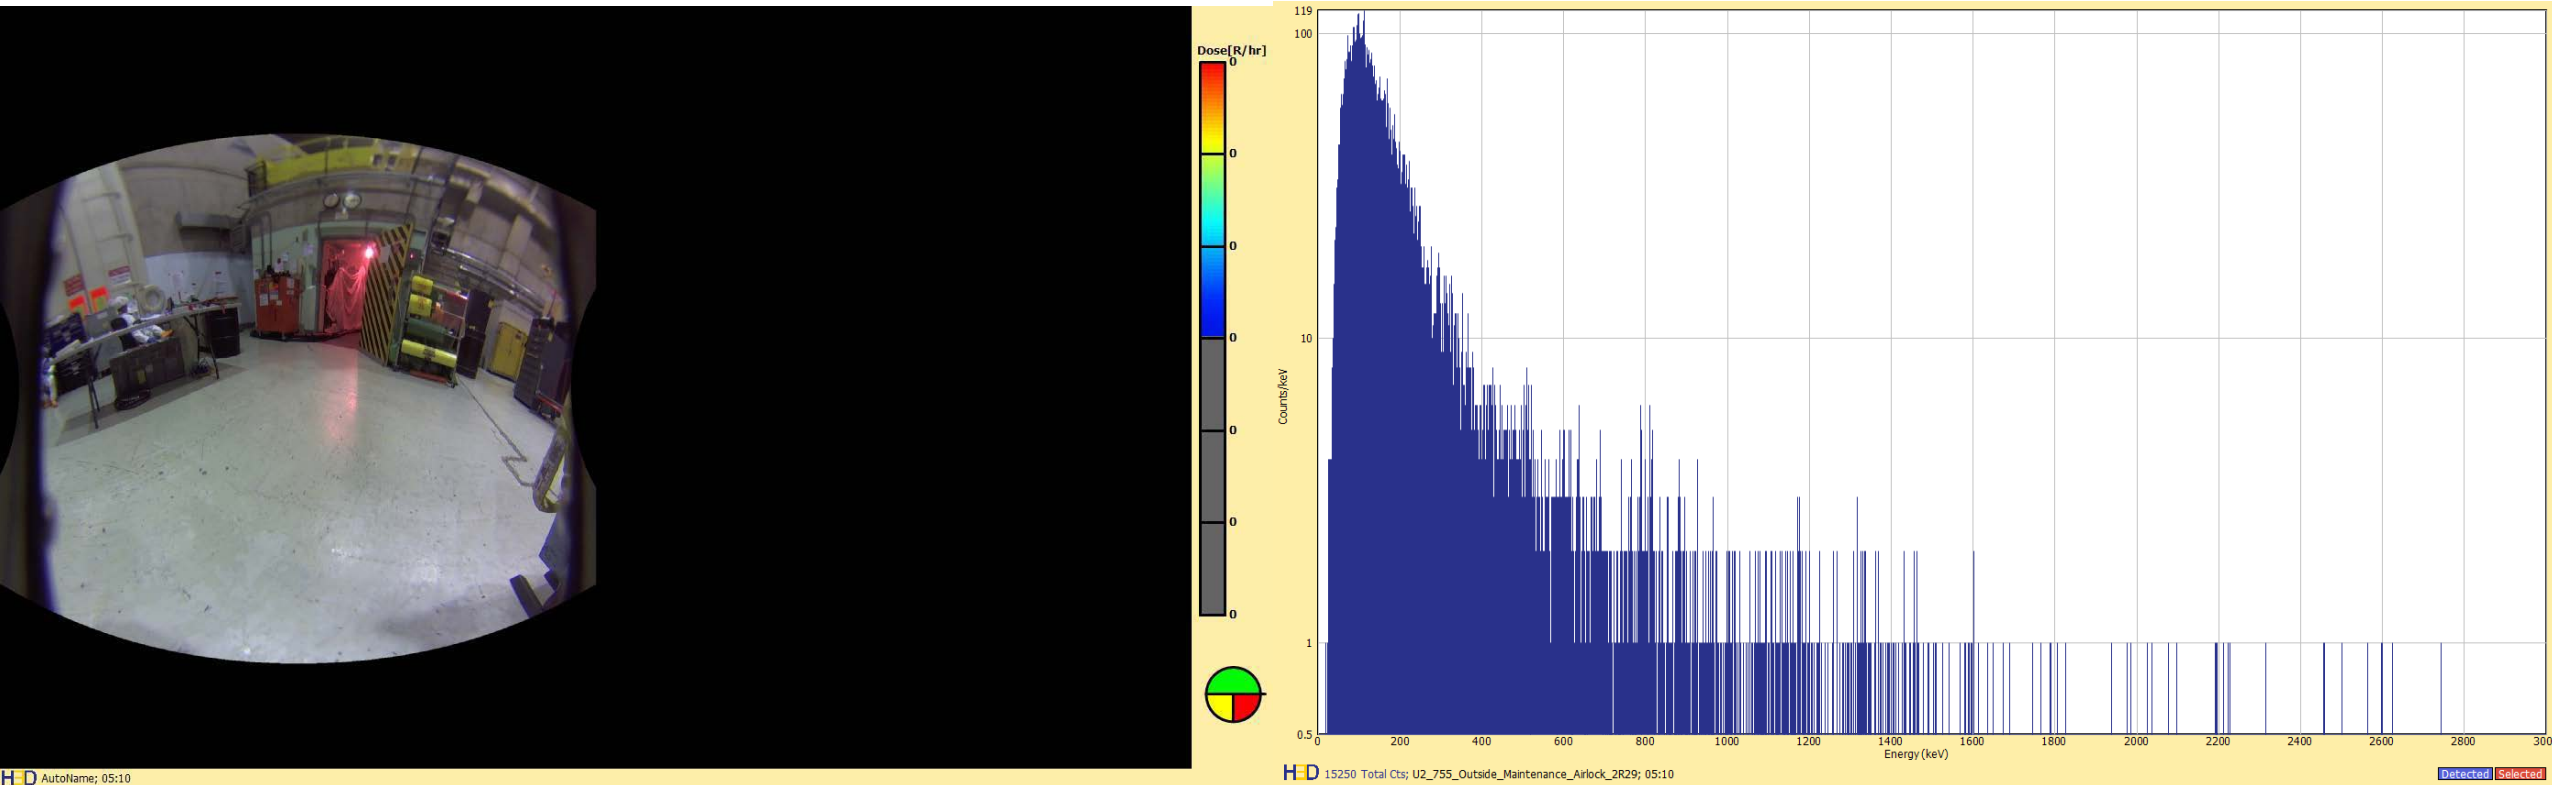
Contamination Control

This image is just outside of the Maintenance Airlock during the Unit 2 refueling outage. There was not enough data to create a radiation image, and there was not enough information to identify any nuclides on the spectrum. This shows that no hot particles or contamination was coming out of the Maintenance Airlock.
