**The situation of individual dose management of the workers  
who engaged in emergency work in  
Fukushima-daiichi nuclear power station accident**

Tokyo Electric Power Company, Inc.  
September ,2012

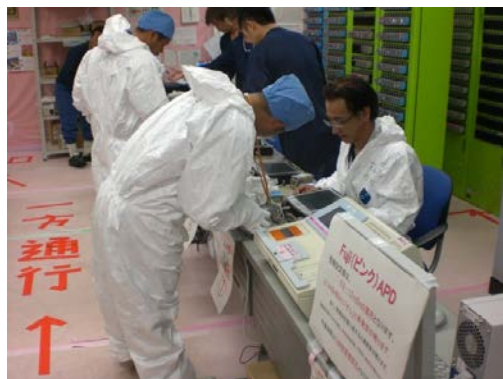
APD lending place  
at anti-earthquake building

- Unable to use about 5,000 APDs and their chargers for the tsunami.
- Gathered 320 available APDs.
  - All workers couldn't have APD.
  - A representative of the work carried a APD. (necessary condition: same work, same work place, etc)
- Newly purchase of 100 APDs 1 April, 2011 and brought 640 APDs from Kashiwazaki Kariwa Nuclear Power Station (1,060 APDs in total)
  - It went back up for the use that all workers could have APD (Now about 6,300 APDs in total).
- Started operating the individual discrimination system (bar codes) at 1F 1 April, 2011 and J-Village 8 June, 2011.
  - Sure of radiation management
- Started to notify individual dose by receipts 6 August, 2011.

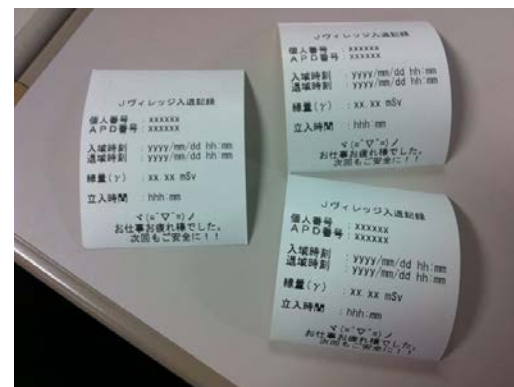
Printed form of  
APDs measured value

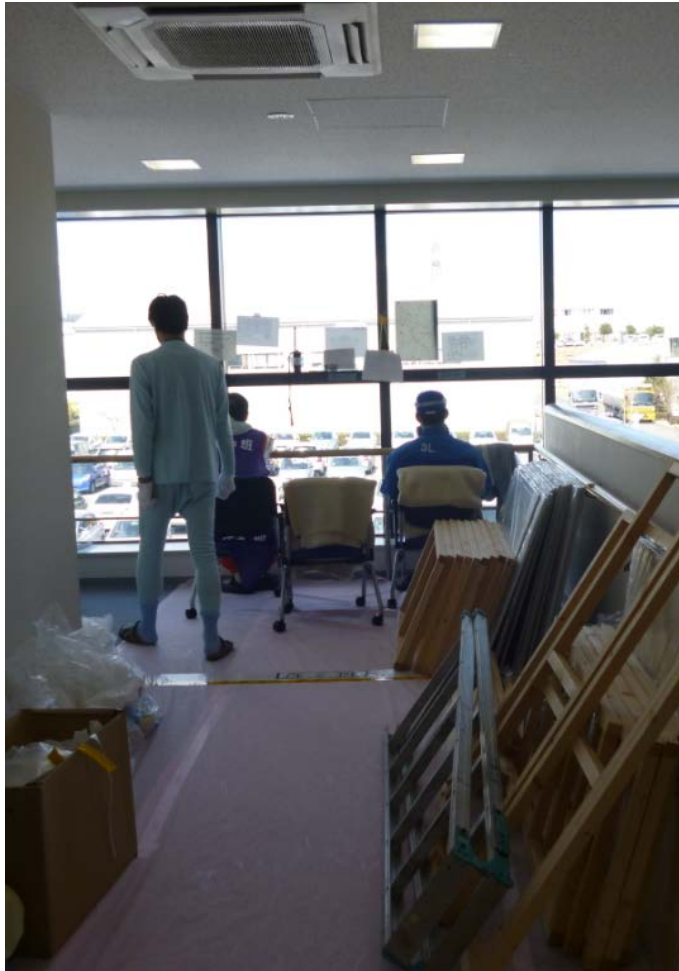
**Before construction**

*The dose exposure reduction measures of seismic isolated building  
(Setting of the lead board to the window)*

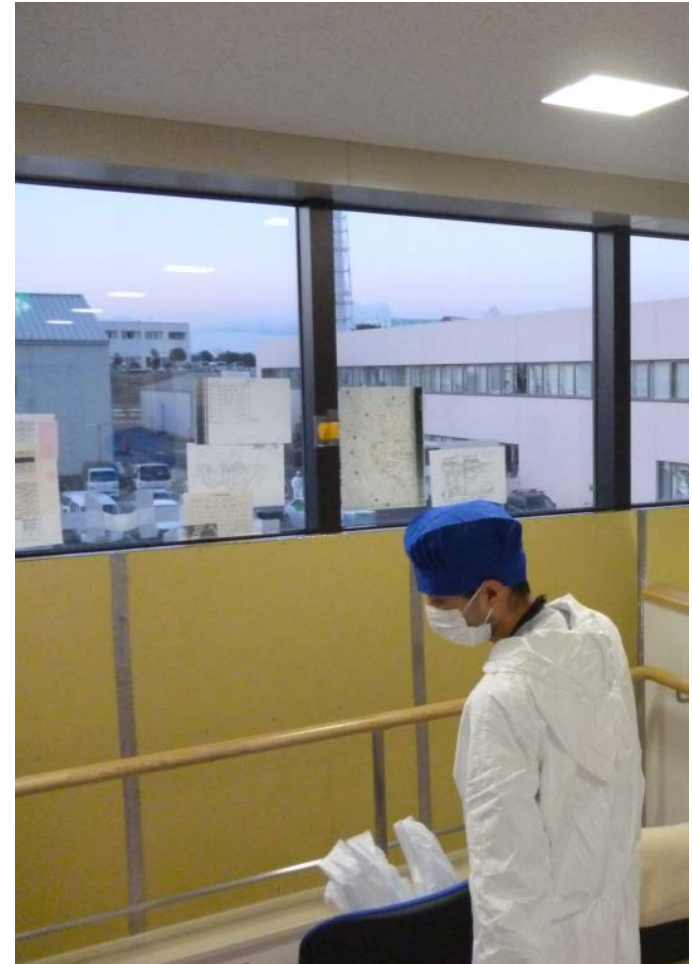
**After construction**

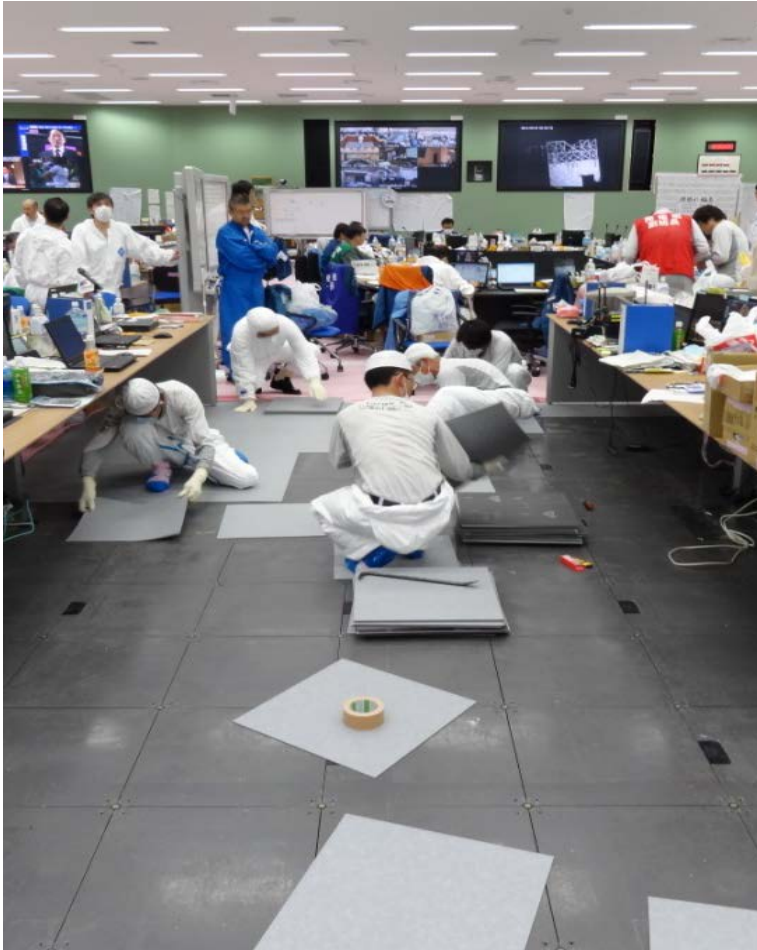
**Under construction**

***The dose exposure reduction measures of seismic isolated building  
(Setting P-tile on the floor)***

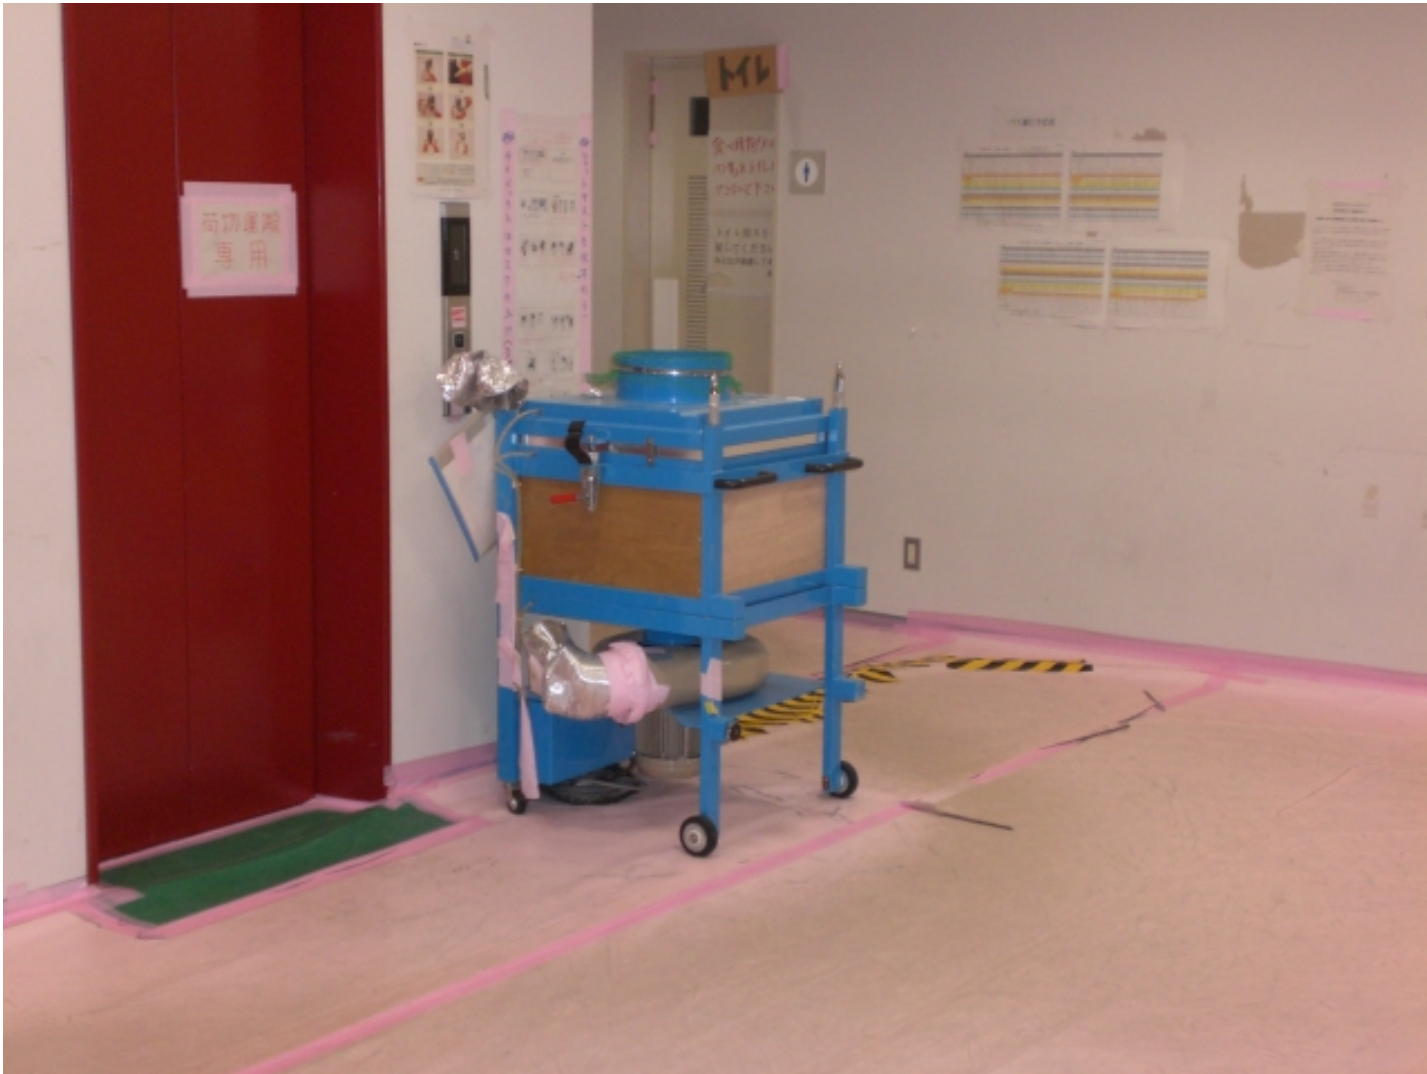
***Setting of the local exhauster***

- Use not to let female workers work at 1F since 23 March ,2011.
- Change to the tile which is hard to attach and deployment of the local exhauster.  
→Reduction of radioactive matter concentration in air in the anti-earthquake building.

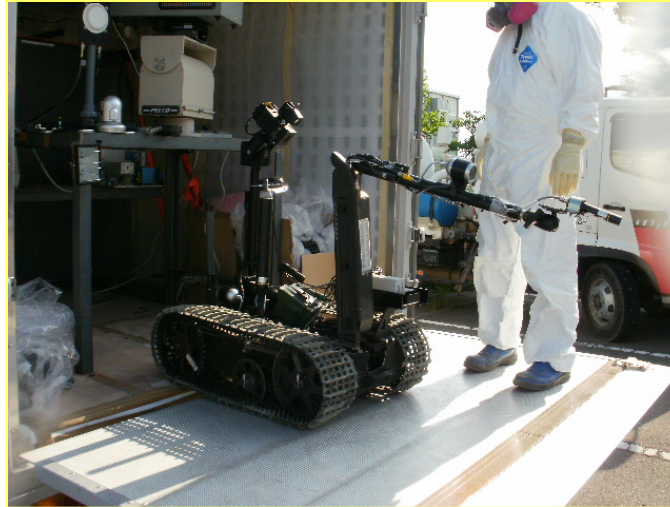
**Robot for measurement of dose rate(Taron)**

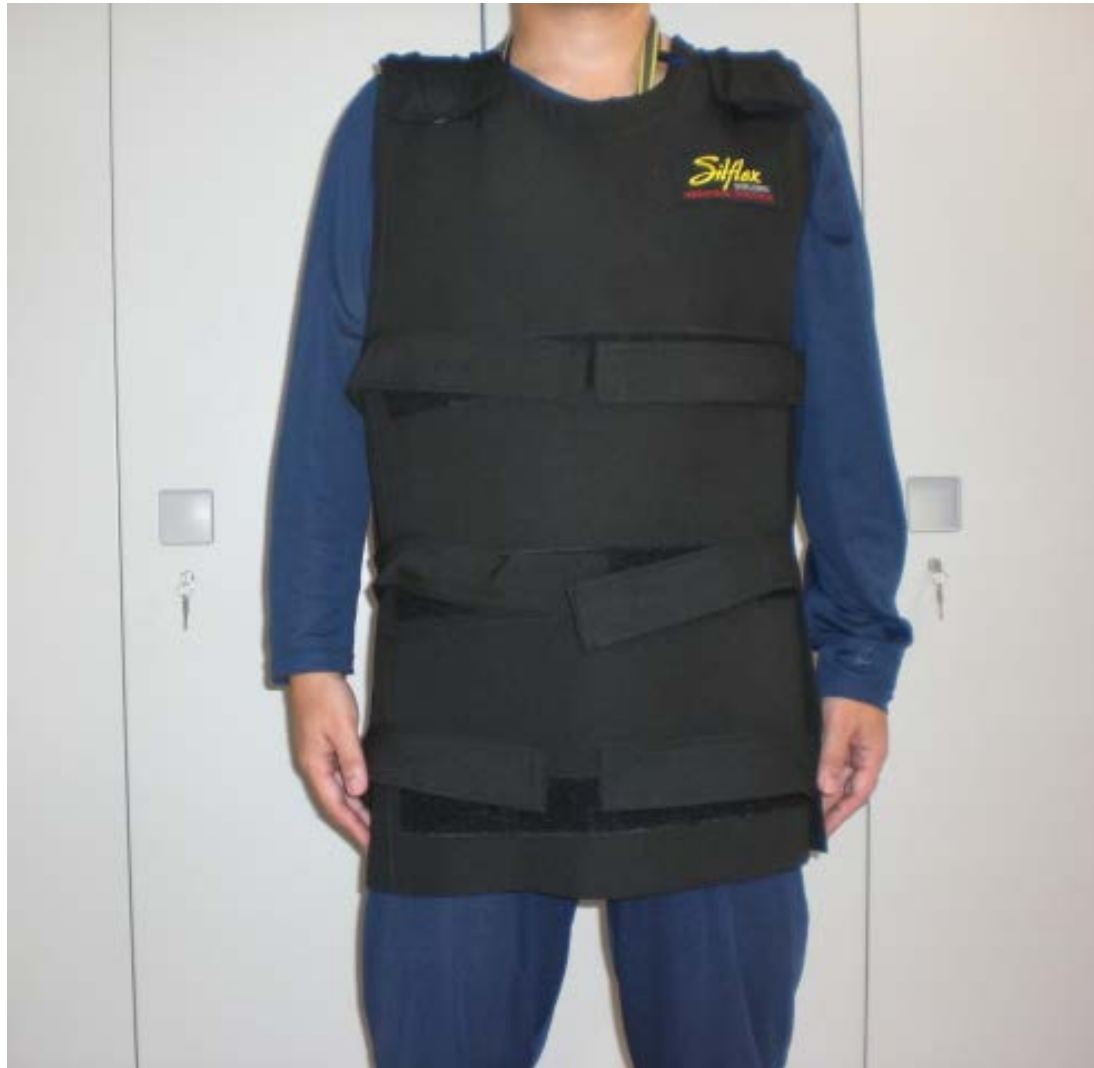
***The tungsten best***

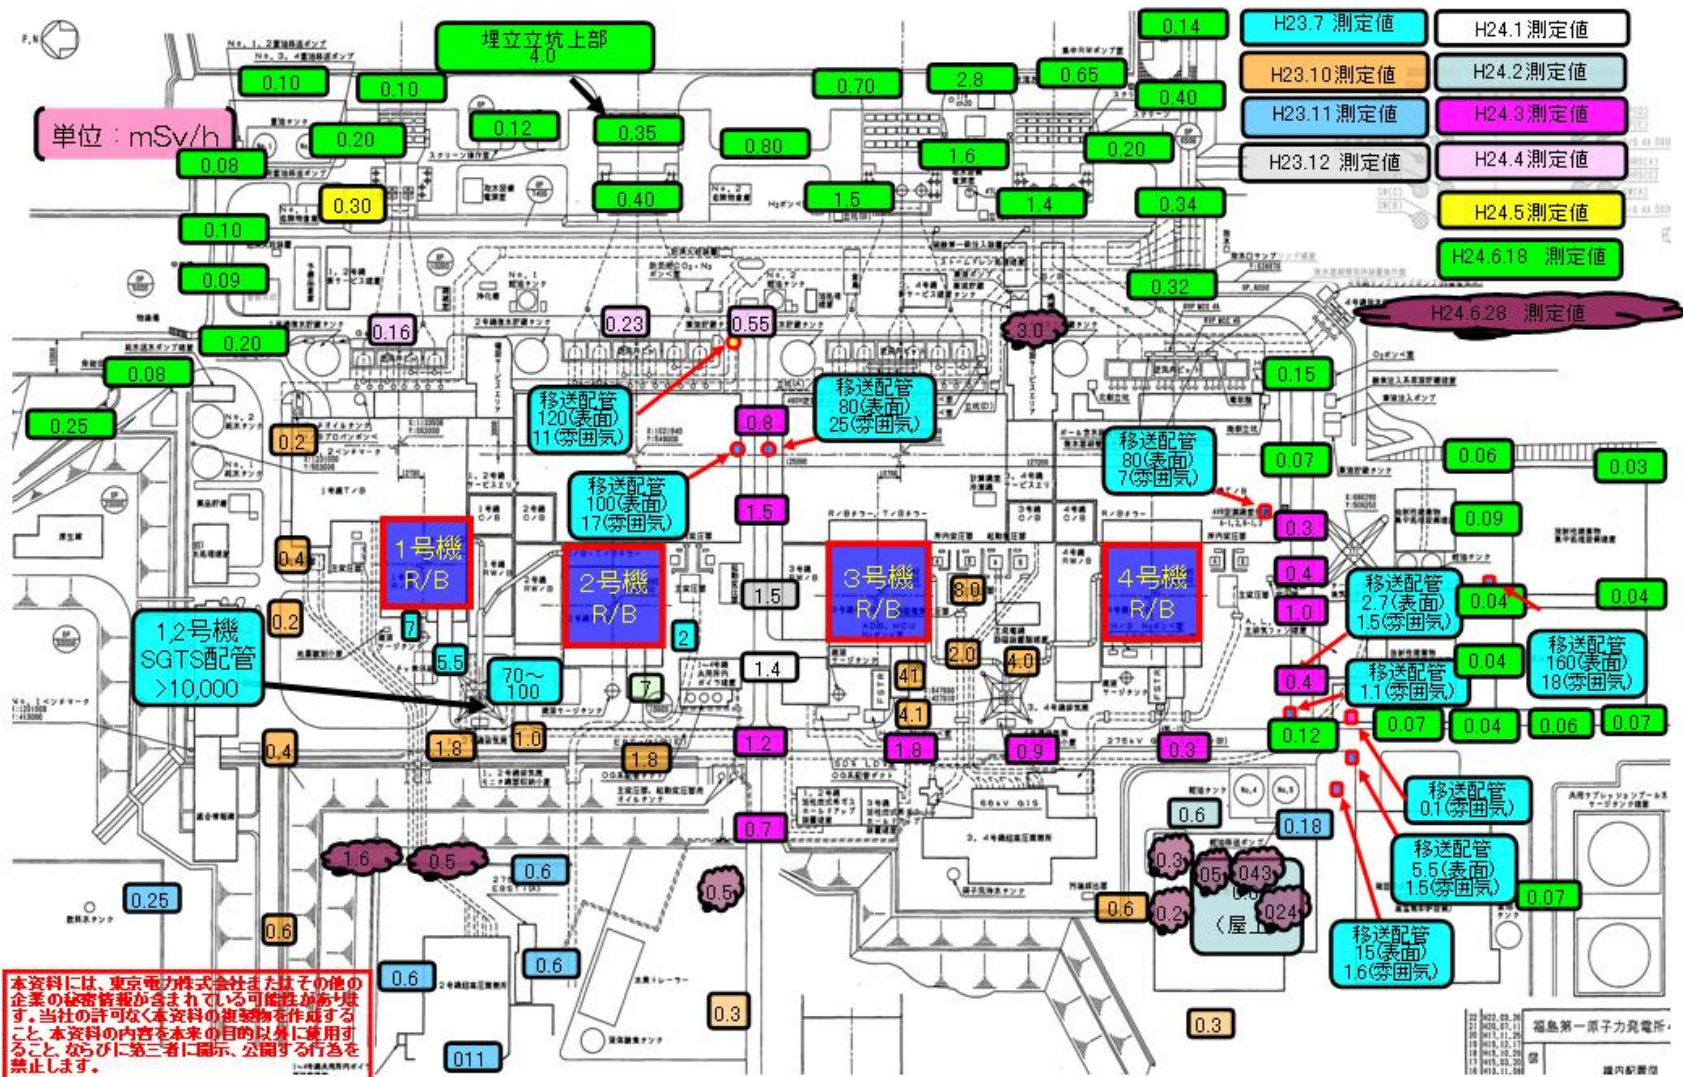
福島第一サーベイマップ（平成24年 6月28日 17:00現在）
