# **Severe Accident Management: Radiation Dose Control Fukushima Daiichi and TMI-2 Nuclear Plants**

**ISOE Expert Group on Occupational Radiation  
Protection in Severe Accident Management**

**June 17, 2014**

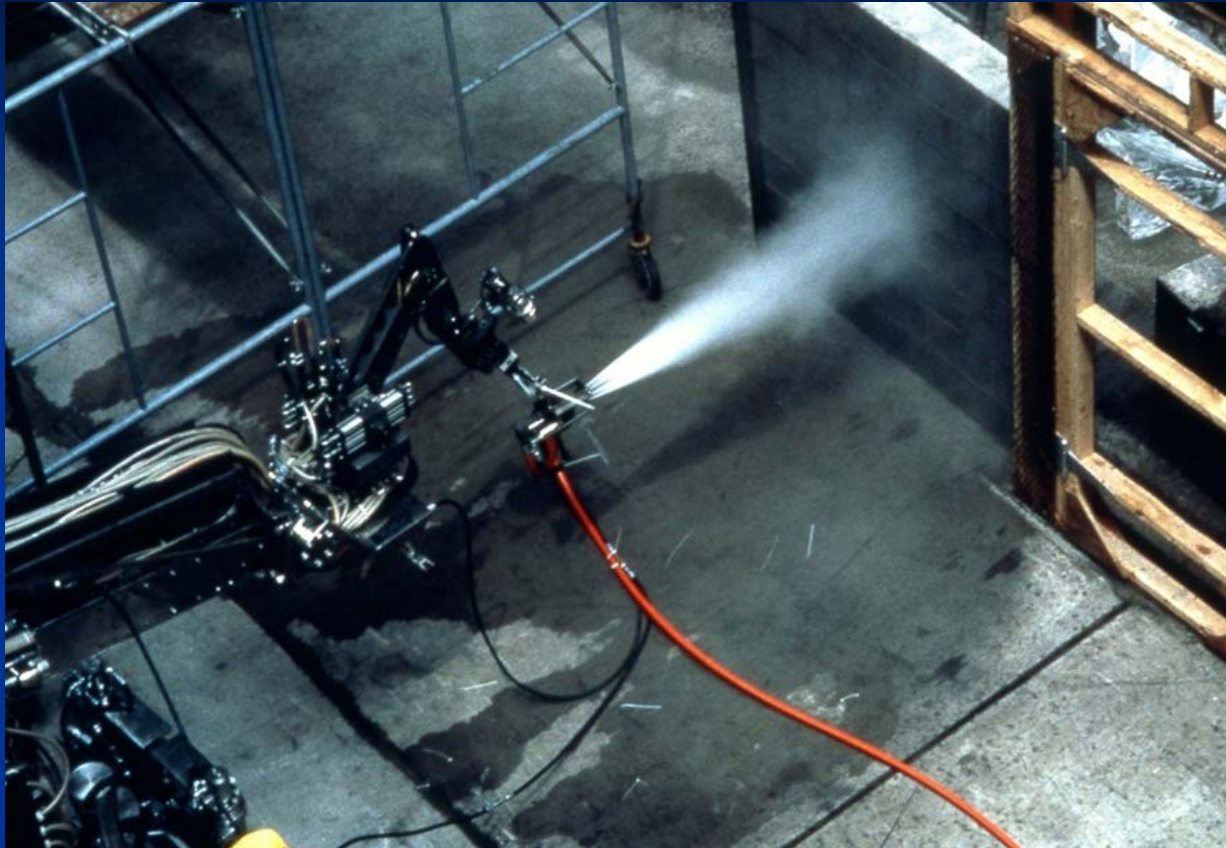
**TMI “Workhorse” Hydrolasing Robotics**  
**50k psi Water**

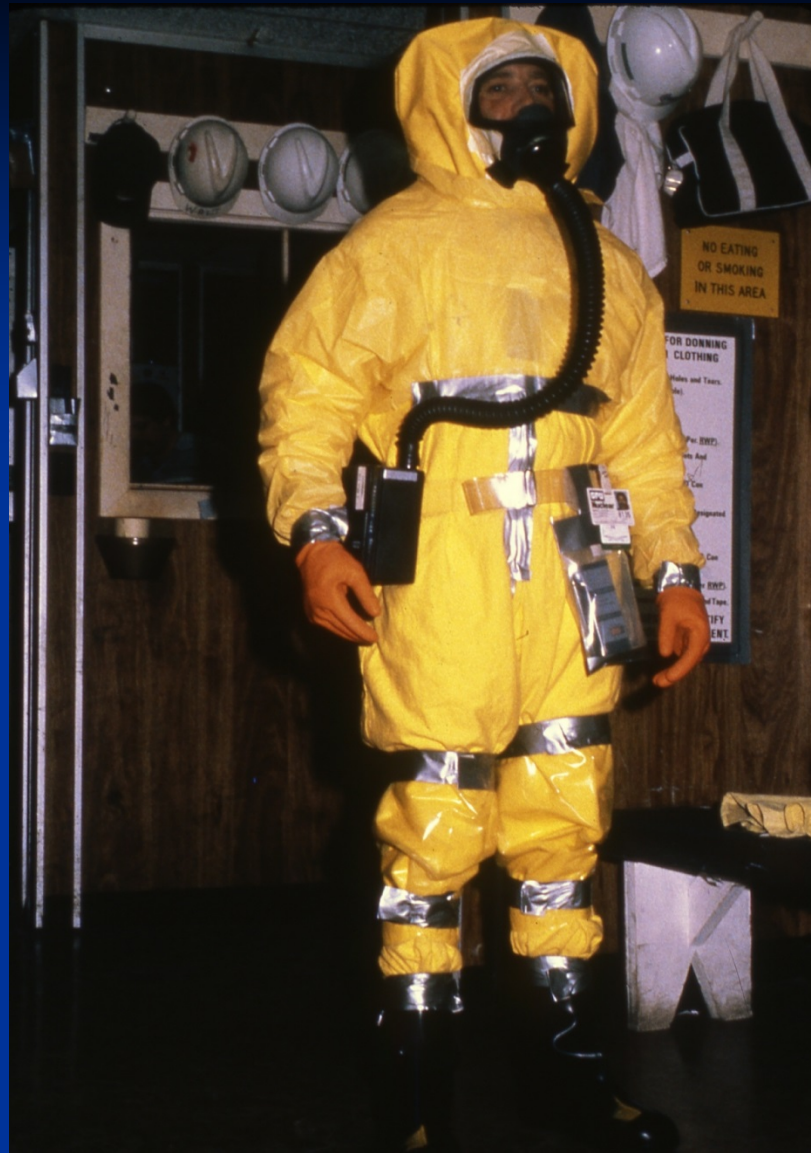
**PPE Issues Played a Major Role  
Care needed with Sr-90/Y-90 and alpha !!**

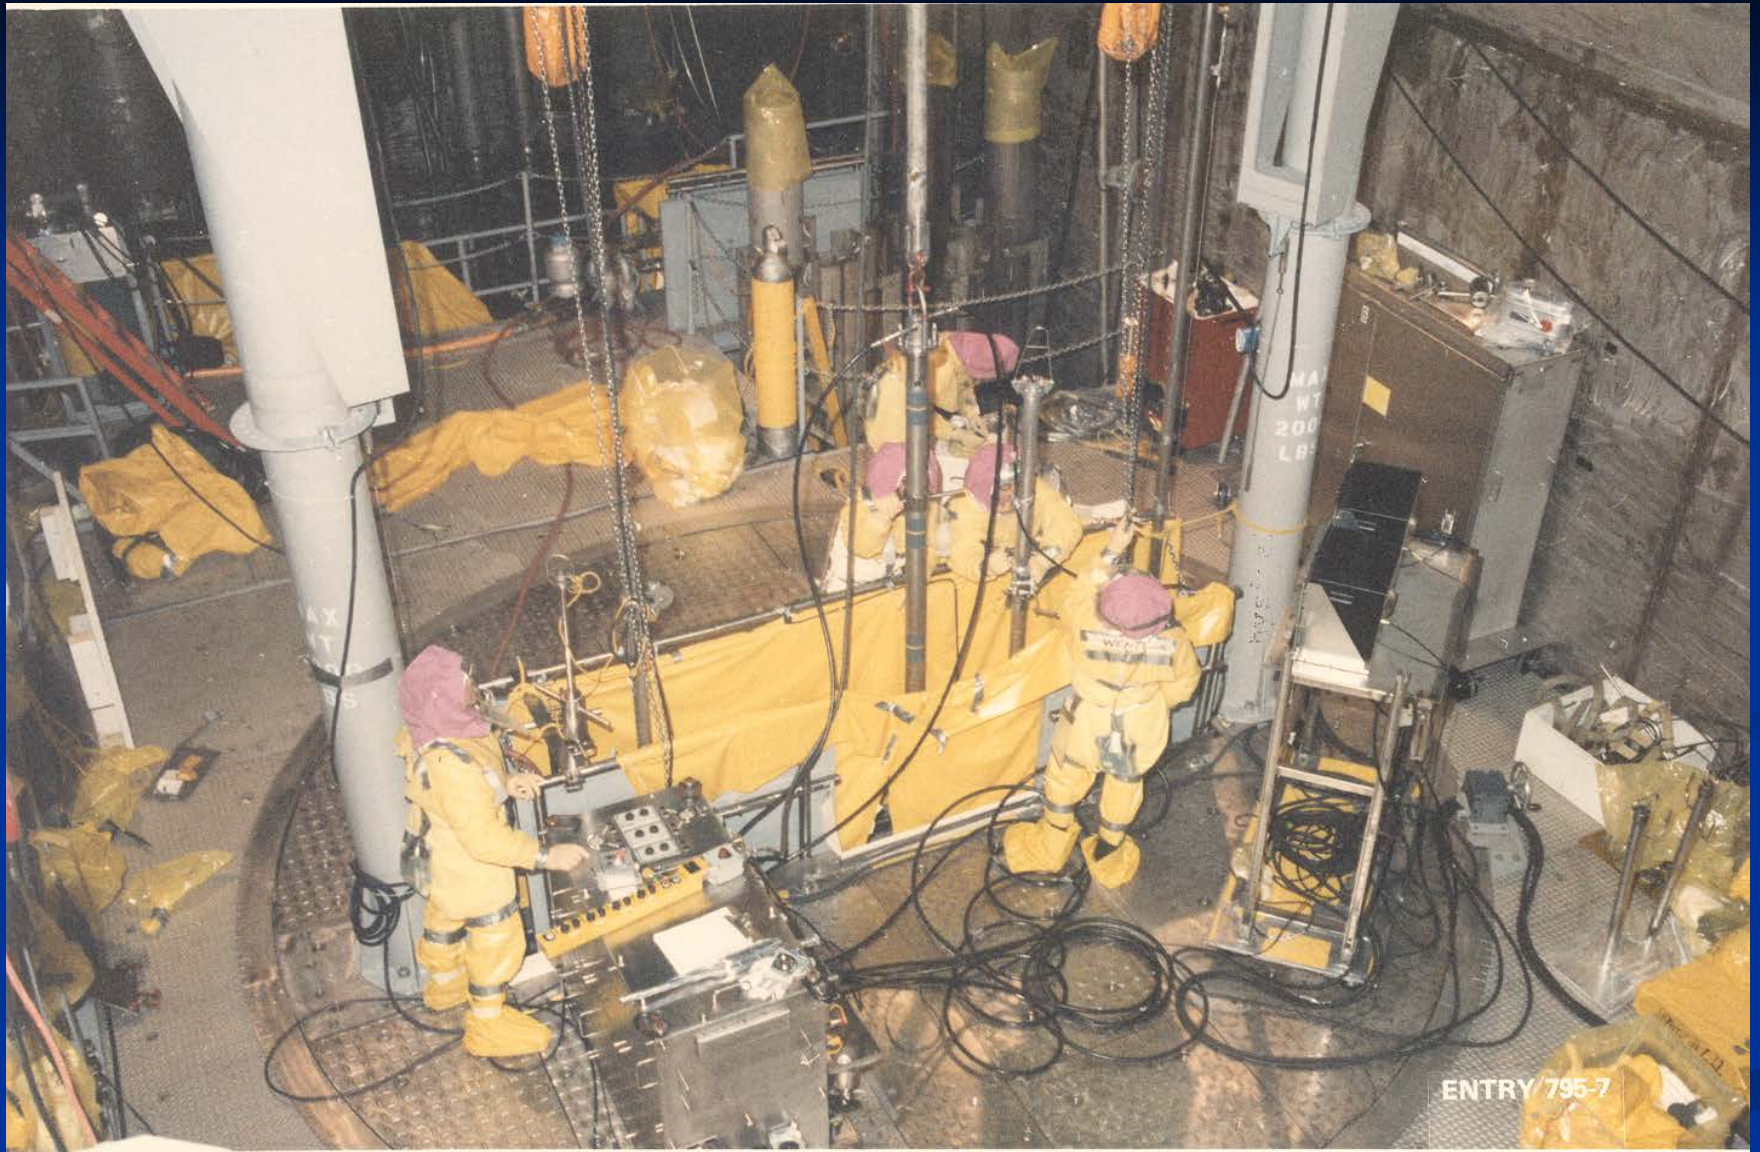
**Remote Shielded Rotating Work Platform**

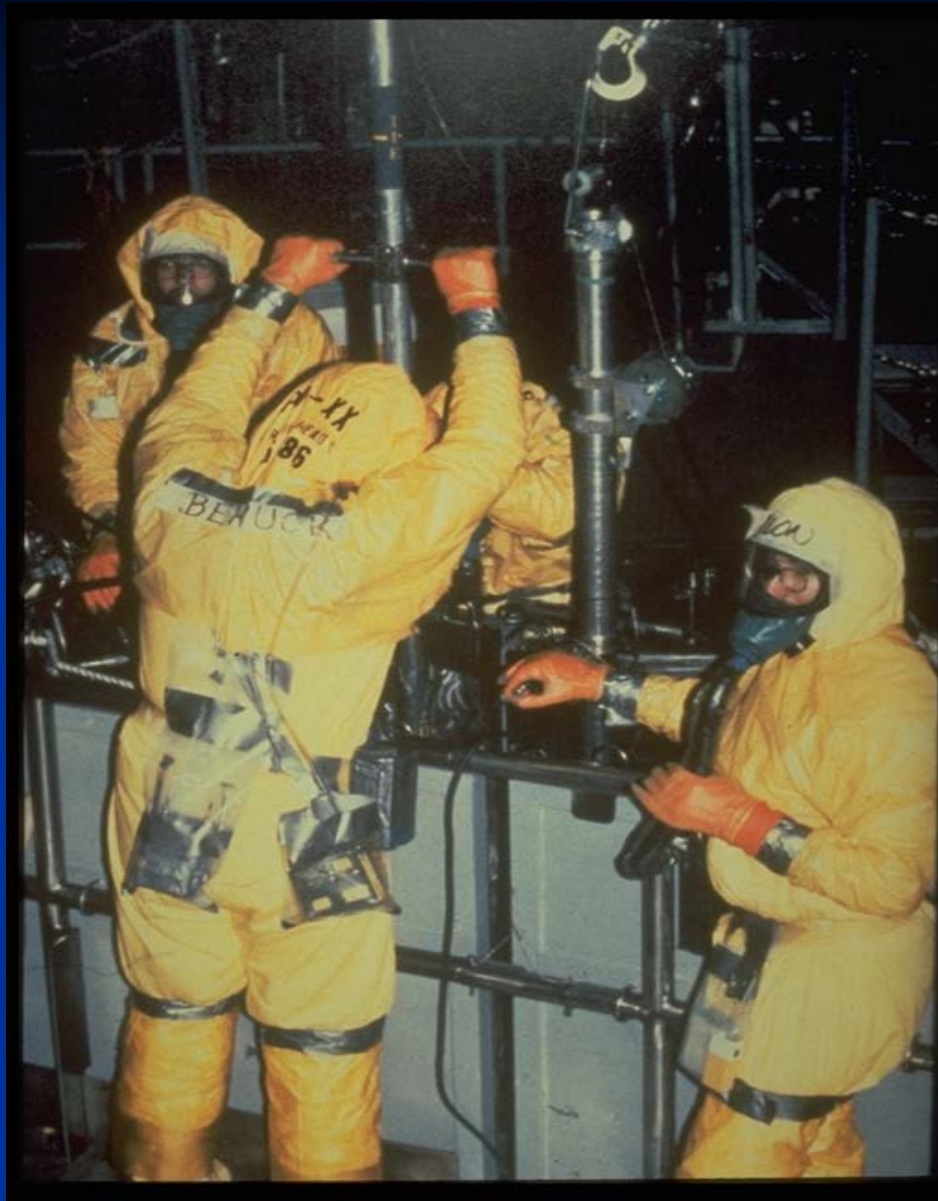
**Personnel Protective Equipment for Platform Work**
