# Sizewell B Thermal Sleeve Replacement

## Radiological Protection Aspects

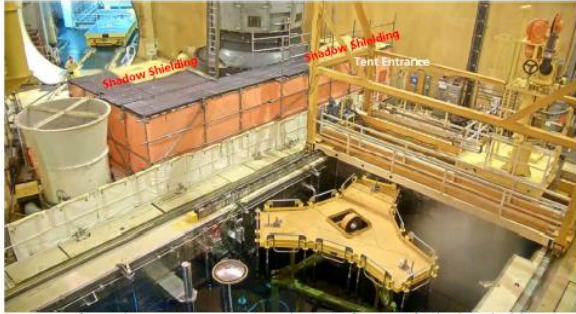
Overview of tent showing tent entrance and extent of tent roof "shadow shielding"

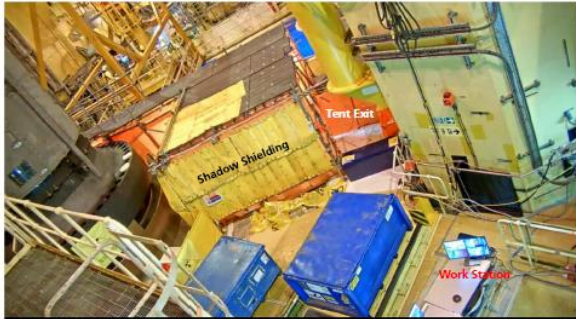
Overview of tent showing tent exit and location of EDM/Inspection work station

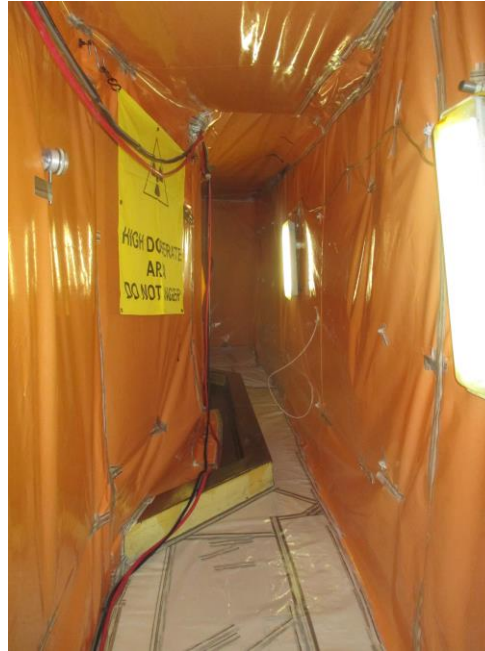
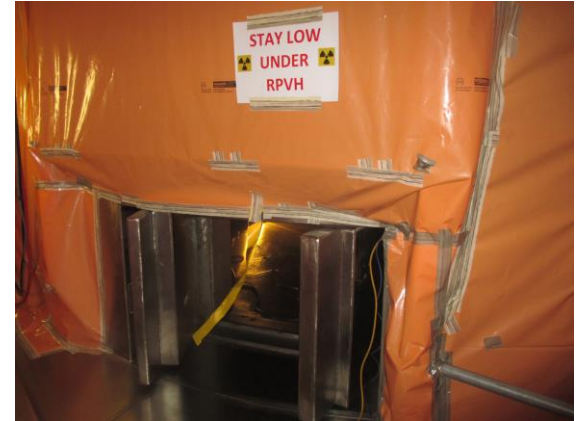
Given the size of the tent two filtered extract units were employed, one close to the RPVH storage stand doors and the other extracting from the undressing/low dose rate waiting area.

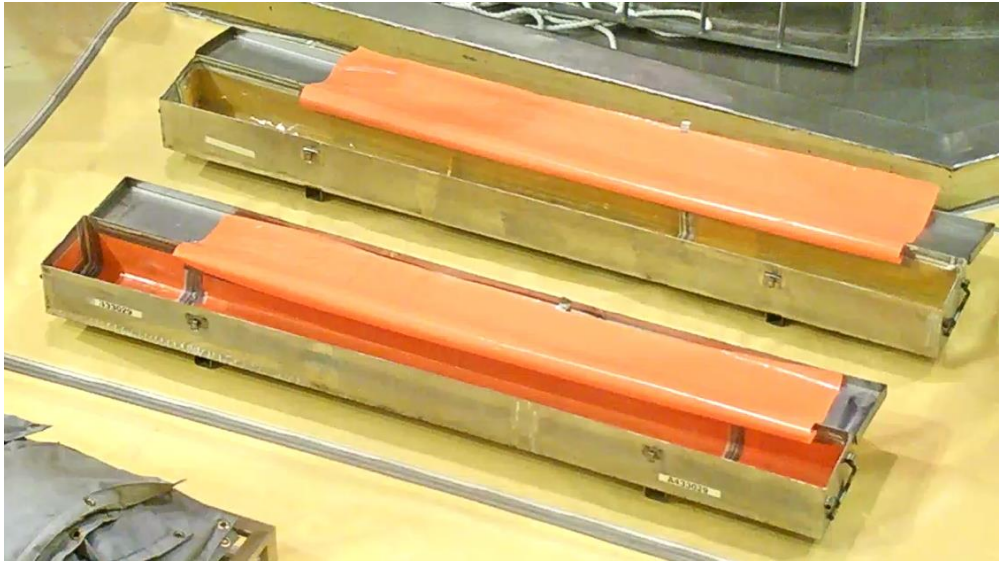
# Handling and Storage of removed thermal sleeves

Bespoke aluminium containers were made to move and store the removed thermal sleeves. With good preparation the doses for loading and moving the containers were very low and the risk of contamination spread was minimised.
