# **Three Mile Island Unit 2 Radiological Dose Management: Lessons Learned Applicable to Fukushima Daiichi**

**2012 International ISOE ALARA Symposium**

**Roger P. Shaw, CHP**  
Principal, Shaw Partners LLC

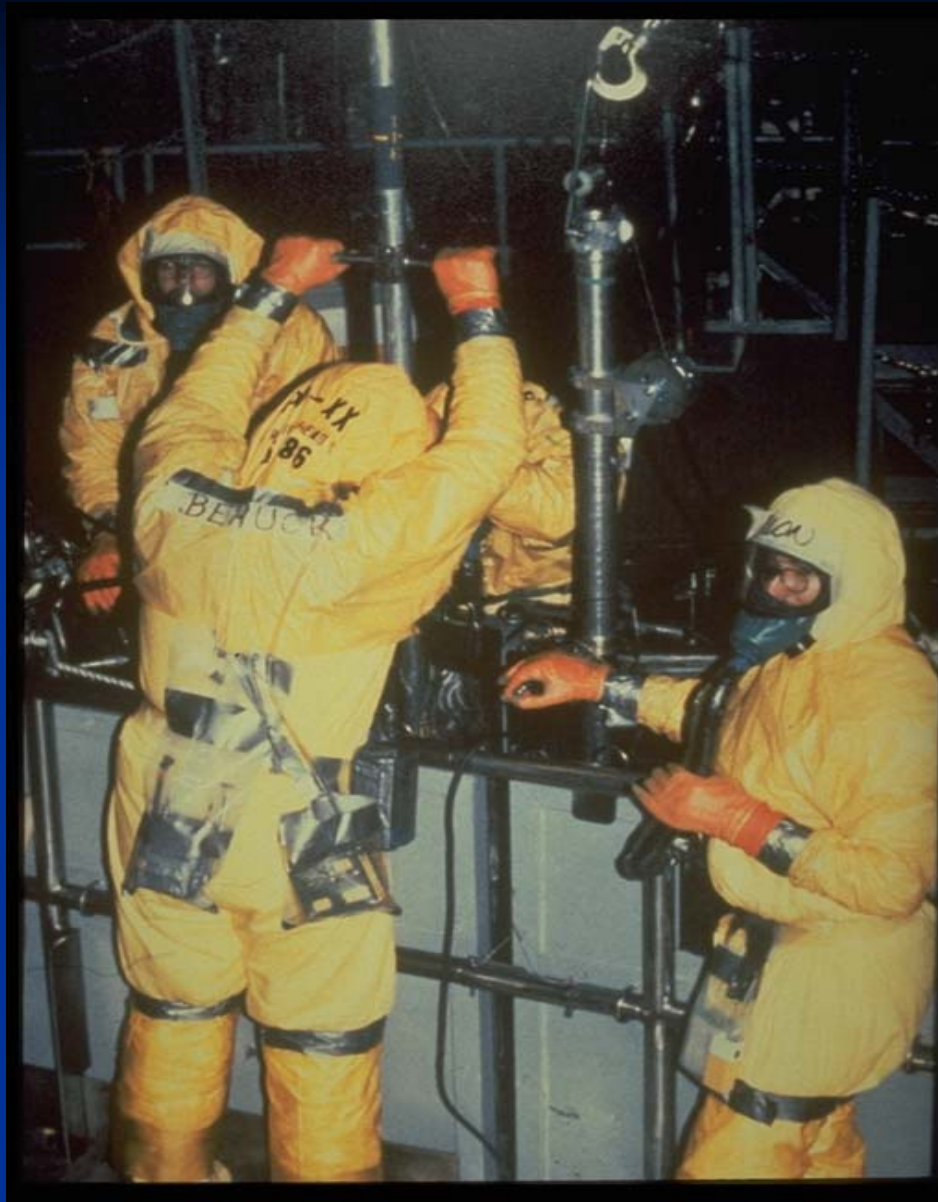
Personnel Protective Equipment for Platform Work

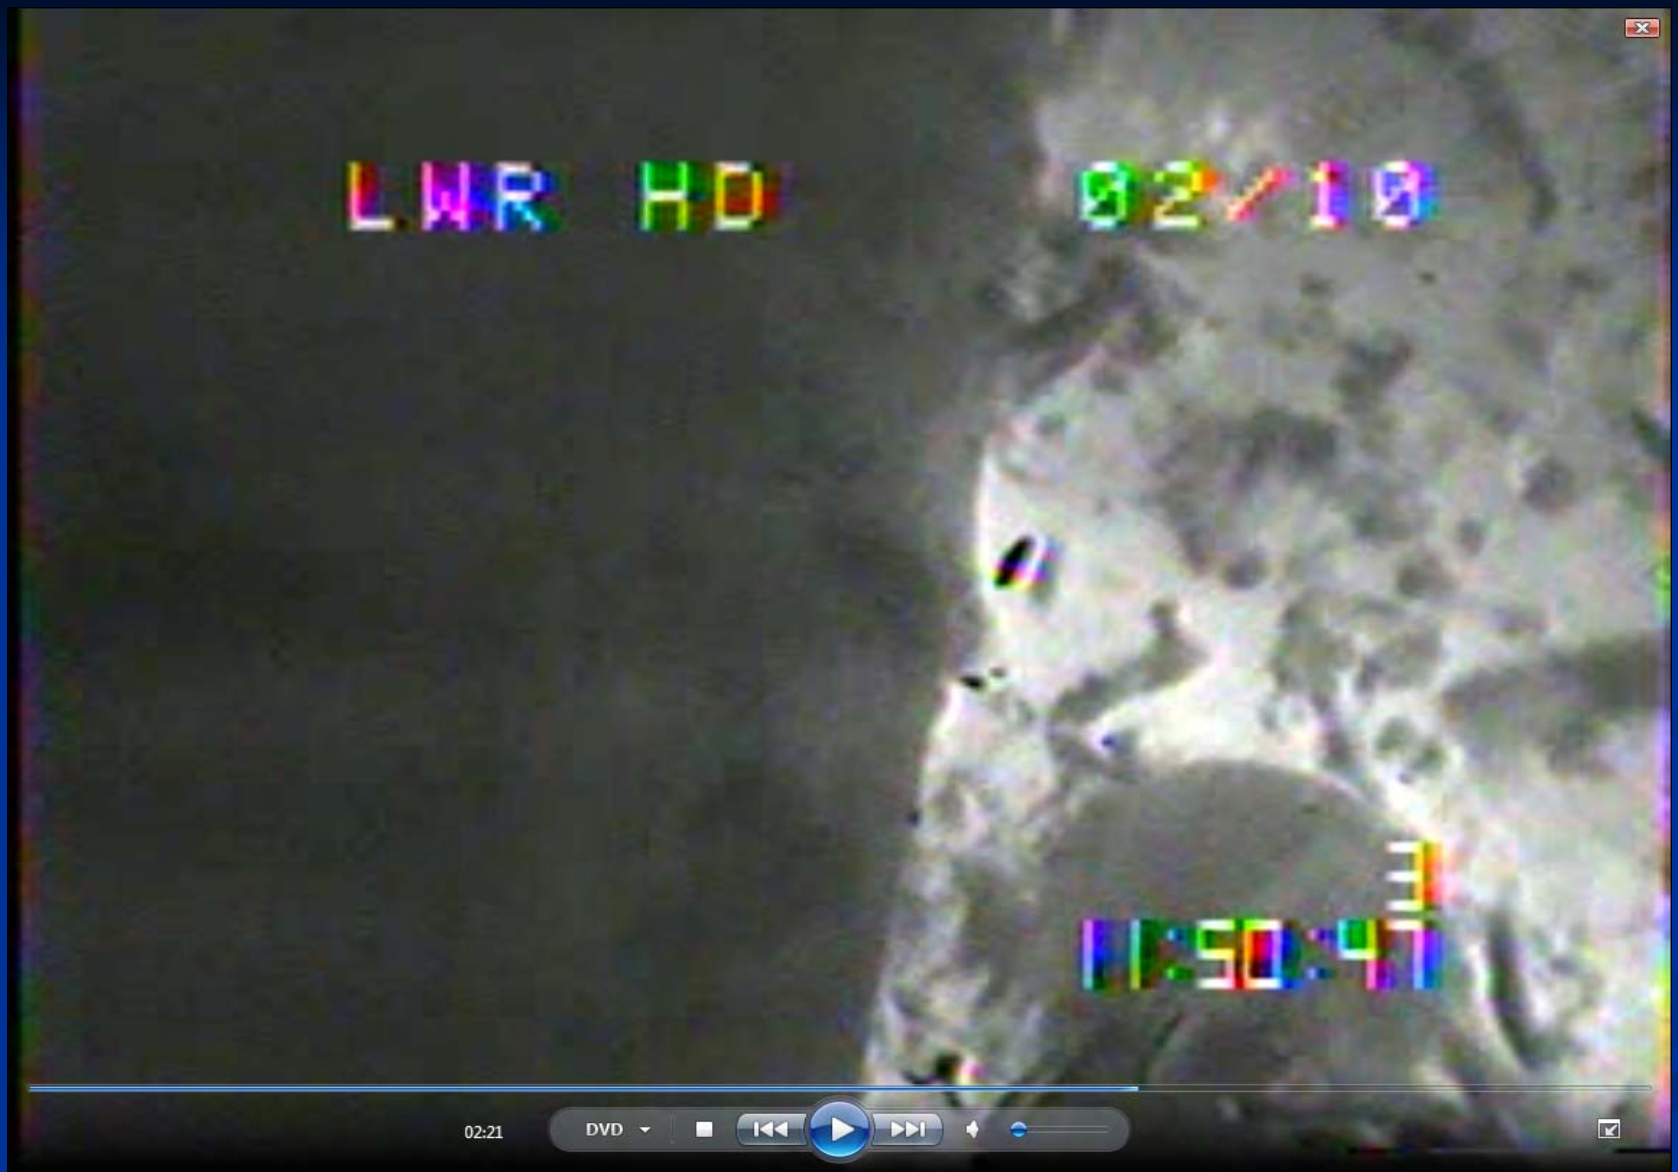
**Reactor Vessel Microorganism Turbidity Problem**
