Contamination control at the exit from radiation controlled area and NPP site at Bohunice NPP

Svitek Jaroslav, Bohunice NPP, Slovak republic

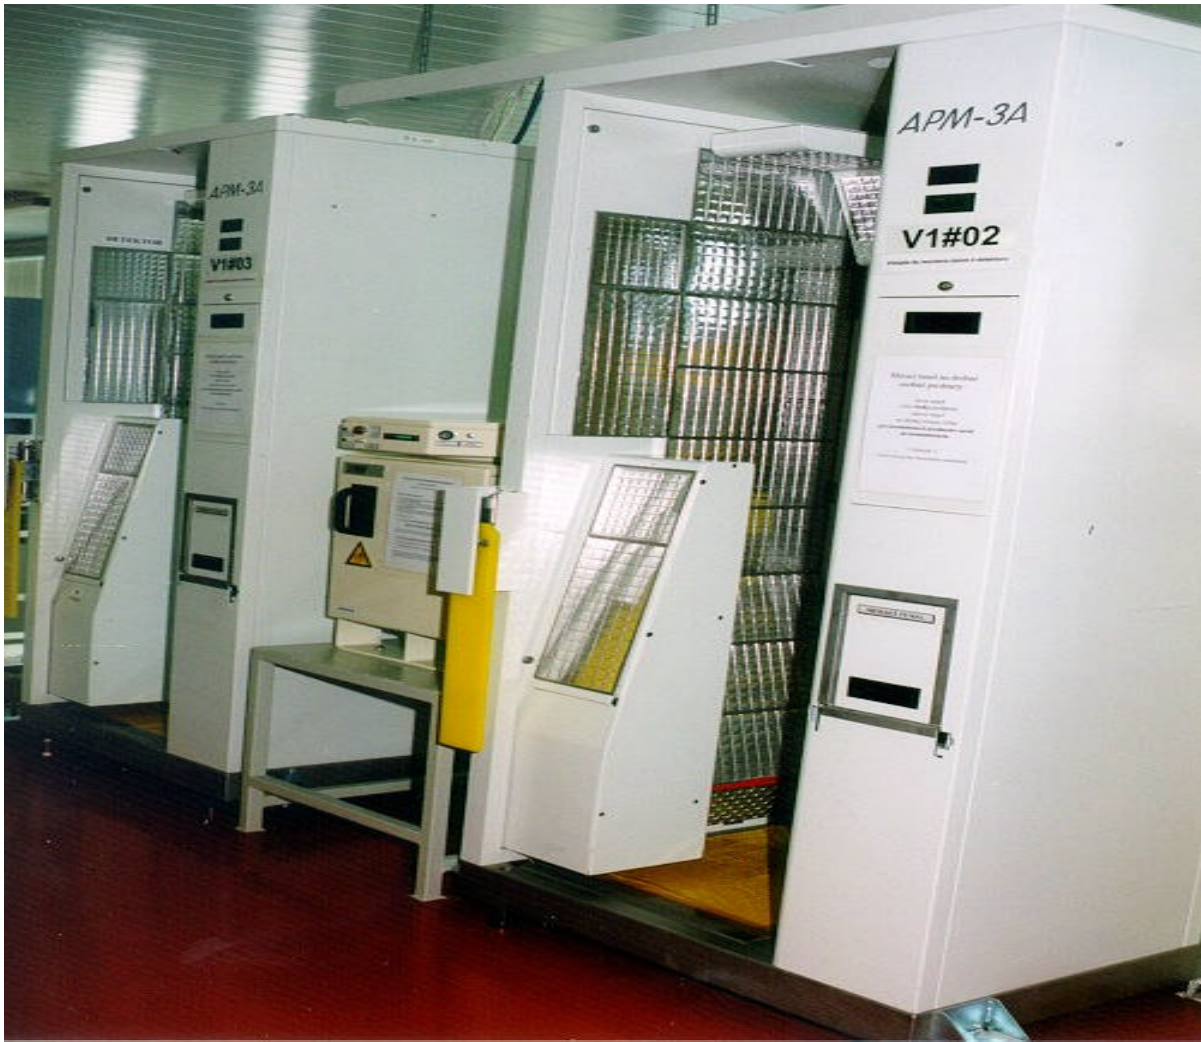
Fig. 1: CPO and APM-3A monitors

APM-3A is two steps alfa , beta and gamma-ray sensitive whole-body monitor. There are large gas flow proportional detectors split into some internal compartments for monitoring the hands, body, feet, head and small objects. The monitor comprises twenty four large area LFP-800 detectors and two LFP-330 detectors. The active monitoring area is 32 000 cm² for the body and 3200 cm² for small objects. There are entry/exit barriers, foot, hands and body photosenzors and reader for ID cards. The control takes place in two steps: body front and one side first, then back and other side. The measurement time is more than eight second for one step.

The APM-3A monitors are used for monitoring of the surface contamination of personnel at the exit from the hot changing-room. The alarm set point is 45 Bq for each detector as well as for sum-zone. Radioisotope ¹³⁷Cs is used for calibration. The APM-3A is highly-sensitive monitor with an excellent coverage of body surface.

The CPO uses two large area scintillation detectors (1225 cm² each) in the top and bottom sites. There also is the lead shielding (25 mm), entry/exit barriers and audible warning.

The CPO monitors measure the small objects taking out of radiation controlled area. The calibration is performed by ⁶⁰Co and the alarm level is 90 Bq. The complex of APM-3A and CPO monitors creates the radiological contamination barrier at the exit from the hot changing-room which is the RCA boundary.

There were larger problems with the control of the P10 gas flow of APM-3A monitors because the gas supply system is situated outside the building.

Immediately after the putting the monitors into the operation a large number of shoe soles contamination had been indicated by those monitors. Those shoes are used only for passage from the hot to the cold room. The main cause of the contamination was the superposition of the small contamination existing on the floor of the hot change room on the shoes' soles. The accepted corrective actions were: more frequent washing of the hot change rooms floors and positioning of the deco foils at the entrance to the hot change rooms

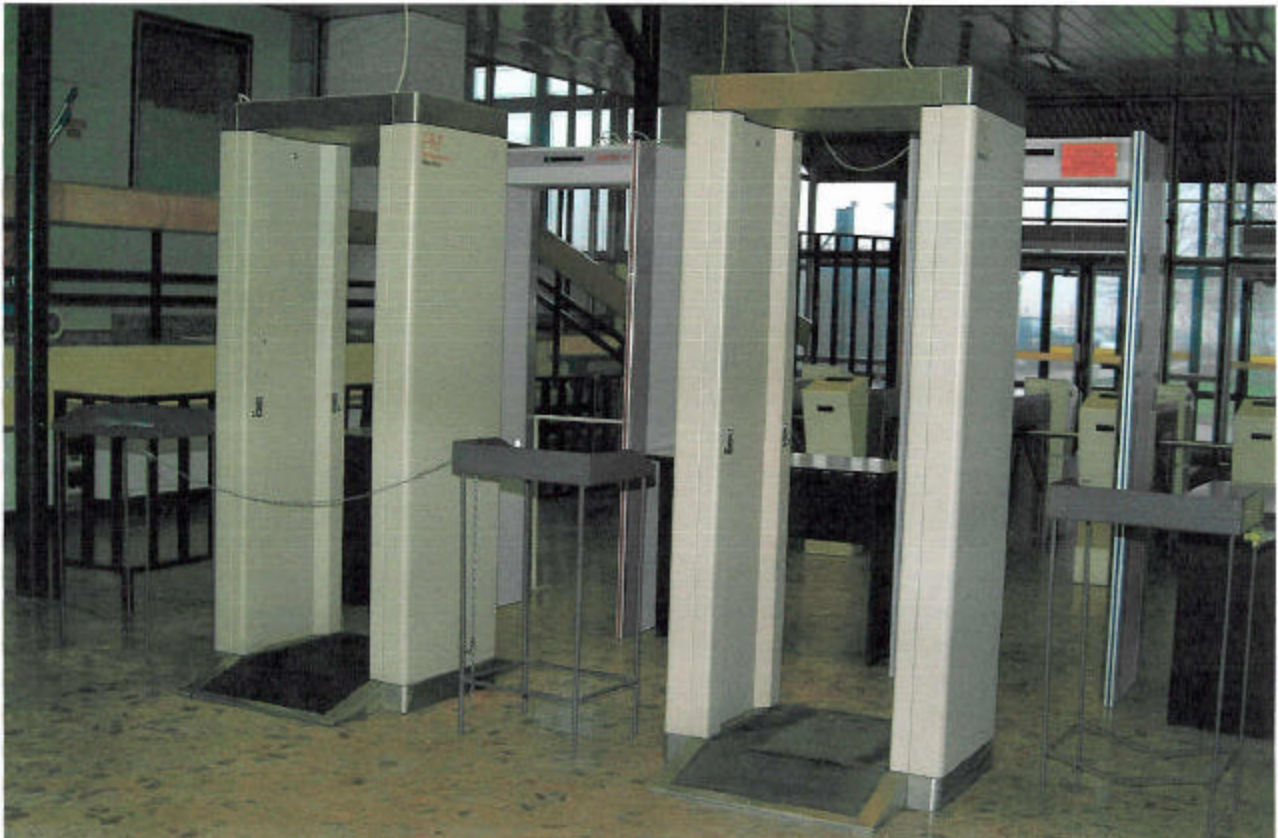
Fig. 1: PM7 monitors

Several instruments PM7 had been integrated into the overall security system of NPP. The condition for integration was to do not restrict the number of passing people. The PM7 monitor is equipped with the plastic scintillation detectors and with the lead shielding. Scintillators are distributed partly in each pillar (left, right) and in top and bottom part of the monitor. The RDA (Reliable Detectable Activity) of PM7 monitors lies within the interval (9.2 – 10.4) kBq for ¹³⁷Cs (dotted source in the middle of the monitor).

The innovated system of contamination measurement at the personal and vehicle site gates was put in operation in January 1998.

The measuring algorithm of PM7 had been accommodated during the installation in order to facilitate fluent passing of the personnel through the monitors.

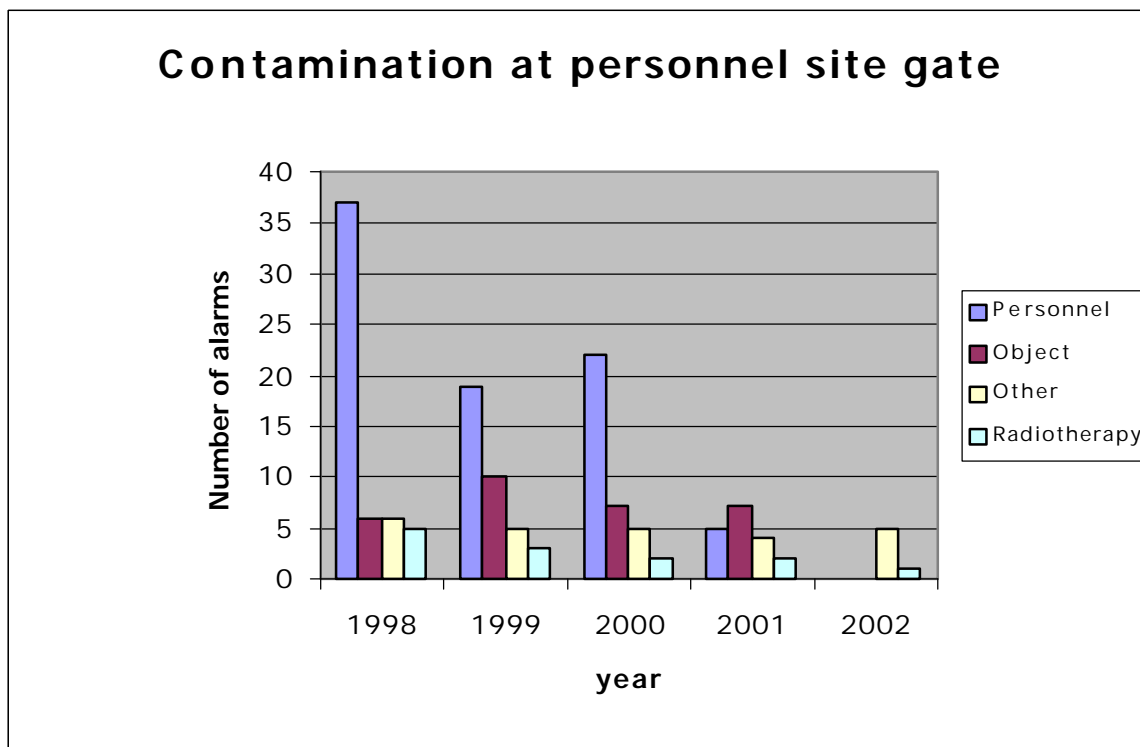
Table No.2

The number of contamination found during the first period is in the table 2.

Year	No of personnel contamination	No of object contamination	Other	Radiotherapy
1998	37	6	6	5
1999	19	10	5	3
2000	22	7	5	2
2001	5	7	4	2
2001-2002 after the modernis.	0	0	5	1

The contamination events were divided into the four groups.

1. Personnel contamination - the group contains all the events caused by worker's surface body contamination, his/her dressing or internal contamination.
2. Object contamination - contamination of objects, things wearing by personnel
3. Other - contamination found at the entry to the NPP site which are brought from other sites or caused by natural contamination
4. Radiotherapy - usually found at the entry

- More than 70% events of personnel contamination was caused by insufficient characteristics of old equipment RZB-04-04 a RUSSI-1 at the exit from RCA
- Less than 30% of personnel contamination was caused by human error - by violation of RP rules at the exit from RCA
- Up to 60% of events was caused by the contractors workers
- Up to 80% of all events was found at JE V-1 which was caused by a large extend of reconstruction works during the reconstruction and the higher contamination of the primary circuit
- All contamination events represent only negligible risk on the human health (the maximum found activity moved around the kBq)

After the 1st June 2001 no exceeding of activity alarm due to the real contamination has been registered at personal site gates of Bohunice NPP. The fact can be explained by higher radiation awareness of the personnel and mainly by finishing of the replacing of the personal contamination monitors at the exit from radiation controlled areas.
