HOT TOPIC REPORT OF
BOTTOM HEADER DEFECTED
,YGN PLANT 5 IN 2003

KOREA HYDRO AND
NUCLEAR POWER COMPANY

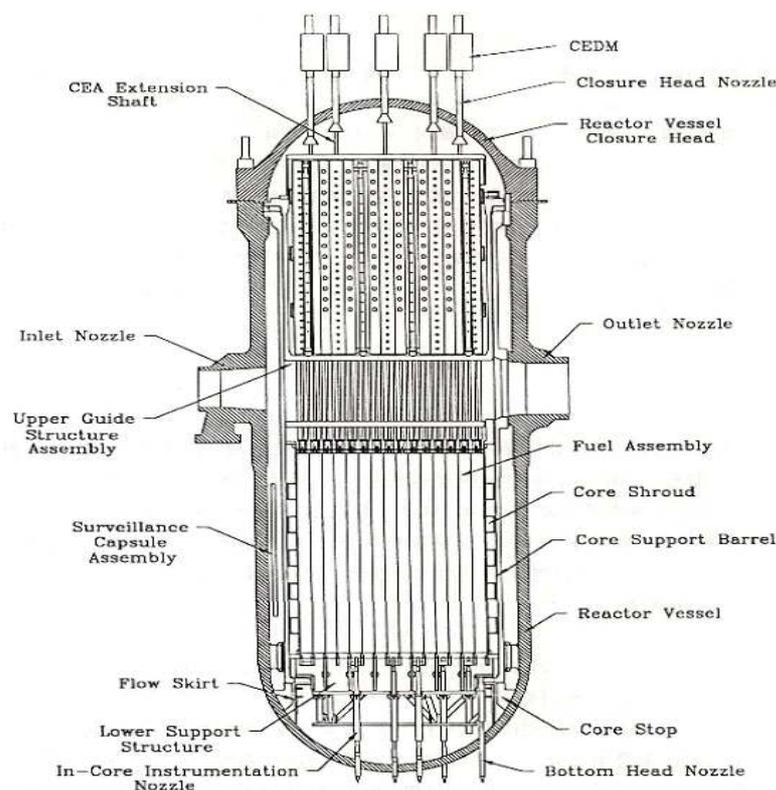
[Picture 1] The Design of Rx Vessel

The Rx Vessel consists of fuel assembly, CEA and Internal Structure to be needed supporting Rx Core which covered with the minimum depth of S/S<1/8"> and made of Mn metal including Mo metal. It is divided into two parts such as the upper header part and the lower part. The ICI with forty five guide nozzle is located through the lower header part to monitor the of neutron inside Rx and prevent from moving toward the radius direction of the core support barrel and core stop inside the upper Rx Header part restricts to moving toward the vertical direction of core support barrel.

The upper closure head consists of CEDM housing with seventy three, Rx Header vent line with one, Heated junction thermo couple system with two, including upper closure head with eighty four, in addition the material of Rx Vessel is made of carbon SA S08 and the material of cladding is made of S/S 318, 319.

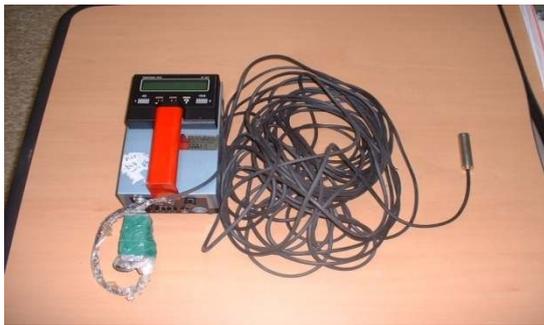
[Picture 5] Hi-Hi Teletector

Radiation Dose Evaluation has precisely monitored by using Hi-Hi Teletector, TLD and ADR for Rx internal wall and center of Rx Vessel damaged according to the elevation level.
