# **HOT TOPIC REPORT OF BOTTOM HEADER DEFECTD, YGN 5 IN 2003**

**KOREA HYDRO AND NUCLEAR  
POWER COMPANY**

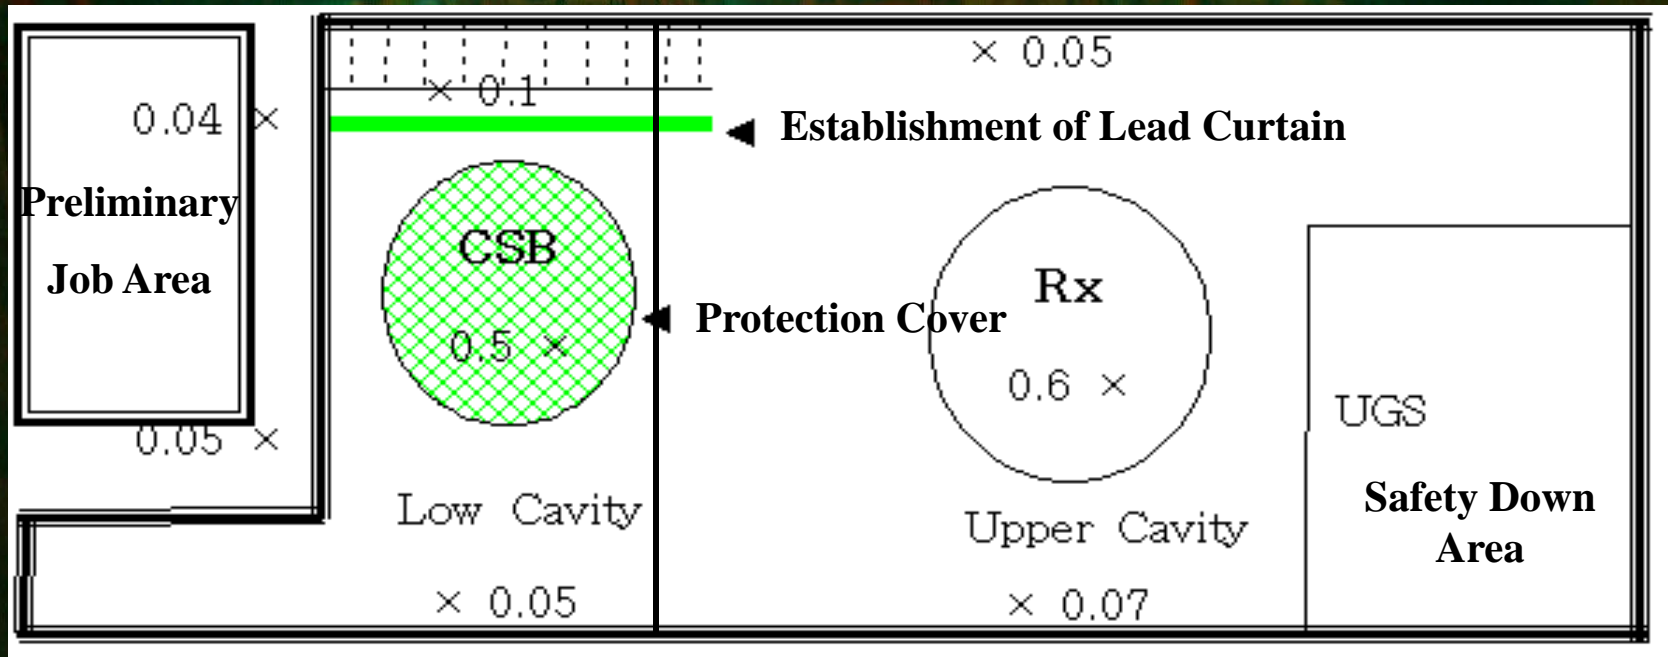
# Survey of Radiation dose Around RX Cavity

RX Cavity with  
Full Water (140')

Unit:(mSv/hr)

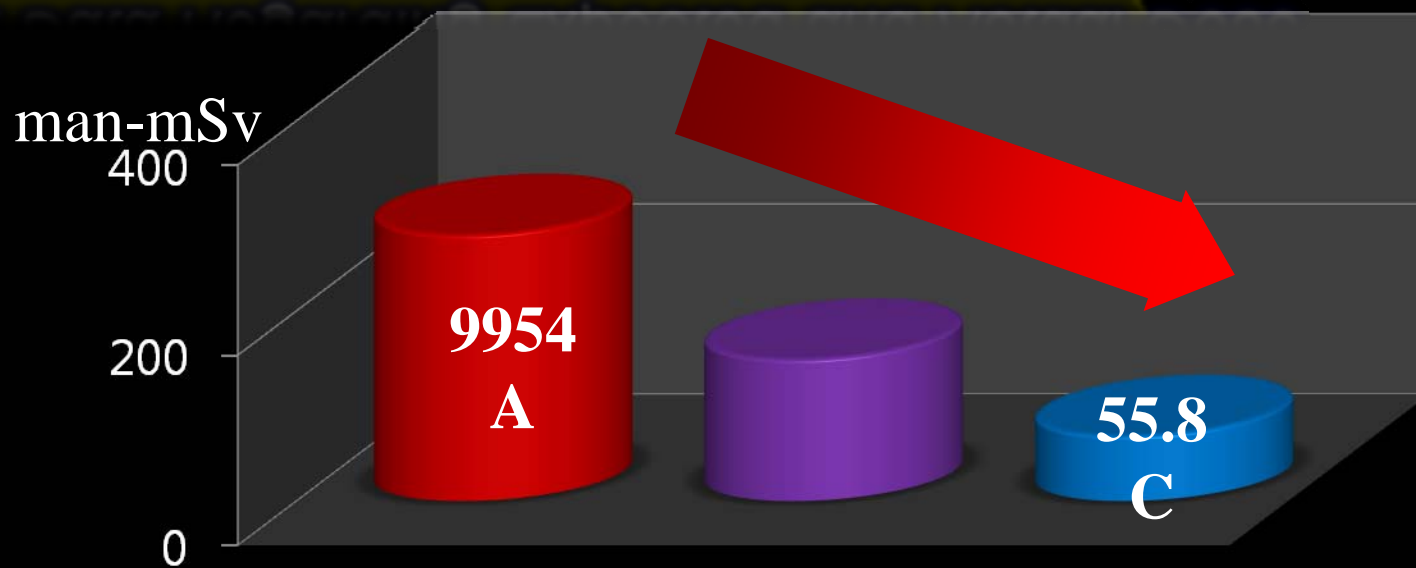
## Result Data Regarding Expected and Actual Dose

Target VS Result data

A : Target dose of maintenance, repair without shielding.

C : Target dose of maintenance, repair with shielding.
