Radiation protection aspects of a fuel handling incident at Forsmark NPP 2013

Forsmarks Kraftgrupp AB, SE-742 03 Östhammar, Sweden
ISOE European Symposium April 9-11, 2014 Bern, Switzerland

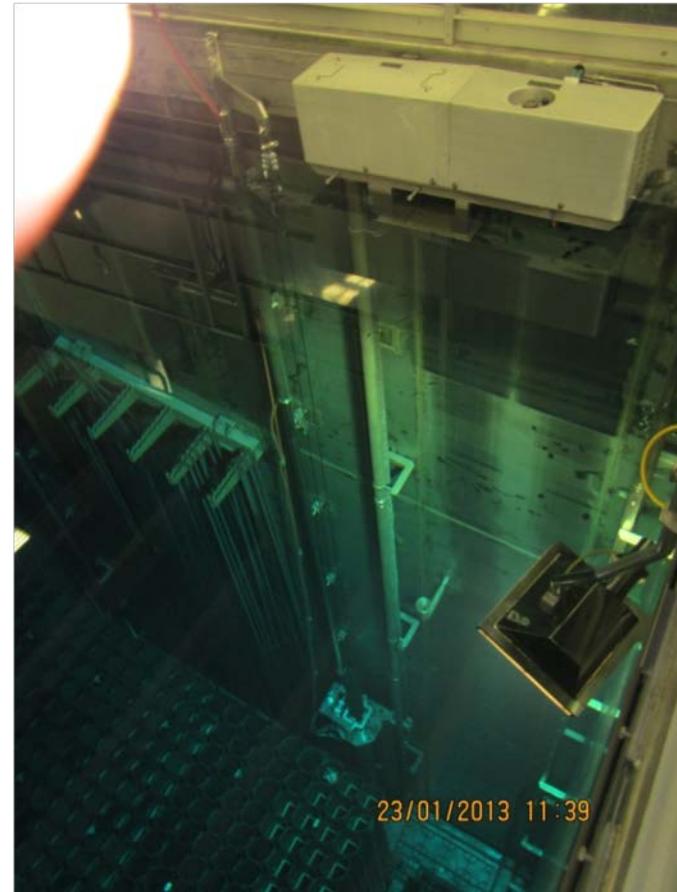
- A crack or break of one or several fuel rods.
- Wear of the fuel cladding.
- The procedure might not release but make the bundle even more stuck.

Releasing the grip from the fuel machine was not an option; there was the risk of the fuel assembly falling down.
