Reactor vessel head replacement

Reactor Vessel Head Replacement at Tihange 3 – Transport conditions and storage of the reactor vessel head

02 june 2016

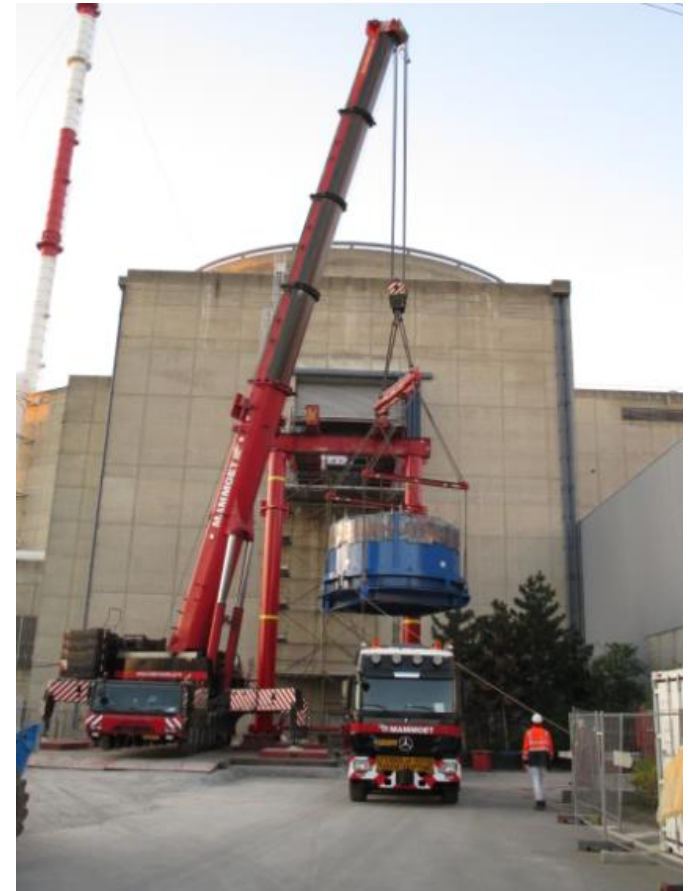
- *Transport realised by an external society*
- *Even if it was a transport on site, ADR7 was applicable*
- *Transport under UN2912 – LSA-I*

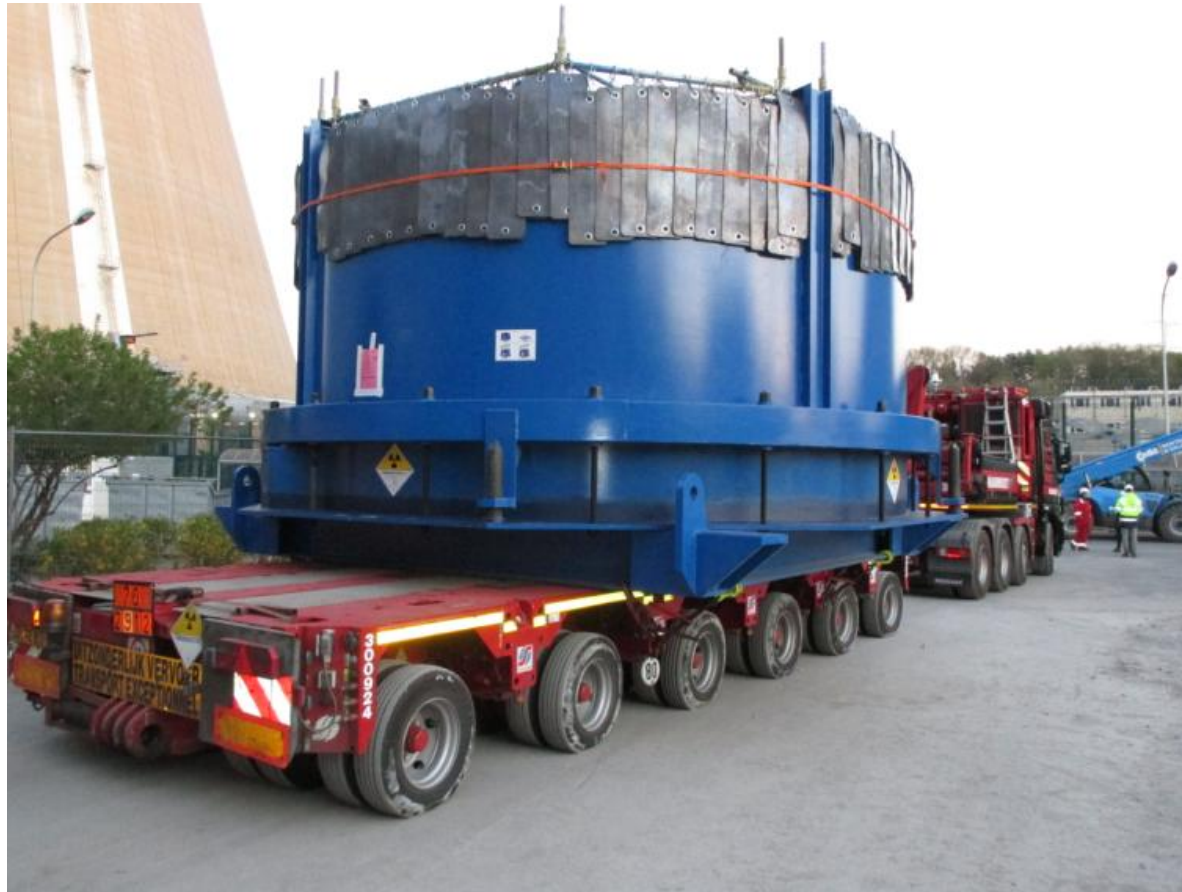
Reactor vessel head transport

- *During reactor vessel head preparation, the measured dose rate was higher than expected dose rate.*
- *Decision to shield the higher dose rate area to respect LSA-I criteria*
