# Unplanned Exposure During Diving in the Spent Fuel Pool

**Andreas Ritter, KKL**

Kernkraftwerk Leibstadt

## August 31st 2010, during RFO26

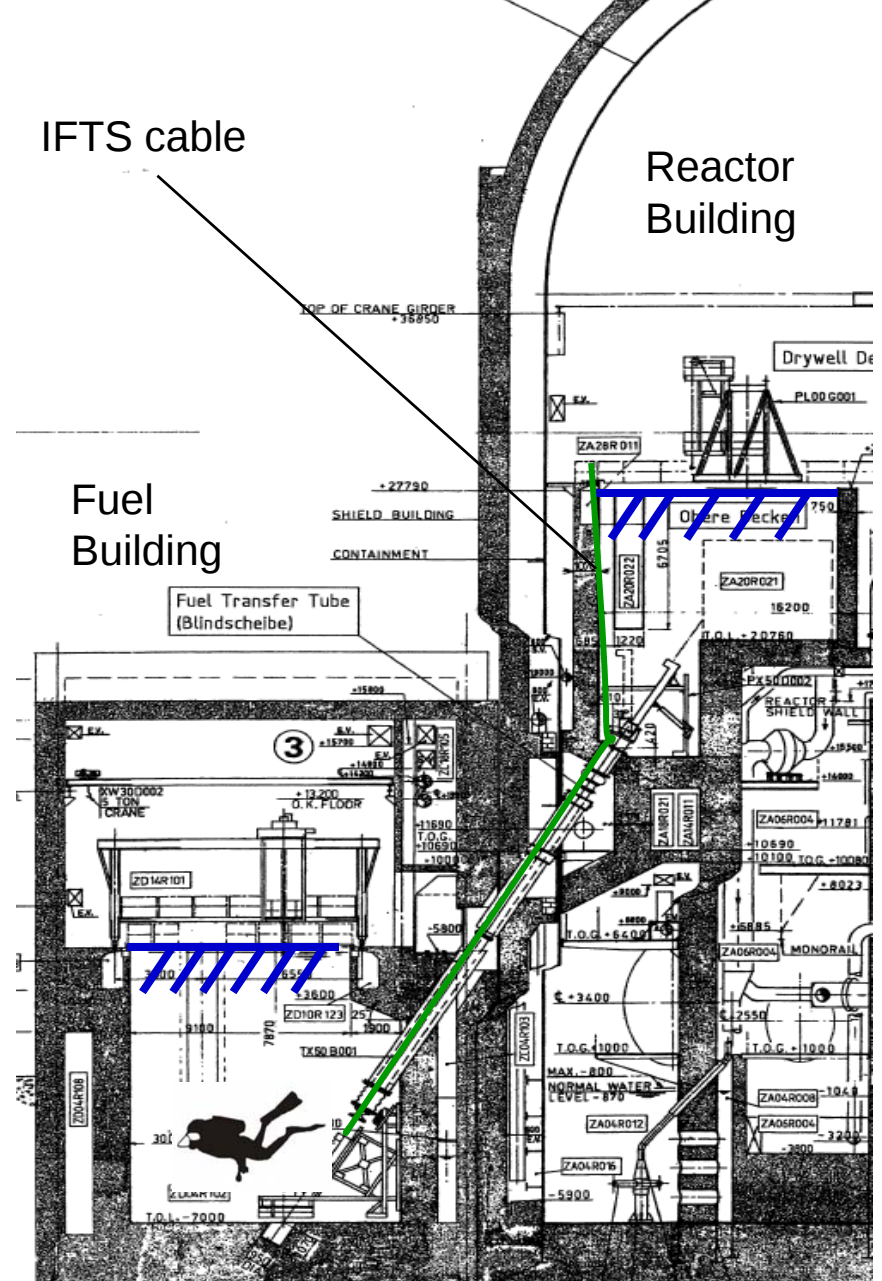
- The Inclined Fuel Transfer System (IFTS) moves fuel and reactor internals from the Reactor Building to the Fuel Building and vice versa
- Planned maintenance: Replacement of cables on IFTS
- The same job has been performed safely by a diver in the past
- Decided to do it with the diver again

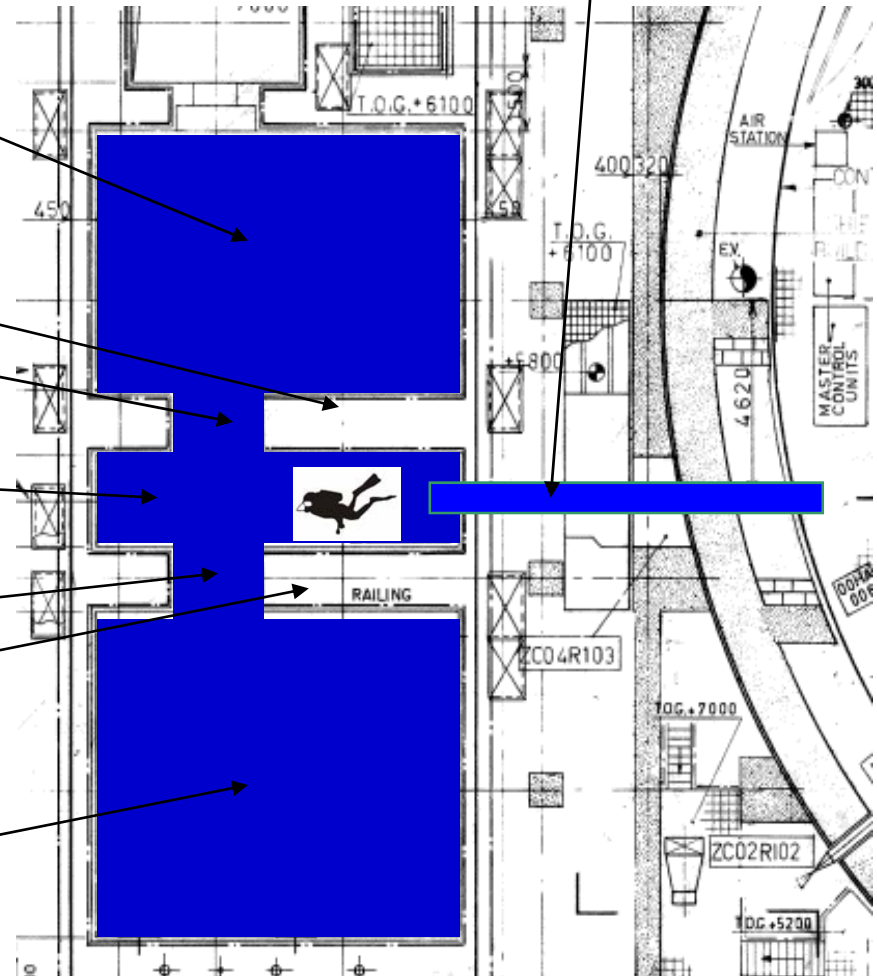
IFTS Tube

- Spent Fuel Pool „East“
- Wall
- Gate
- Transfer Pool
- Gate
- Wall
- Spent Fuel Pool „West“
