Pressurizer Heater Sleeve Replacement

San Onofre Nuclear Generating Station

5th ISOE Workshop on “Occupational Exposure Management at Nuclear Facilities”
Essen, Germany, 15-17 March 2006

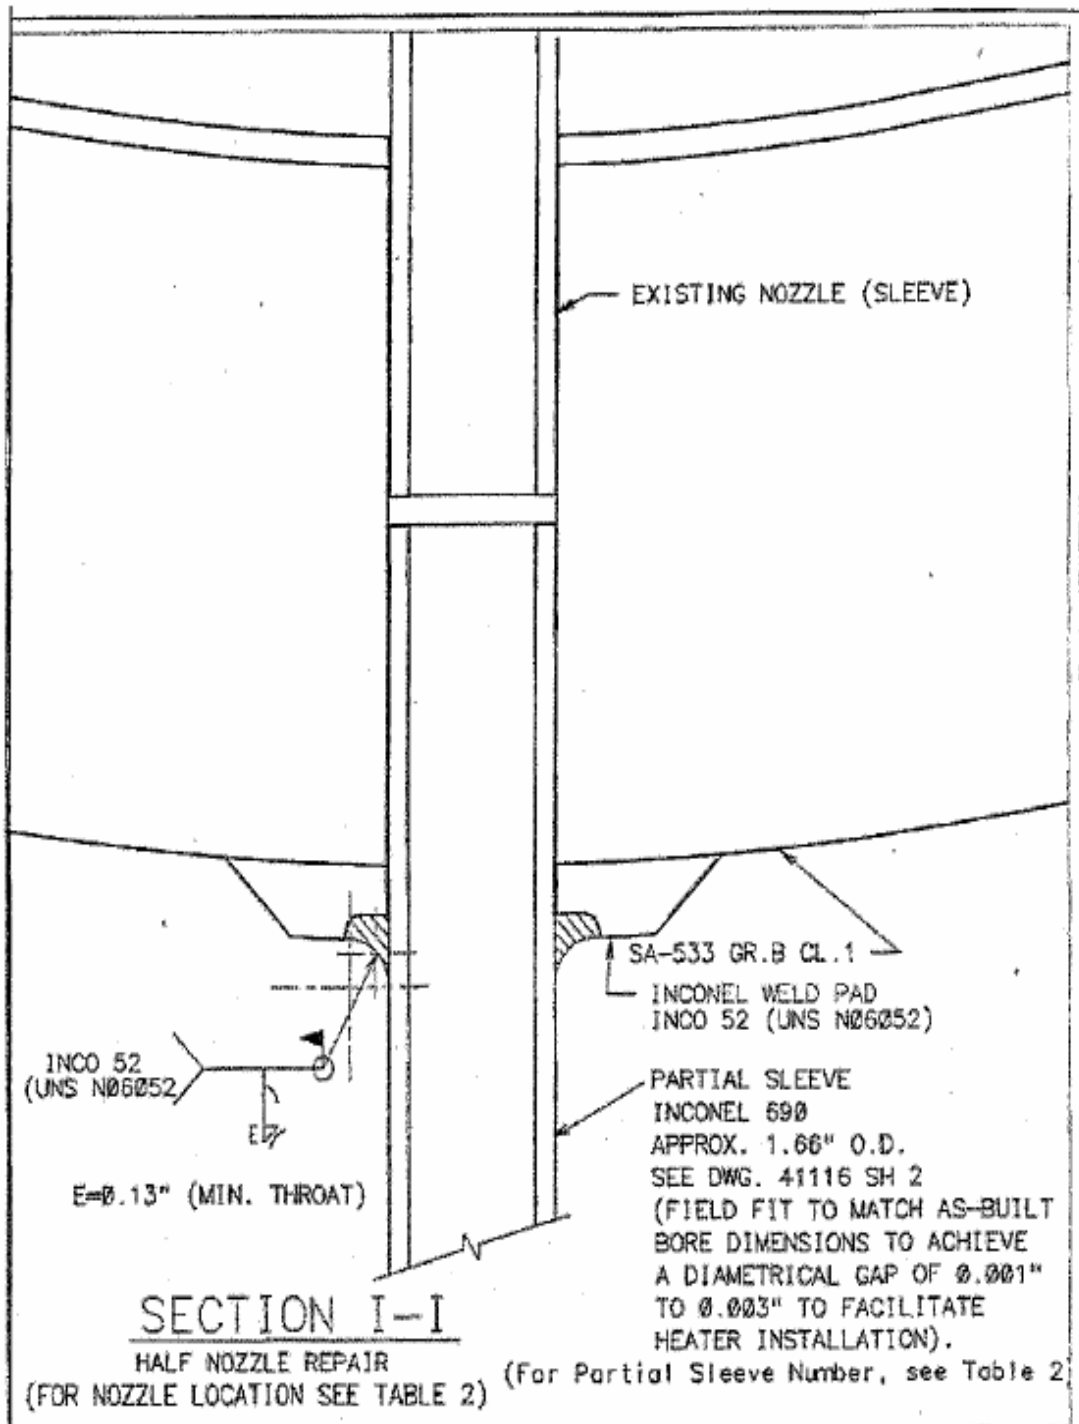
Figure 1

The nozzle repair work begins by machining the external heater weld off and then securing each of the 30 heaters in place with a mechanical clamp. Once all of the heater welds are removed, all of the clamps and heaters are removed one at a time consecutively to minimize contamination of the work platform. Following heater removal, half of the original heater sleeve is removed by reaming and cutting the sleeve internally. After the partial sleeves are removed, a bare metal non-destructive examination (NDE) inspection is conducted on the Pressurizer vessel and the new weld pads, and then sacrificial plugs are installed to provide a surface for adding weld pads to facilitate the new RCS pressure boundary. Following the installation of the weld pads, the sacrificial plugs are then machined out. After the sacrificial plugs are removed, new Alloy 690 half sleeves are installed and welded. Finally, the Pressurizer heaters are inserted into the new sleeves and welded. The new primary system pressure boundary is now located on the outside of the Pressurizer.

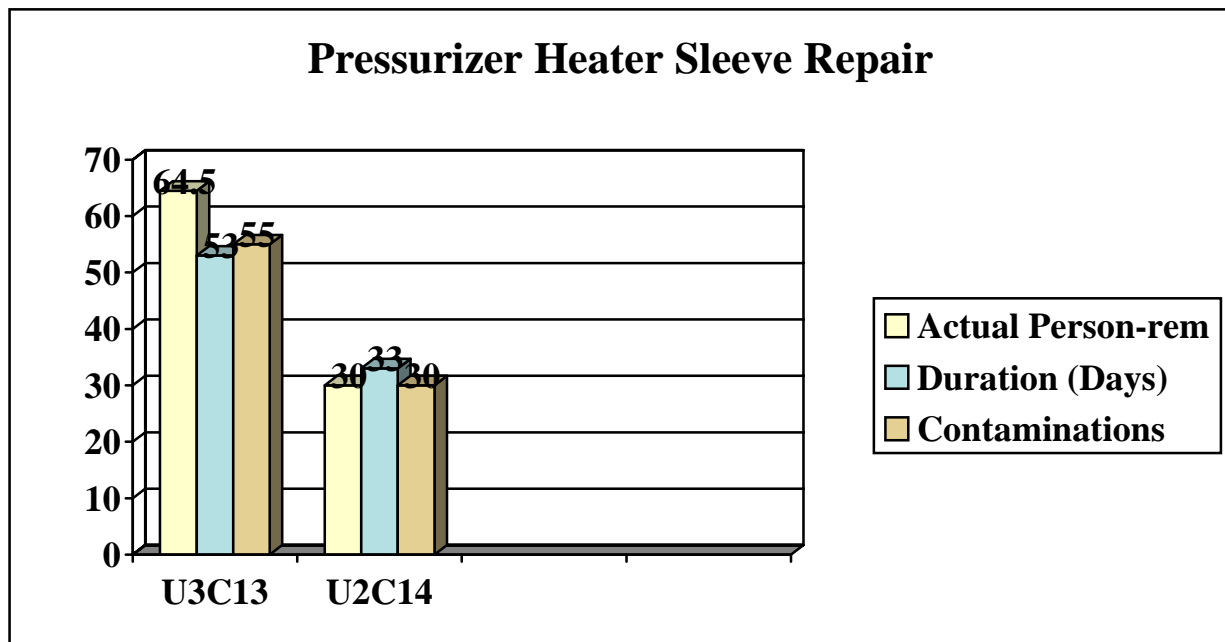
Figure 2

Major challenges during the repair were radiological exposure and radioactive contamination control. Extensive engineering controls were used to reduce general area dose rates as well as surface and airborne contamination levels. Engineering controls consisted of lead shielding, HEPA ventilation, vacuums, work area containment, and sleeving. Dose gradients in the work area below the Pressurizer required the relocation of dosimetry to the worker's head. Improved work practices, teledosimetry, and temporary shielding on the sleeves, the surge line, and the work platform saved 17 Person-Rem of exposure over the originally dose estimate of 81.6 Person-Rem. Total exposure for U3C13 outage was 64.5 Person-Rem. The highest individual exposure was 1685 mRem. Lessons learned from similar work at Palo Verde were freely shared and were very helpful to SONGS.
