# Incident with exposure to high dose rate

When the RP tech's instrument is faulty

Johannes Isokivelä – Forsmark NPP

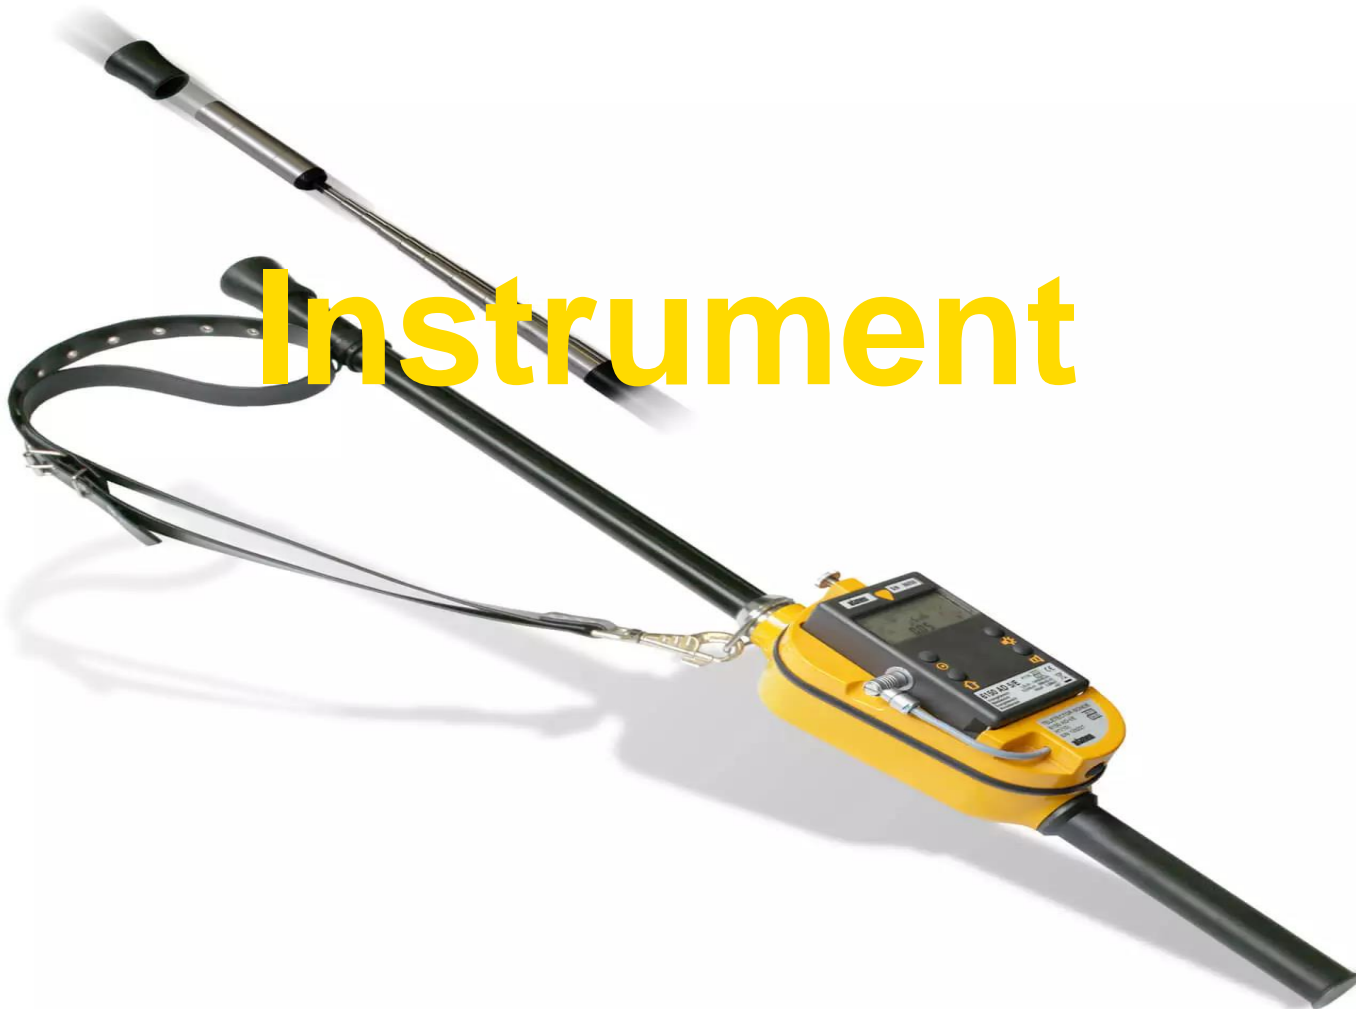
# The instrument

- Automess 6150 AD-t

Measuring range: 0,1  $\mu\text{Sv/h}$  - 10  $\text{Sv/h}$   
Low range: 0,1  $\mu\text{Sv/h}$  - 10  $\text{mSv/h}$   
High range: 1  $\text{mSv/h}$  - 10  $\text{Sv/h}$

Energy range: 65  $\text{keV}$  - 1,3  $\text{MeV}$  (low range tube)  
65  $\text{keV}$  - 3  $\text{MeV}$  (high range tube)

Detector: 2 GM-tube. (ZP 1400 (LDR), ZP 1300 (HDR))

- Function test before use, but only for the low dose rate tube
- We didn't have a source to do a function test of the high dose rate tube, that was a known problem for many years
- RP tech used the instrument without full understanding of its properties.

- Sources to do function tests of the high dose rate tube purchased
- Reinforced training for RP technicians
- Sorting out old instruments that often need repairs
- A comprehensive review of questions regarding radiation protection in pre job briefings
