# Mid-to-long Term Policy for on site Decontamination and the Performance

**TOKYO ELECTRIC POWER COMPANY**

RADIATION PROTECTION & MANAGEMENT GROUP

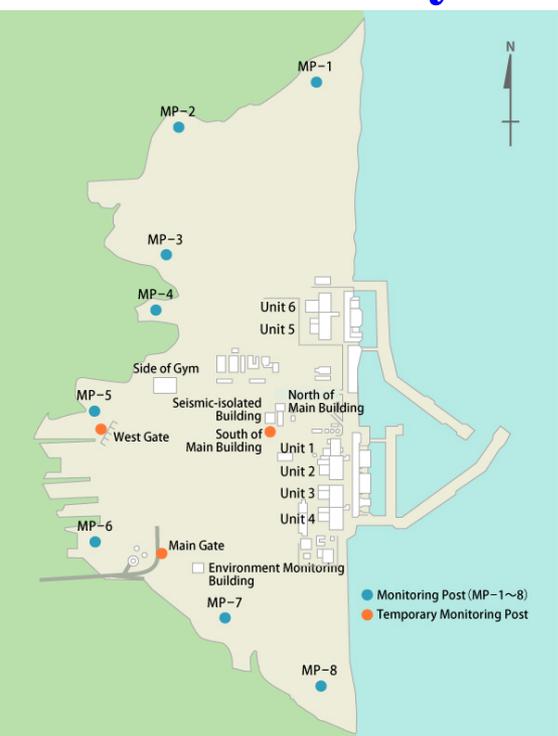
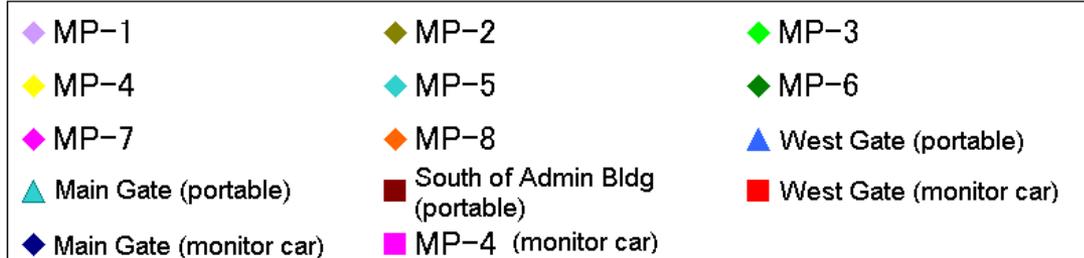
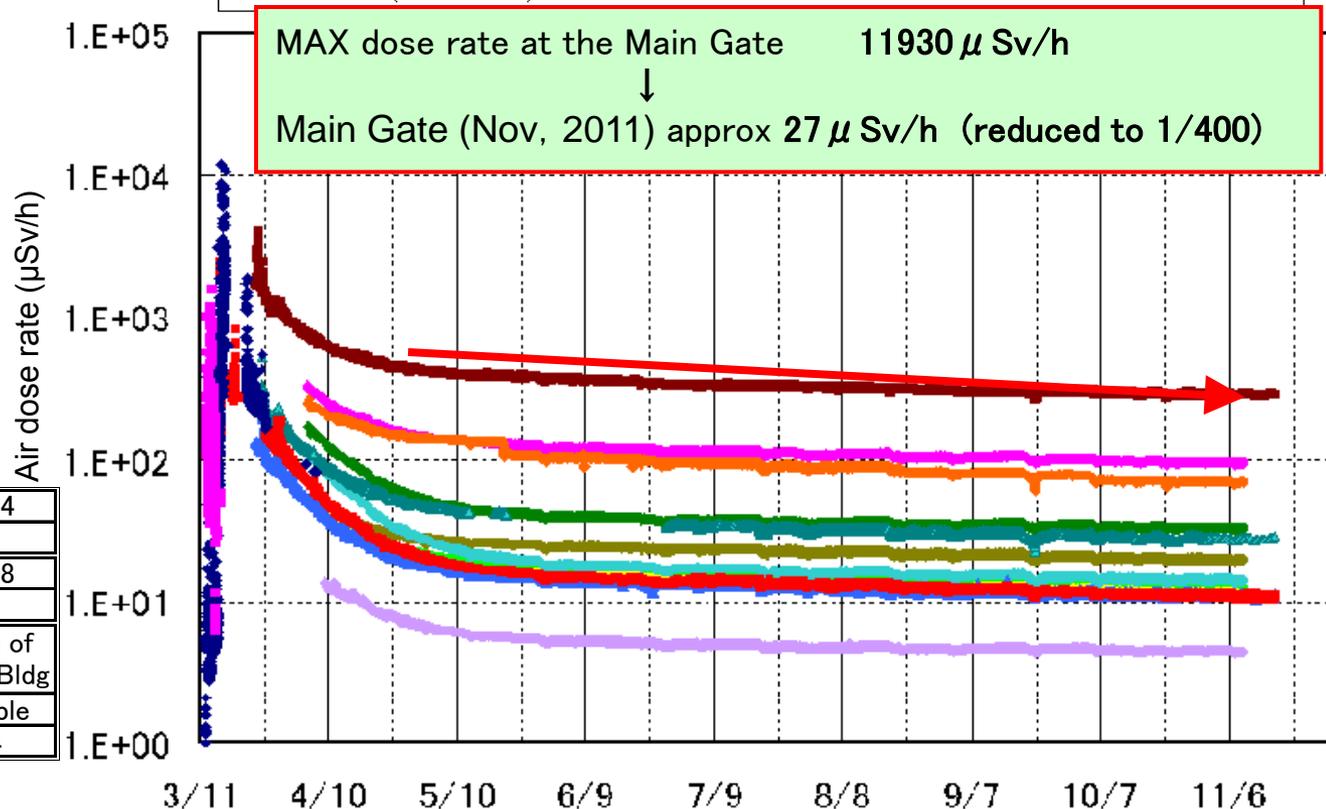
# Air dose rate by Monitoring Posts etc.

MP-1	MP-2	MP-3	MP-4
2.7	4.7	5.4	4.9
MP-5	MP-6	MP-7	MP-8
5.1	2.8	3.2	3.2
West gate		Main gate	South of Admin Bldg
monitor car	portable	portable	portable
3.5	5	15	144

Measurement date: August 7, 2013

The air dose rates at each point were dramatically increased by the accident. After that, indicated steady downward trend and at this moment, at the background level at each point.

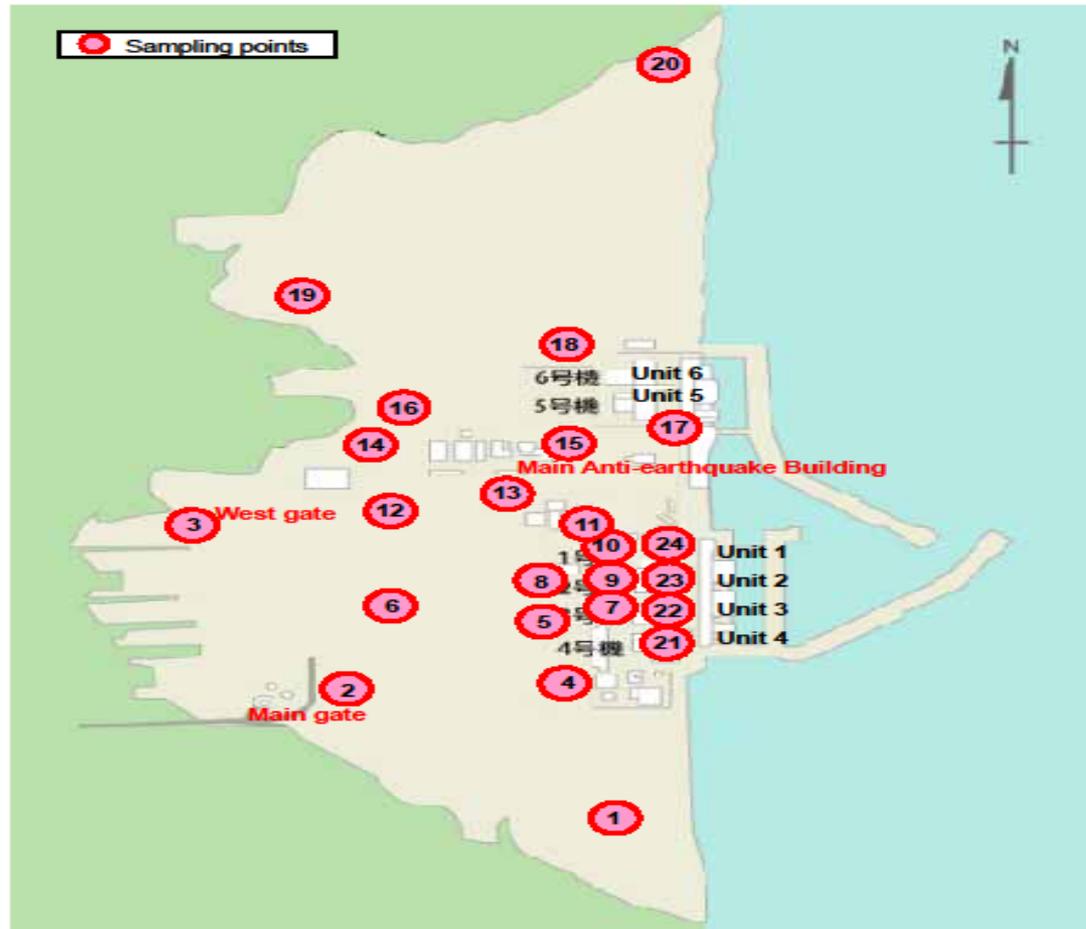
Radioactivity density measurement results of the air within the grounds of Fukushima Daiichi Nuclear Power Station

| 1: MP6 | 9: Mountain side of Unit 2 | 17: In front of Unit 5-6 PP |
| 2: In front of the Environment Building | 10: Mountain side of Unit 1 | 18: In front of Unit 5-6 switchyard |
| 3: In front of the west gate | 11: Slope on the north side of Unit 1 | 19: MP3 |
| 4: Storage area | 12: In front of the temporary warehouse | 20: MP1 |
| 5: Slope on the west side of Unit 3-4 | 13: In front of the Main Anti-earthquake Building | 21: Opening of Unit 4 Reactor Building |
| 6: Wild Bird Forest | 14: Water Treatment Building | 22: Opening of Unit 3 Reactor Building |
| 7: Mountain side of Unit 3 | 15: Solid material storage | 23: Opening of Unit 2 Reactor Building |
| 8: Slope on the west side of Unit 1-2 | 16: Array in front of the Incinerator entrance | 24: Opening of Unit 1 Reactor Building |

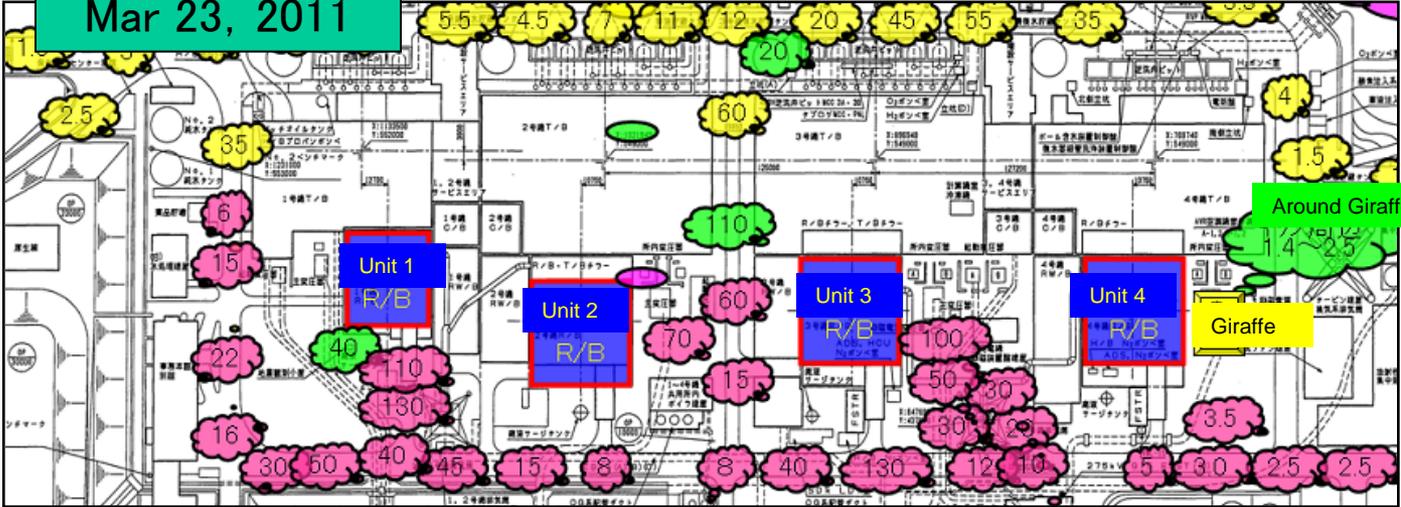
Mar 23, 2011

# Air dose rate in the Power Station (Immediately after an earthquake disaster)

Air dose rate decreased by removal of rubbles

Unit: mSv/h

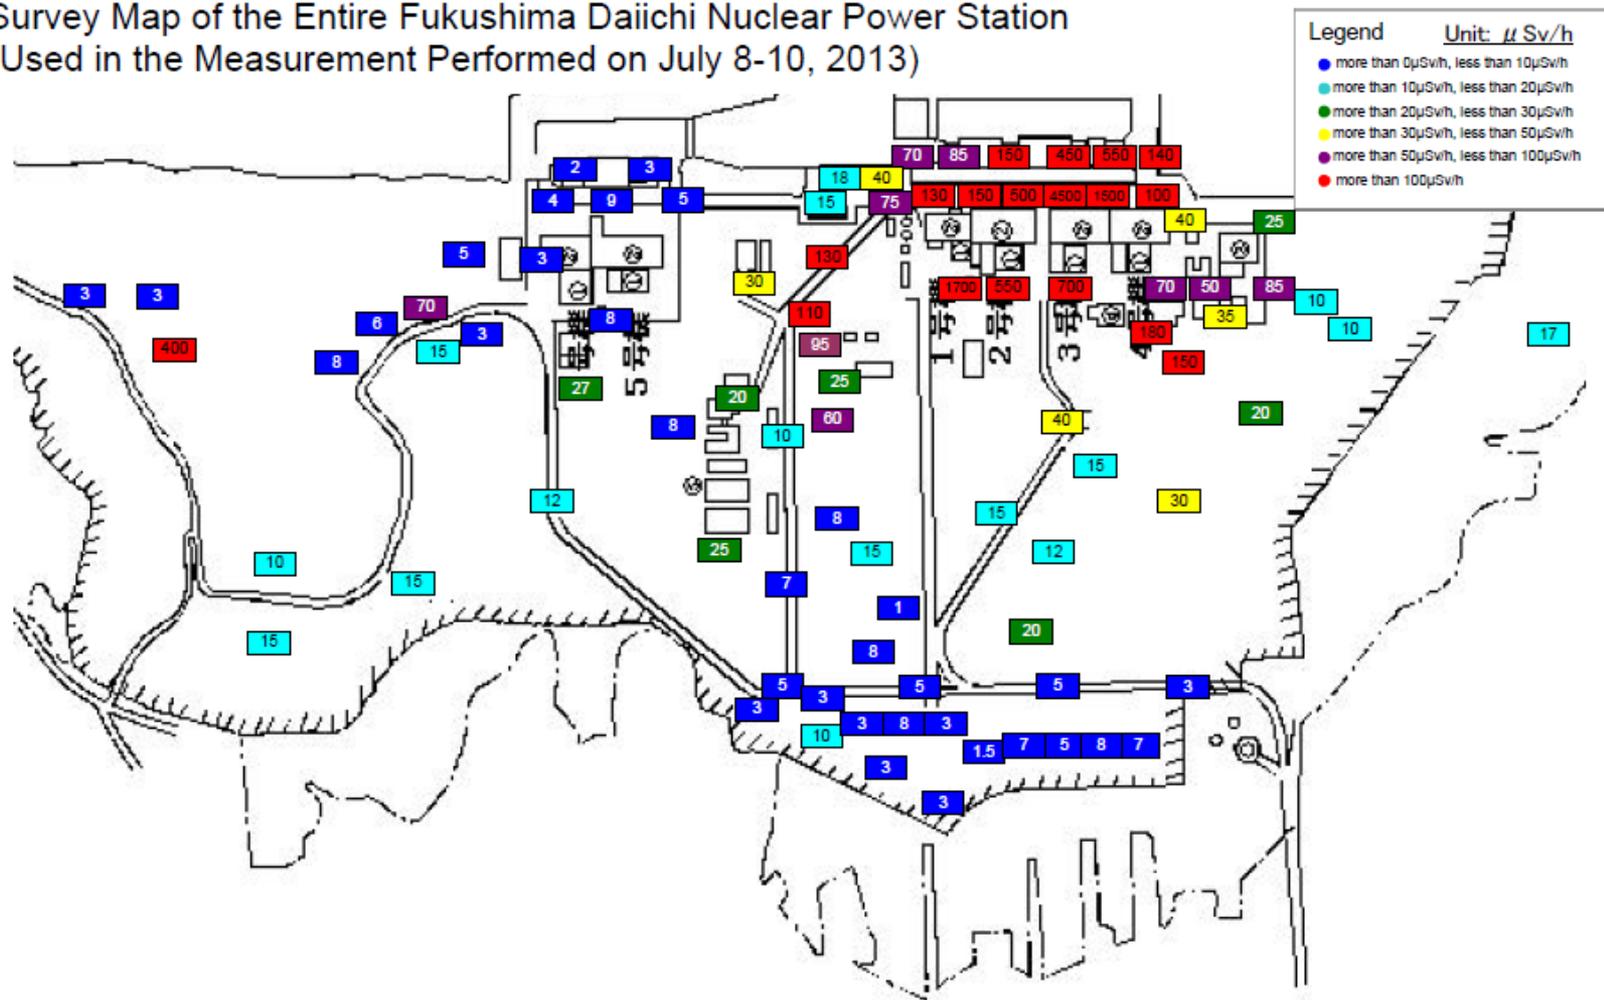
Survey Map of the Entire Fukushima Daiichi Nuclear Power Station  
(Used in the Measurement Performed on July 8-10, 2013)

Following amount in the red frames were corrected on July 26, 2013.  
450→4500, 150→1500, 170→1700

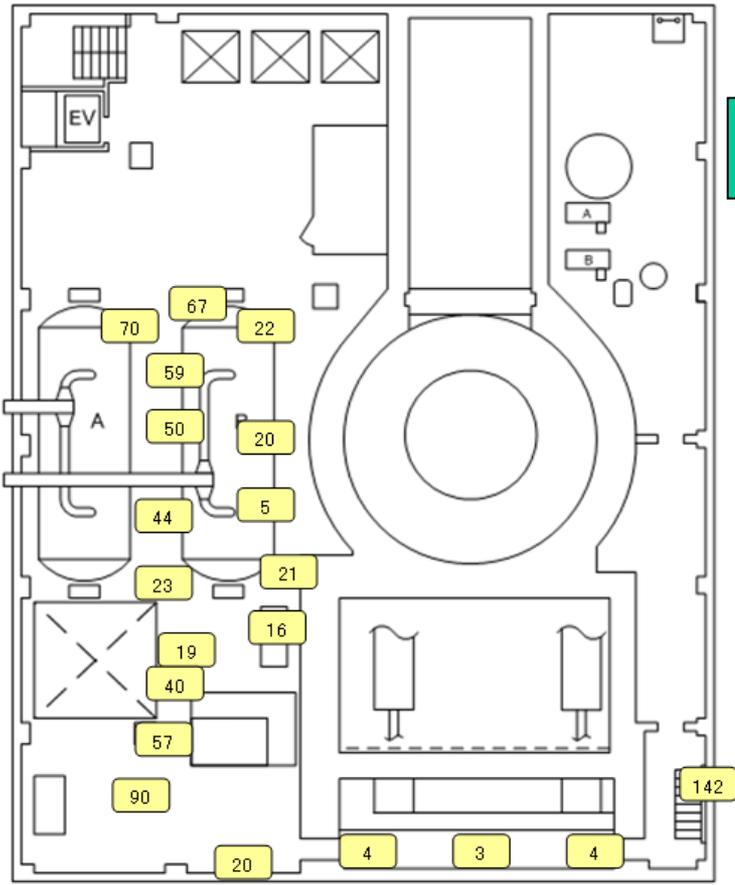
■ 4FL, R/B, Unit 1

We are endeavoring to reduce radiation dose by sharing info regarding the air dose rate at the work site.

Unit: mSv/h

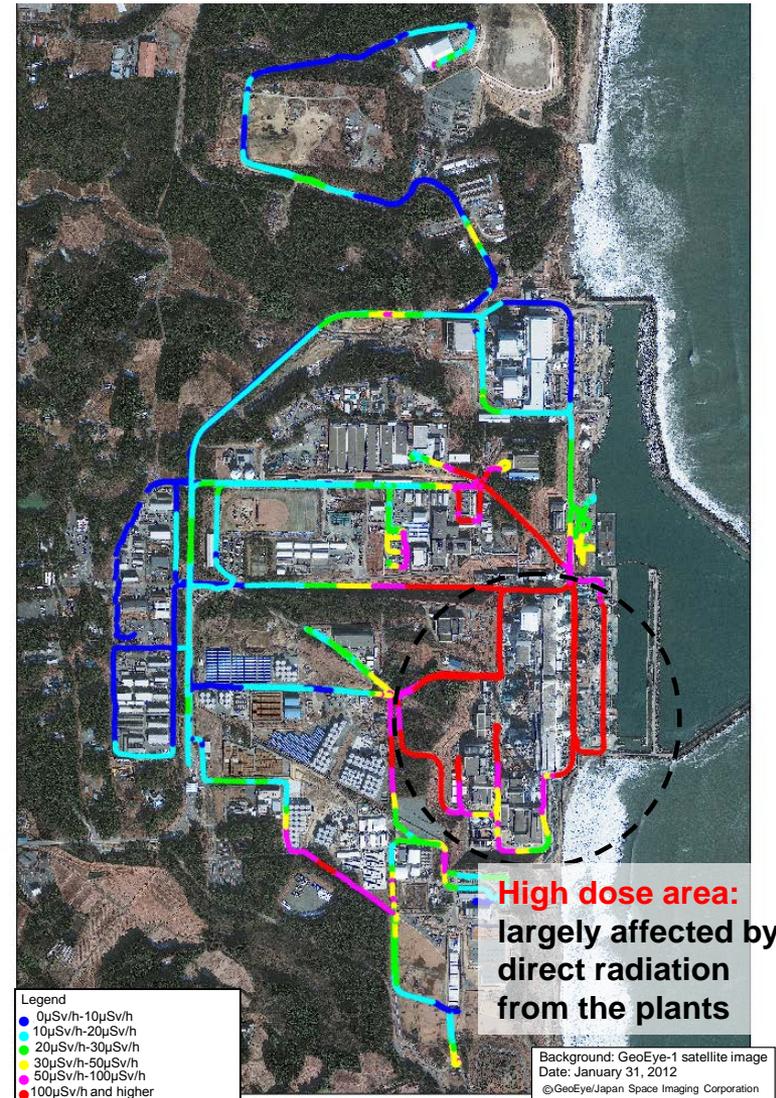
Air dose rates in the vehicle at a running survey

- The dose rates within the power station site vary in the range of a few  $\mu\text{Sv/h}$  to  $1000\mu\text{Sv/h}$  and higher due to the impact of radioactive fallouts. (See the figure on the right)
- The high dose area around Units 1-4 (the area within the black dotted circle) is particularly affected by direct radiation as it is close to the Reactor Buildings. On the other hand, the area outside of the circled area is more affected by radioactive fallouts which land on the ground surface.

Measurement date: Wednesday, May 9, 2012

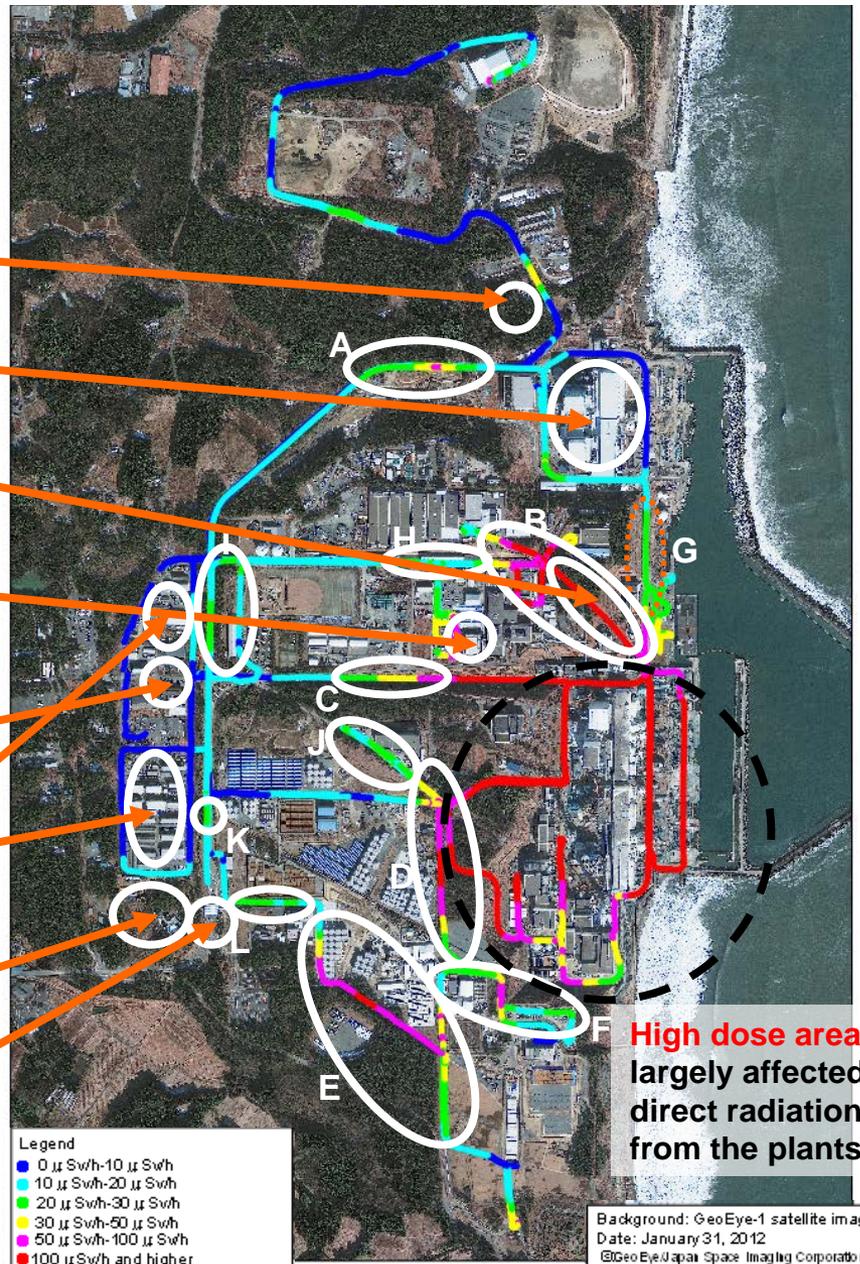
Areas subject to dose reduction selected for the purpose of reducing doses in areas where many workers enter and the current dose rates

6. Around the Incinerator Building (to be constructed):

Less than 50 $\mu$ Sv/h

4. Around Units 5-6: Less than 30 $\mu$ Sv/h

5. Main road (Shiomizaka, etc. Points A-L):

Less than 220 $\mu$ Sv/h

1. Around the Main Seismic Building:

Less than 180 $\mu$ Sv/h

2. Around the Welfare Building: Less than 20 $\mu$ Sv/h

2. Around the Cooperative Company Building:

Less than 20 $\mu$ Sv/h

6. Around the Entrance Control Building

(under construction): Less than 50 $\mu$ Sv/h

3. Around the main gate: Less than 25 $\mu$ Sv/h

For the locations indicated by underlined red letters, dose reduction measures have been implemented in the past.

**High dose area:**  
largely affected by  
direct radiation  
from the plants

Blue	0 $\mu$ Sv/h-10 $\mu$ Sv/h
Cyan	10 $\mu$ Sv/h-20 $\mu$ Sv/h
Green	20 $\mu$ Sv/h-30 $\mu$ Sv/h
Yellow	30 $\mu$ Sv/h-50 $\mu$ Sv/h
Magenta	50 $\mu$ Sv/h-100 $\mu$ Sv/h
Red	100 $\mu$ Sv/h and higher

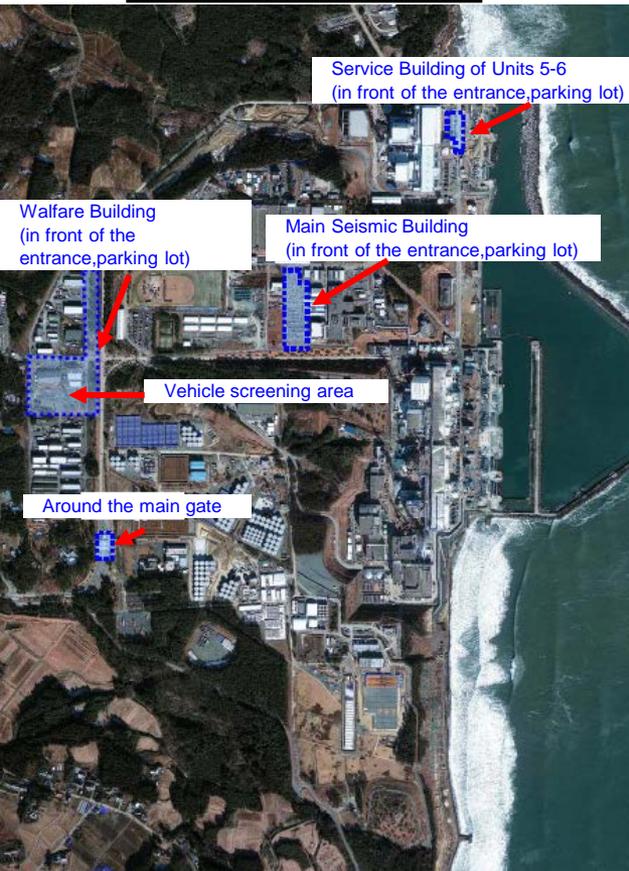
Current

As the radioactive material concentration in air is below the level requiring mask (Particle Cs:  $2 \times 10^{-4} \text{ Bq/cm}^3$ ), the areas indicated in blue have been designated as area not requiring mask.

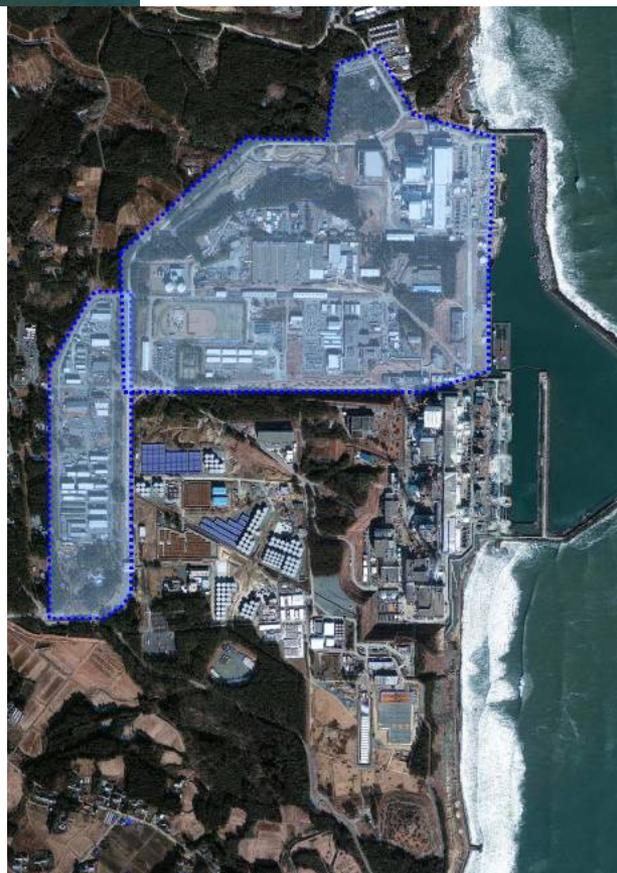
[1st step] (5 years from now)

With the amount of radioactive materials flying into the air being reduced through decontamination, area not requiring mask will be expanded to other areas within the power station site excluding the high dose area around Units 1-4, tank installation areas and the forest.

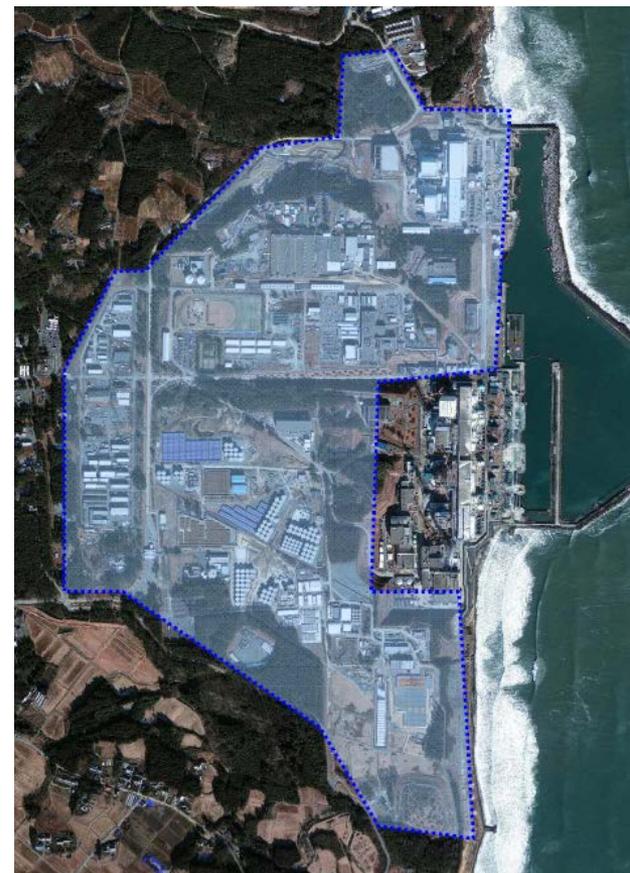
[2nd step] (10+ years from now)

Area not requiring mask will be further expanded according to the reduction in tank installation area, etc. as a result of making the reactor cooling loop smaller and installation of waste storage facilities (excluding the high dose area around Units 1-4 and the forest).

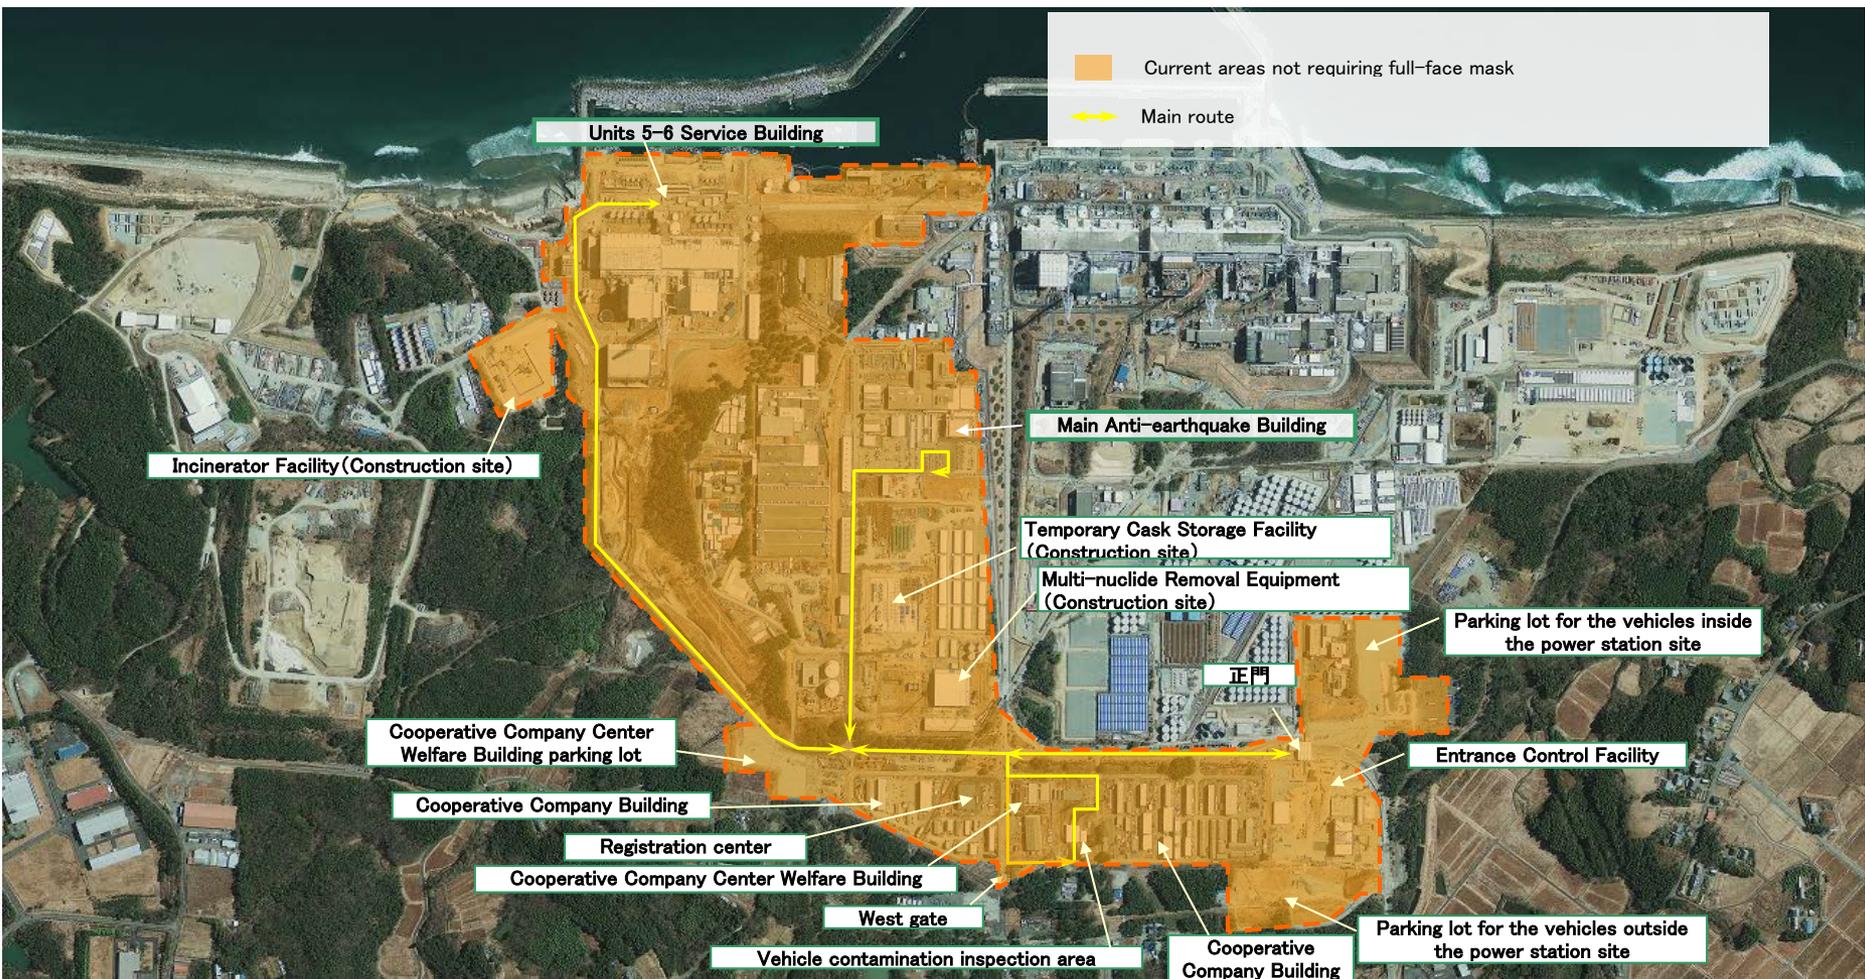
< Areas not requiring full-face mask in Fukushima Daiichi NPS >

**Areas within the dotted line excluding the surrounding area of Unit 1-4, the tank area and the debris storage area are designated as areas not requiring full-face mask. (at the date of August, 2013)**

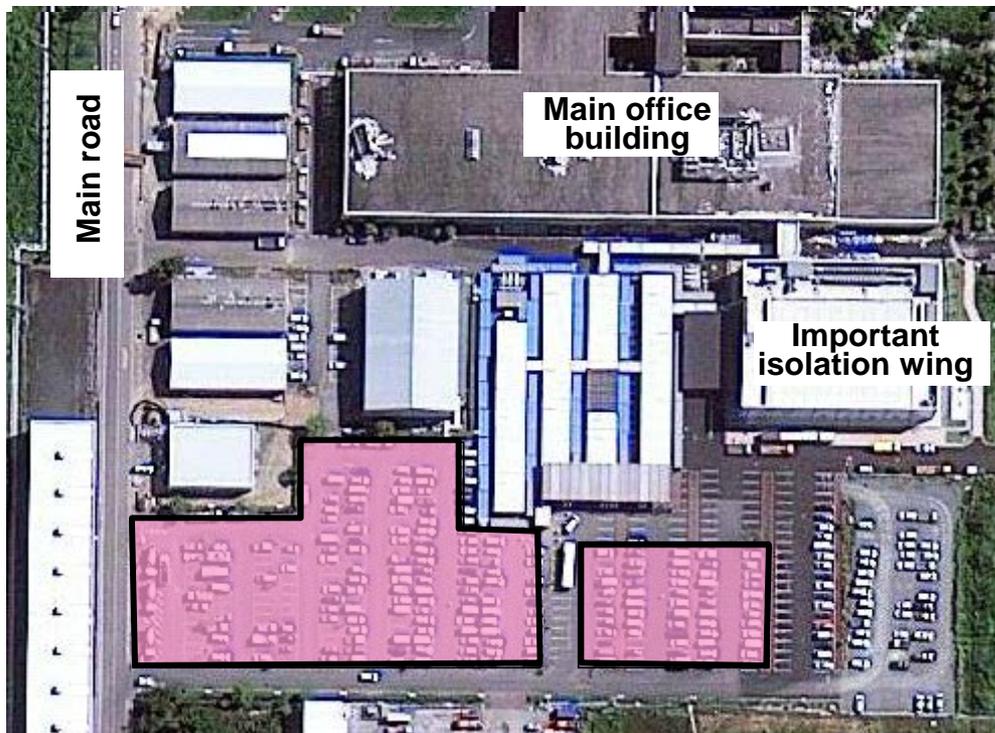
# 1<sup>st</sup> Measure - Collection of Small Debris

Implementation period: January 7 – January 30, 2012

Area: Front parking area of the seismic isolation building

Method: Mainly the collection of small debris on the road.

Result: Confirmed approximate reduction of 34% in the average dose rate from before

(Before) 82 [ $\mu$  Sv/h]

(After) 54 [Sv/h]

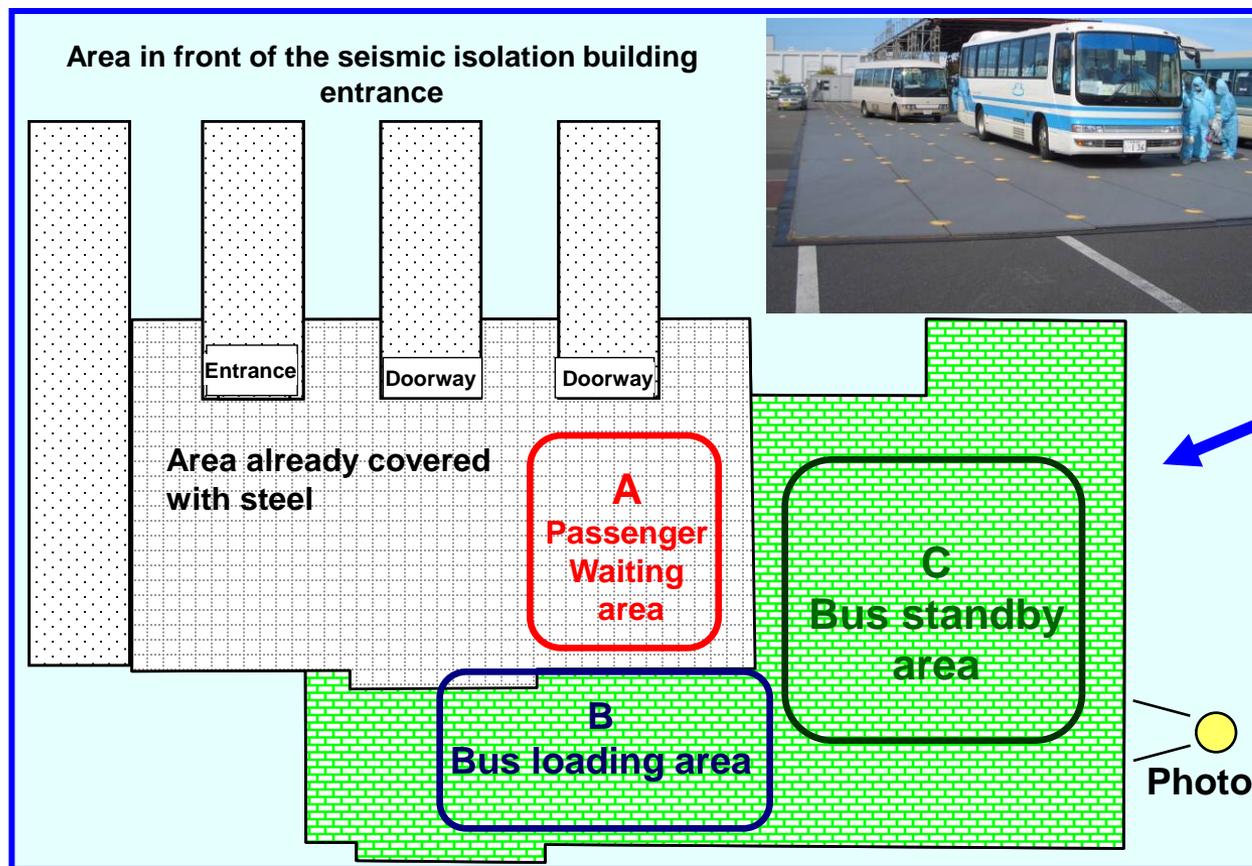
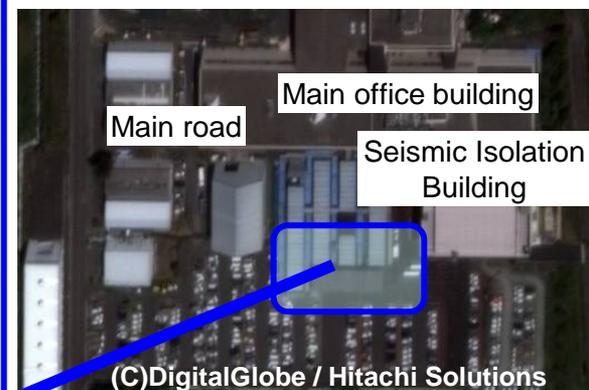
Method: Rubber mats (10mm thickness) + laying of steel plates (22mm thickness)

Result: Confirmed reduction of approx. 58% in the average dose rate in the lower chest area

Average dose rate (Previously measured values)	
<b>A</b>	<b>30 (48)</b>	<b>↓ 37%</b>
<b>B</b>	<b>37 (87)</b>	<b>↓ 58%</b>
<b>C</b>	<b>42 (100)</b>	<b>↓ 58%</b>
<b>Inside the bus</b>	<b>15 (60)</b>	<b>↓ 75%</b>

Unit:  $\mu\text{Sv/h}$

The dose rate (chest area) for the bus loading and standby area in front of the seismic isolation building entrance was reduced by around 58% to 37 – 42 [ $\mu$  Sv/h]. In addition, the rate within the bus dropped around 75% to 15 [ $\mu$  Sv/h]. [As of September 2012]

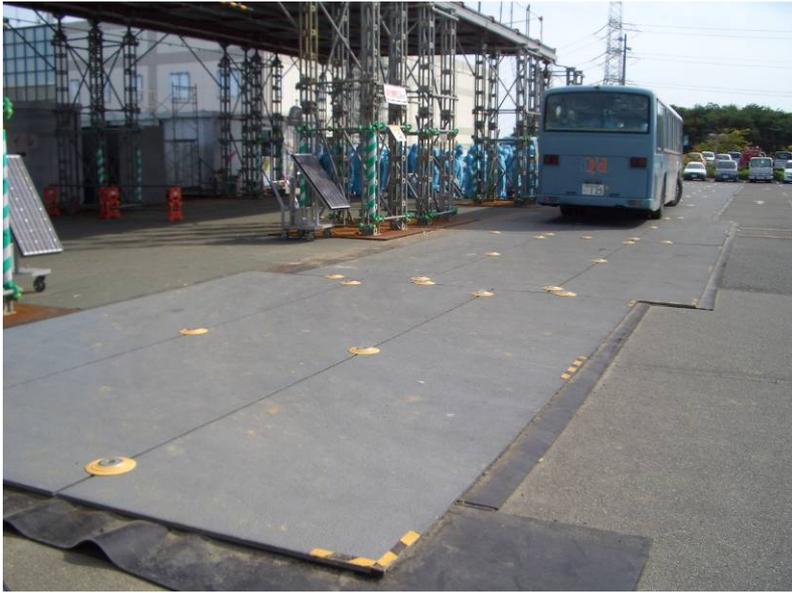
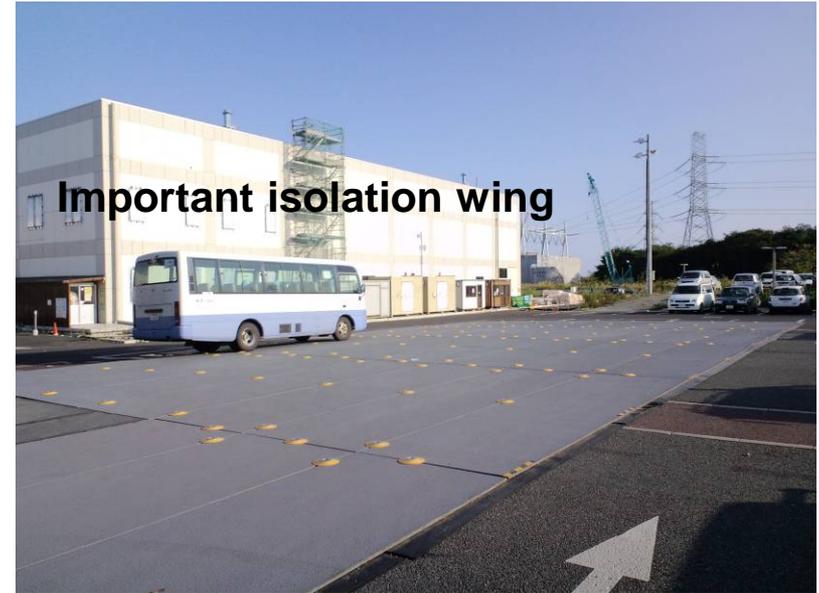
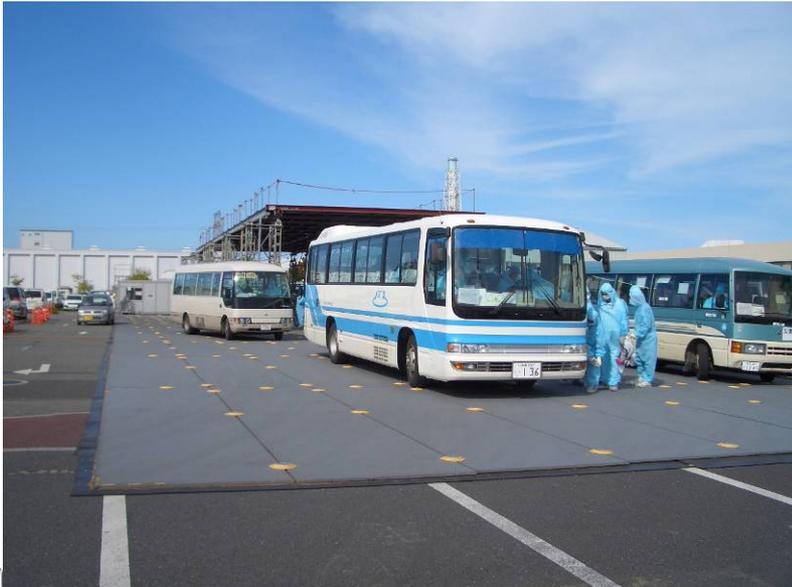
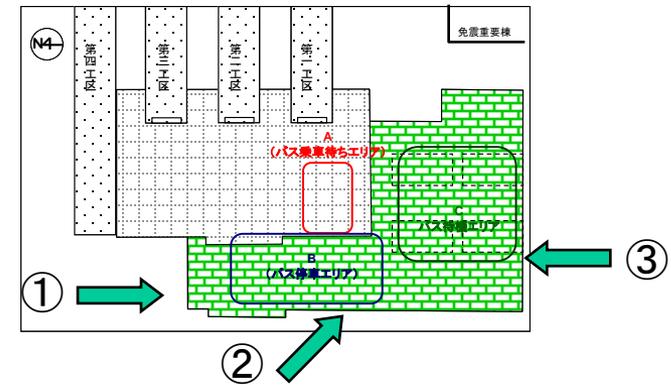
# Dose reduction measure implementation situation

Implementation period:  
August 20 – September 26, 2012

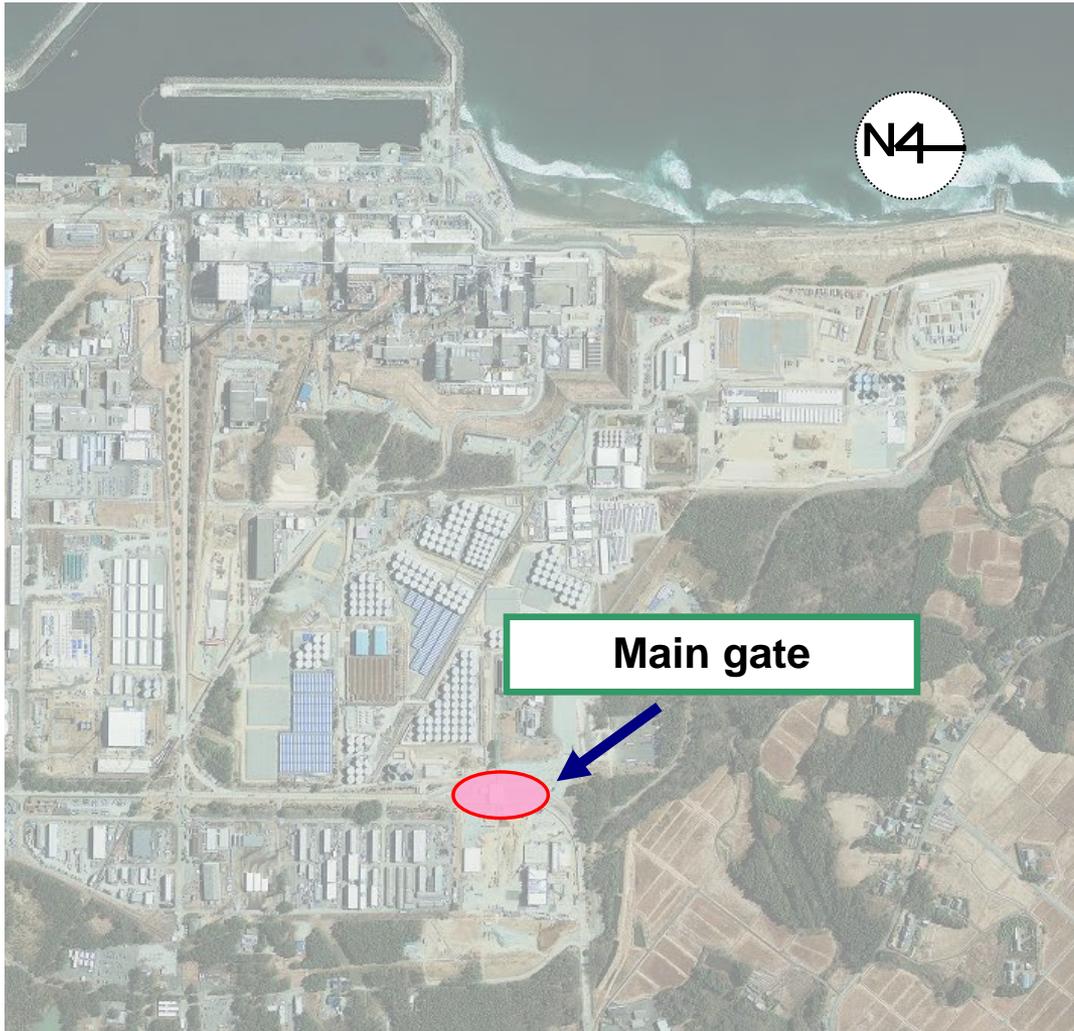
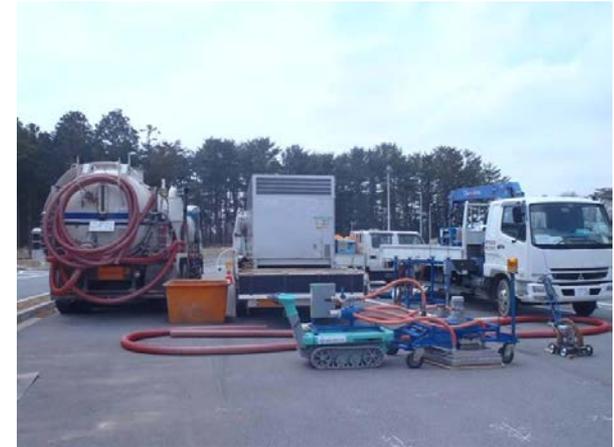
Decontamination shall be carried out by plowing to replace surface soil with subsoil for the green (soil) area and by washing with super high pressure water for the paved area.

Cutting by super high pressure water

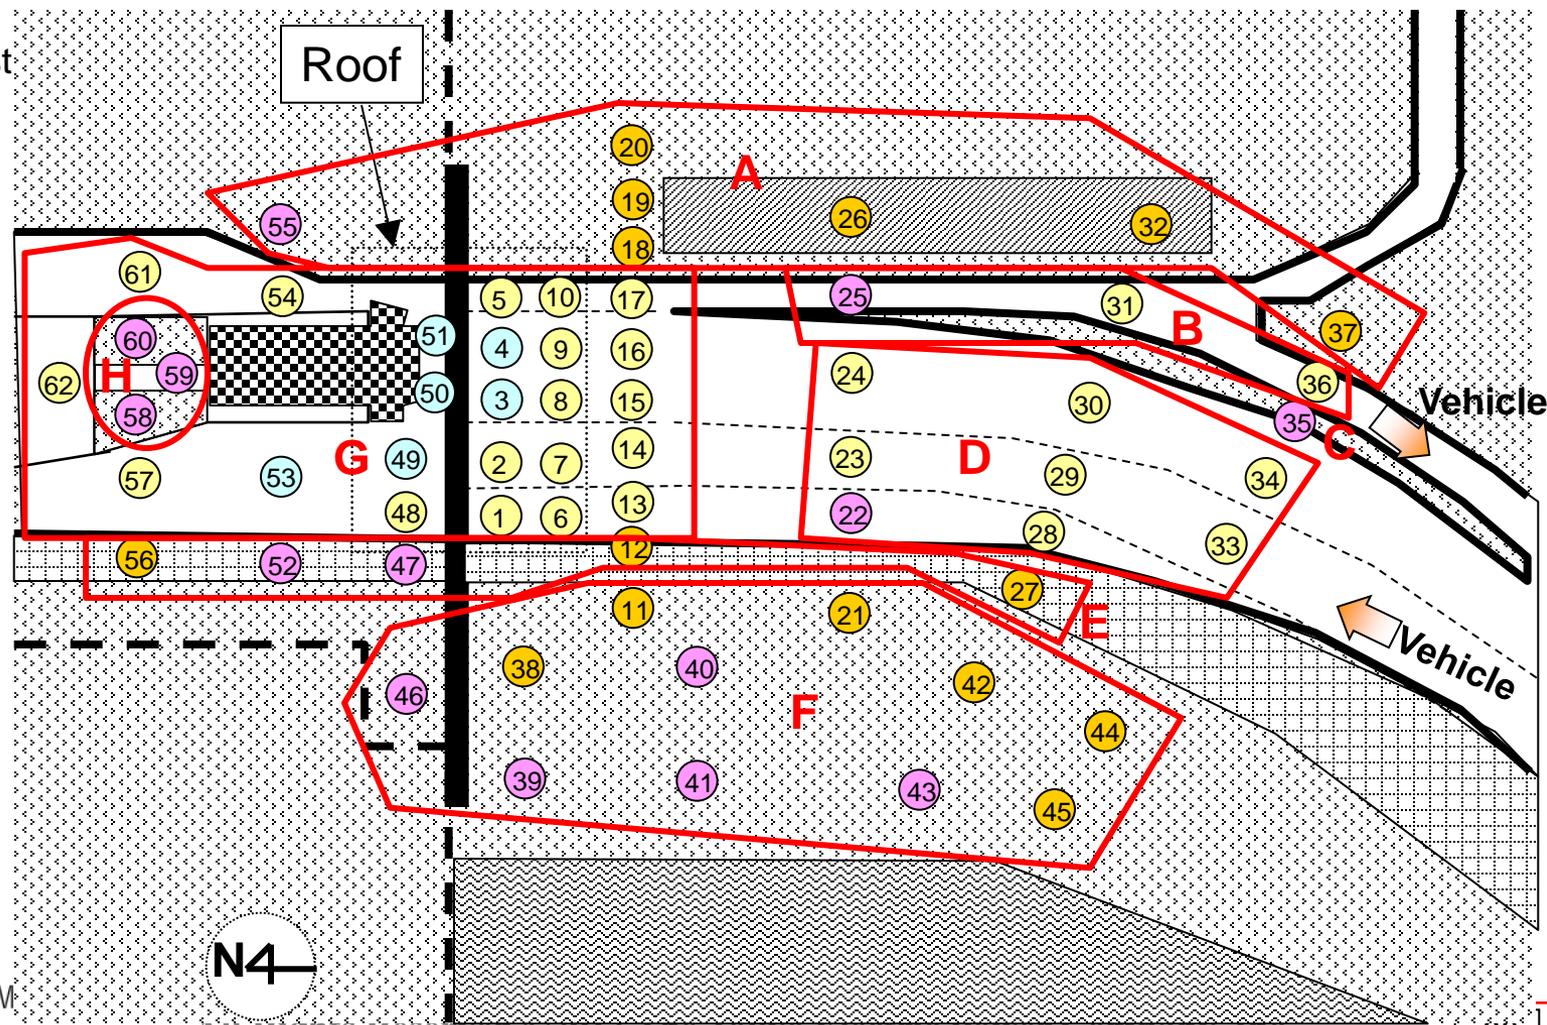
# Result of Measurement of Radiation Dose before Weeding

■ Mean dose rate at the work area of the front gate security guards is 13.6 [ $\mu$ Sv/h].

Dose rate at the chest

- ~ 5 [ $\mu$ Sv/h]
- ~ 10 [ $\mu$ Sv/h]
- ~ 20 [ $\mu$ Sv/h]
- ~ 30 [ $\mu$ Sv/h]
- 30~ [ $\mu$ Sv/h]

- Asphalt
- Lawn or sand
- Grove of trees
- Sidewalk (cushioning properties)
- Control room
- Soil depot

- Before decontamination, since the dose rates of gate security guard work area is  $13.6\mu\text{Sv/h}$ , a gate security guard's annual dose is set to  $27.6\text{mSv}^{*1}$ .
- Under this environment, since  $100\text{mSv} / 5$  years of the dose limit of a statute are exceeded, gate security guard resident area is decontaminated so that the dose limit of a statute may be filled.
- The target dose rates after decontamination is set to  **$5\mu\text{Sv/h}$** (annual dose  $9\text{mSv}$ ) <sup>\*2</sup>.

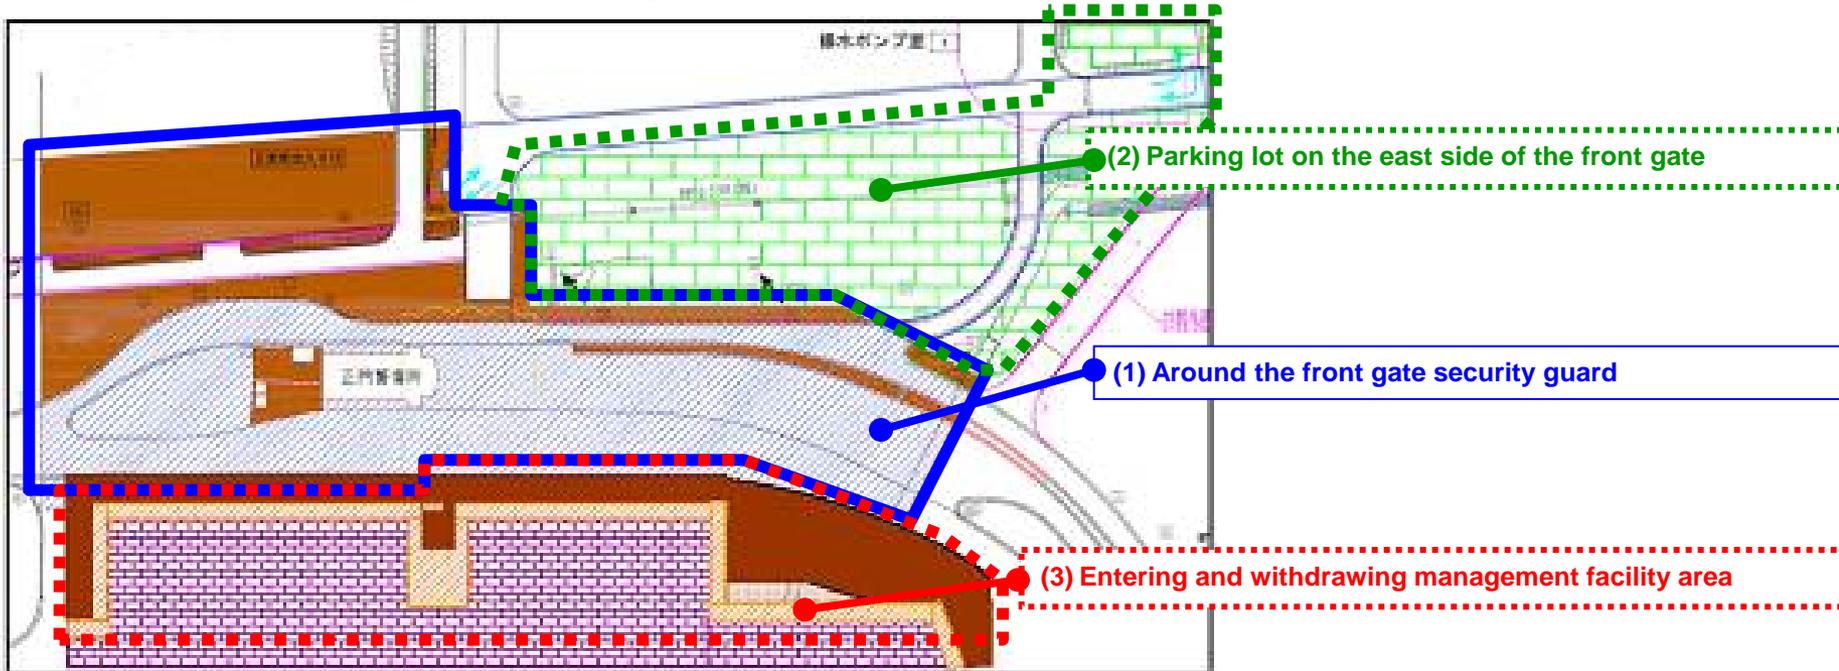
Decontamination shall be carried out by plowing to replace surface soil with subsoil for the green (soil) area and by washing with super high pressure water for the paved area.

Legend	Details
	<ul style="list-style-type: none"> <li>◆ Removal of deposits</li> <li>◆ Cutting by super high pressure water</li> </ul>
	<ul style="list-style-type: none"> <li>◆ Weeding</li> <li>◆ Trimming or pruning</li> <li>◆ Plowing (replacing 10 cm of surface soil with 20 cm of subsoil) or stripping</li> </ul>
	<ul style="list-style-type: none"> <li>◆ Stripping</li> <li>◆ Aggregate (Crusher run RC-40) 30 cm</li> <li>◆ Dense-graded asphalt paving 5 cm</li> </ul>

Legend	Details
	<ul style="list-style-type: none"> <li>◆ Plowing (replacing 20 cm of surface soil with 20 cm of subsoil) or stripping</li> <li>◆ Aggregate (Crusher run RC-40) 10 cm</li> <li>◆ Dense-graded asphalt paving 3 cm</li> </ul>
	<ul style="list-style-type: none"> <li>◆ Plowing (replacing 20 cm of surface soil with 20 cm of subsoil) or stripping</li> <li>◆ Aggregate (Crusher run RC-40) 30 cm</li> <li>◆ Coarse-graded asphalt paving 5 cm</li> <li>◆ Dense-graded asphalt paving 5 cm</li> </ul>
	<ul style="list-style-type: none"> <li>◆ Weeding</li> <li>◆ Plowing (replacing 20 cm of surface soil with 20 cm of subsoil) or stripping</li> </ul>

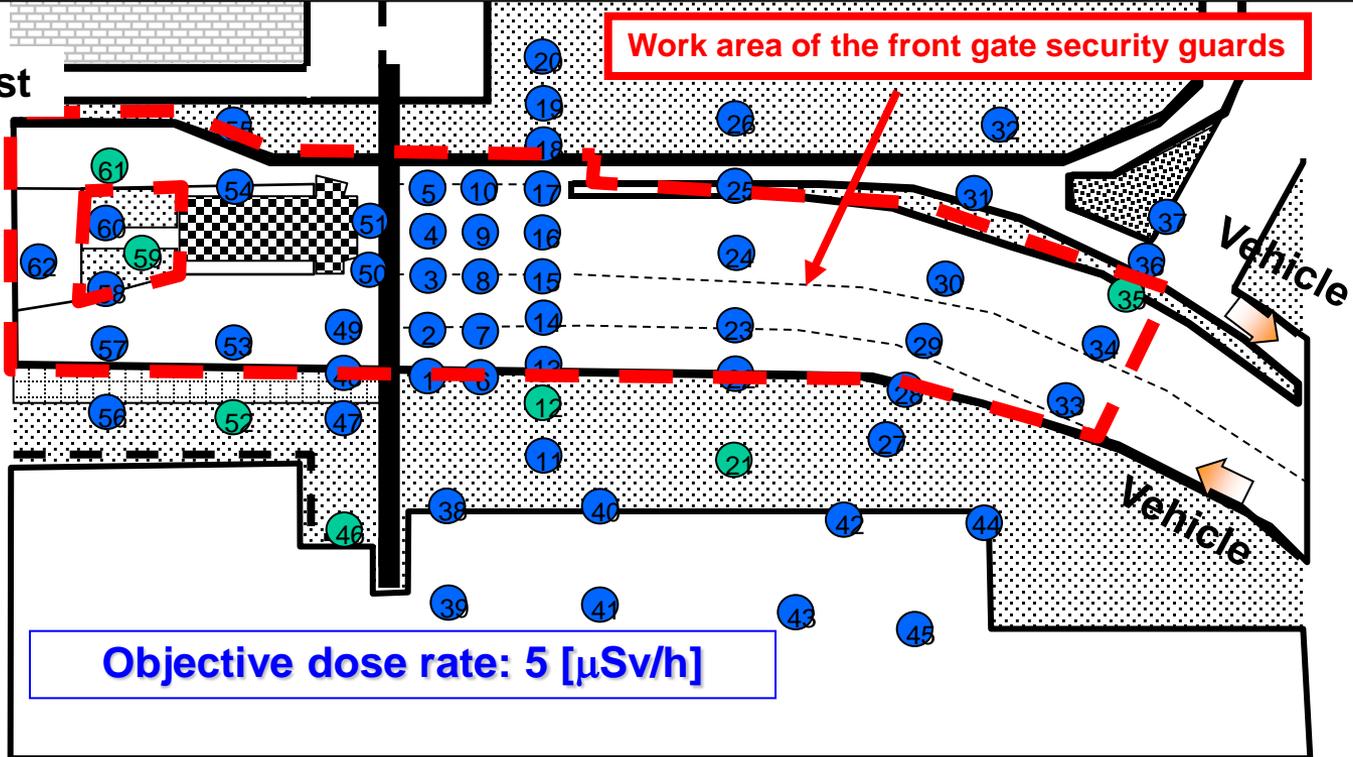
# Result of Decreasing Radiation Dose

Measurement date: May 13, 2013

The mean dose rate at the work area of the front gate security guards is decreased to **3.8[μSv/h]** (before decontamination; 13.6[μSv/h]). With this, the yearly dose of the workers is well below 20[mSv/year].

## Dose rate at the chest

- ~ 5[μSv/h]
- ~ 10[μSv/h]
- ~ 20[μSv/h]
- ~ 30[μSv/h]
- 30~[μSv/h]

- Asphalt
- Soil
- steel sheet
- sidewalk
- Control room

**Before decontamination**  
 Dose rate : 13.6[μSv/h]  
 Annual dose : 27.6[mSv/y]\*  
 \*Yearly 2000 hours

Decreasing rate **72%**

**After decontamination**  
 Dose rate : 3.8[μSv/h]  
 Annual dose : 7.6[mSv/y]\*  
 \*Annually [Yearly] 2000 hours
