# Mid-to-long Term Policy for on site Decontamination and the Performance

**TOKYO ELECTRIC POWER COMPANY**

RADIATION PROTECTION & MANAGEMENT GROUP

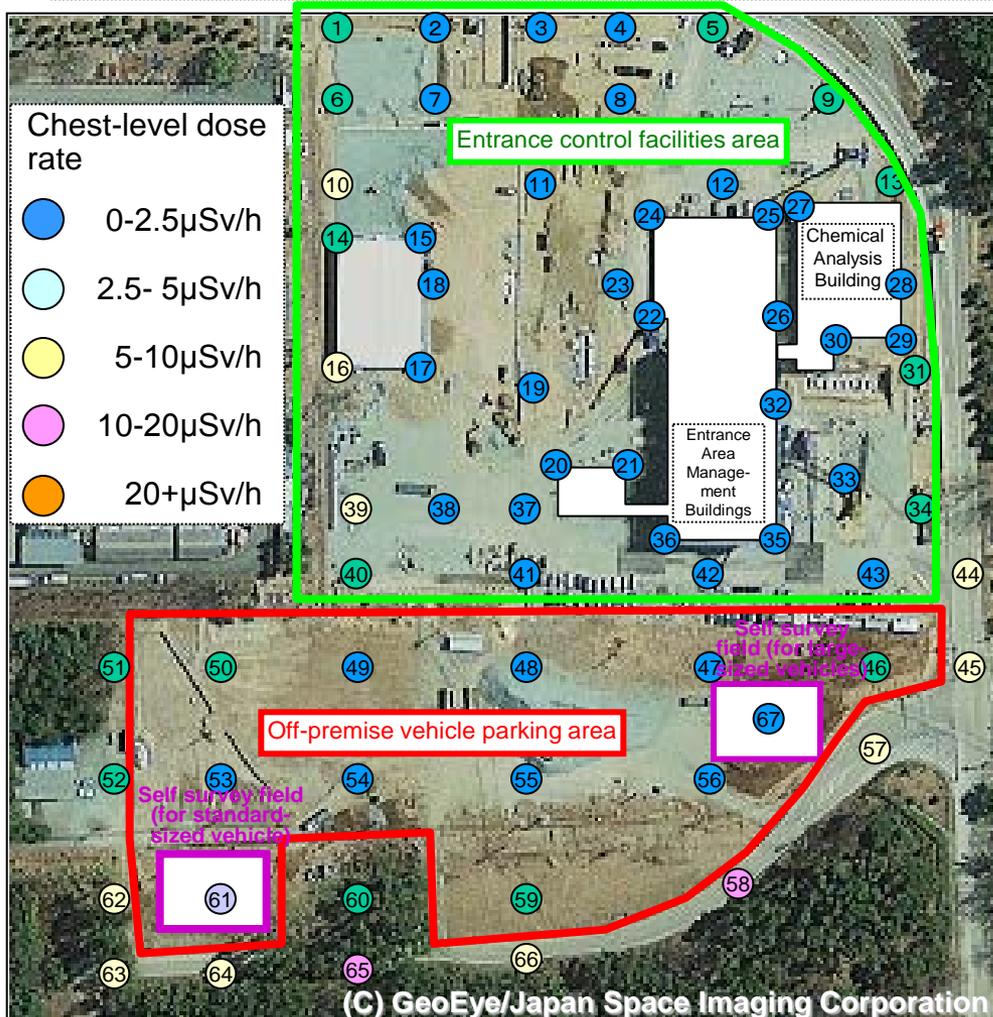
# Dose Reduction Status at Entrance Control Facilities and Off-premise Vehicle Parking (Outdoor)

The average dose rate of the entrance control facilities, the off-premise vehicle parking, and the self-survey fields was reduced to  $2\mu\text{Sv/h}$  (lower than the target dose rate). As we have done so far, we will continue the effort to maintain the environment in order to reduce radiation exposure of workers entering into and leaving from the entrance control facilities and workers working in these areas.

■ Measured dose rates ( $\mu\text{Sv/h}$ ) ■

Entrance control facilities	Off-premise vehicle parking	Self-survey fields
	Target dose rate: 5.0	Target dose rate: 5.0	Target dose rate: 3.0
Before surface soil removal	<b>34</b> (Jun. 27, 2012)	/	/
↓			
After surface soil removal	<b>8.5</b> (Sep. 26, 2012)	<b>13</b> (Feb. 14, 2013)	<b>16</b> (Feb. 14, 2013)
↓			
After asphalt paving	<b>2.1</b> (Jun. 6, 2013)	<b>2.2</b> (Jun. 27, 2013)	<b>1.9</b> (Jun. 27, 2013)
	Target achieved	Target achieved	Target achieved

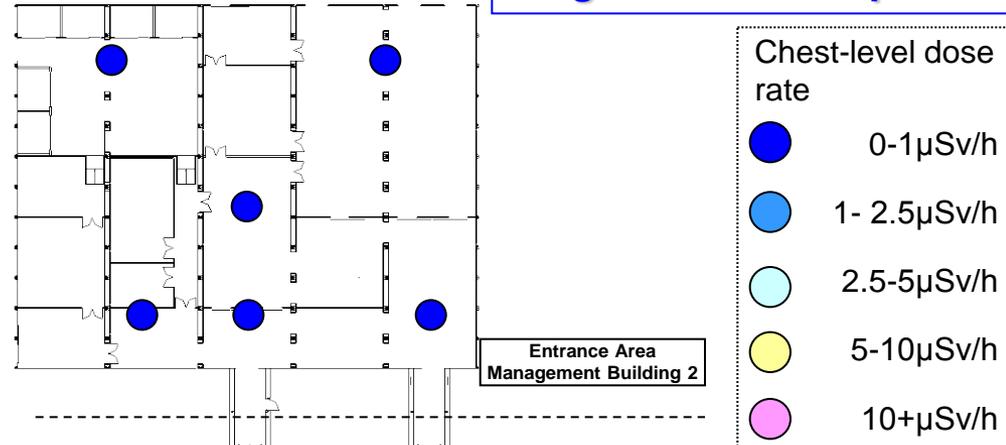
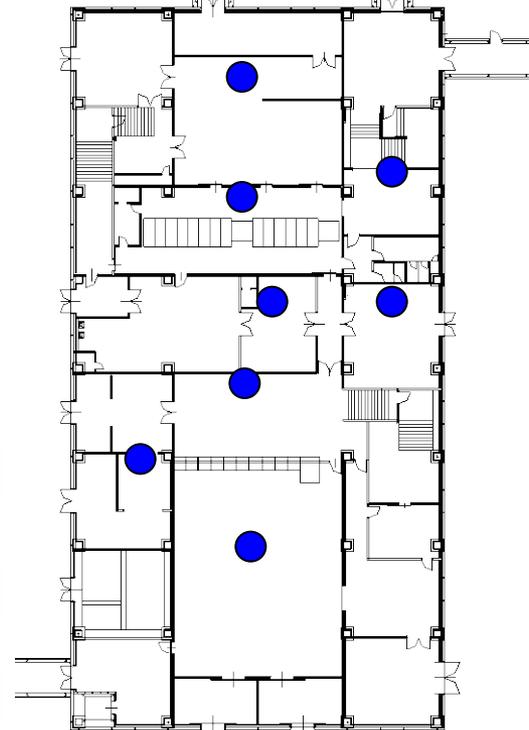
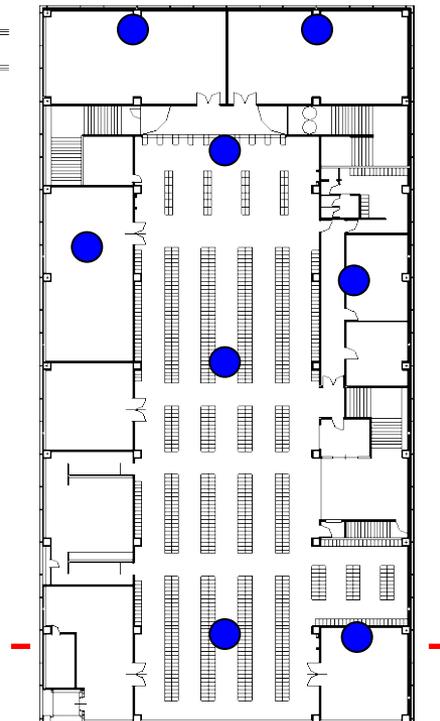
# Dose Environment inside the Entrance Area Management Buildings

The average dose rates in Entrance Area Management Building 1 and Entrance Area Management Building 2 were reduced to **0.07 $\mu$ Sv/h** and **0.6 $\mu$ Sv/h**, respectively (the target dose rate of 1 $\mu$ Sv/h was achieved).

■ Measured dose rates ( $\mu$ Sv/h) ■ (Jun. 27, 2013)

Area	Dose rate [ $\mu$ Sv/h]	
1st Floor of Entrance Area Management Building 1	0.07	Target achieved
2nd Floor of Entrance Area Management Building 1	0.06	Target achieved
Entrance Area Management Building 2	0.57	Target achieved

Target dose rate: 1 $\mu$ Sv/h

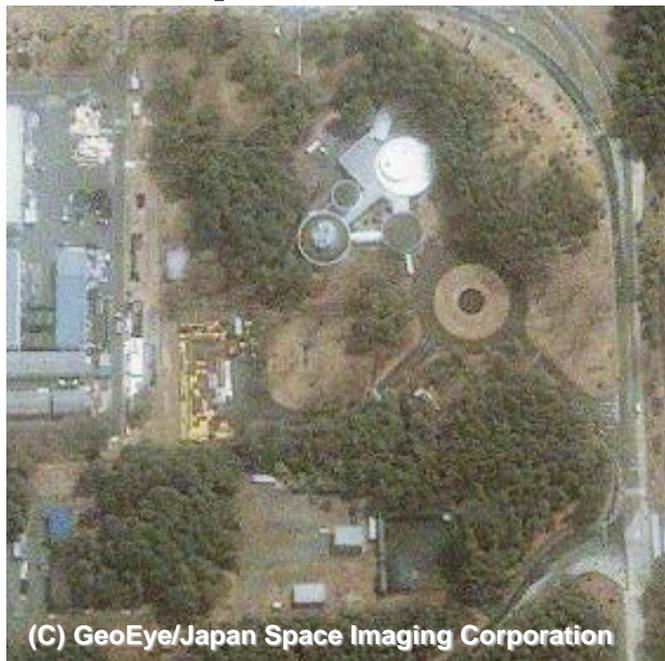
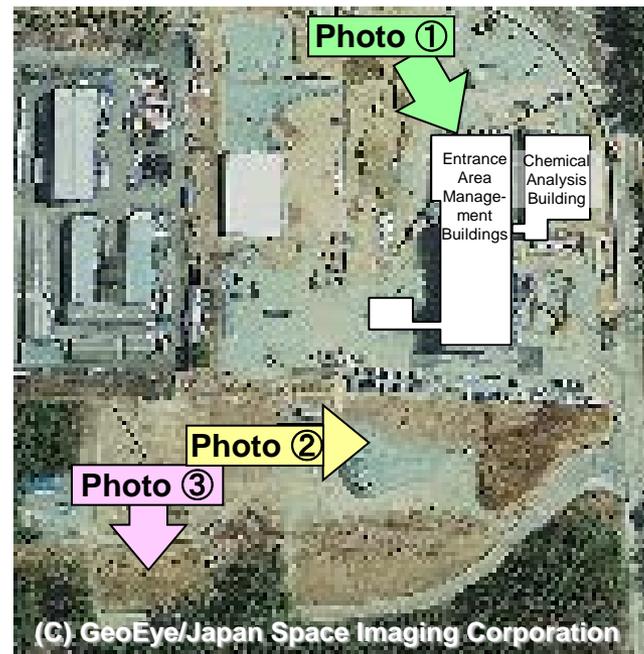
[Before construction]

As of Apr. 16, 2012

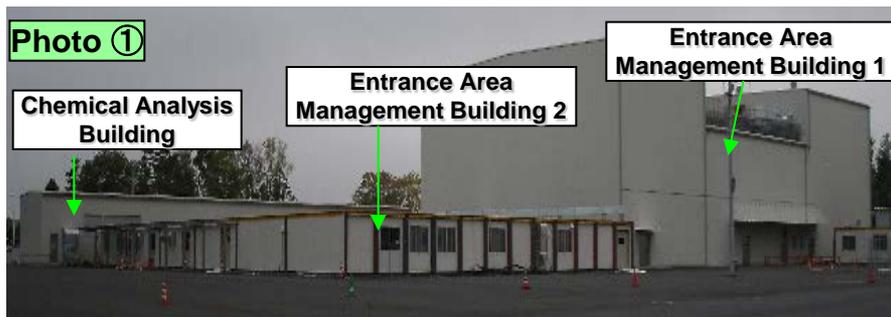
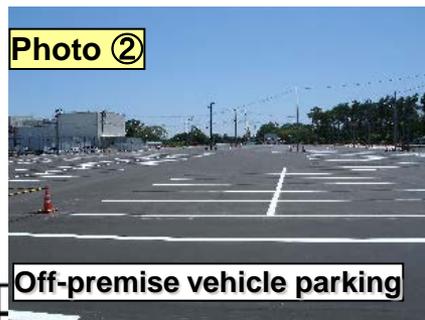
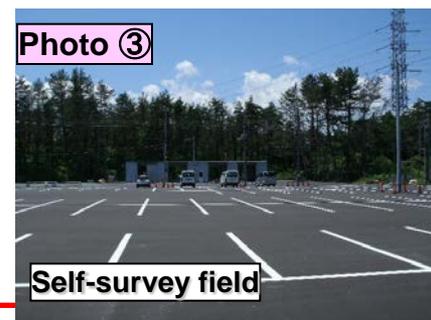
[After construction]

As of May 13, 2013

As of Jun. 27, 2013
