International Workshop on Occupational Radiation  
Protection in Severe Accident Management  
17-18 June 2014, Washington DC, USA

# Radiation Protection Management in Fukushima Daiichi NPS and Post-accident Measures

*Tokyo Electric Power Company,  
Radiation Protection and Management Group  
Shiro TAKAHIRA*

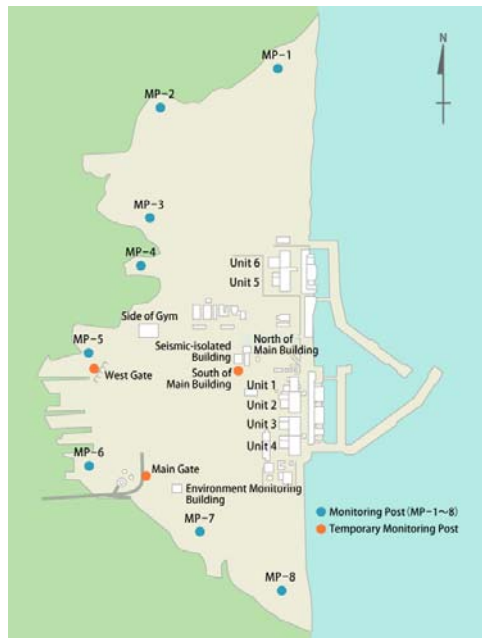
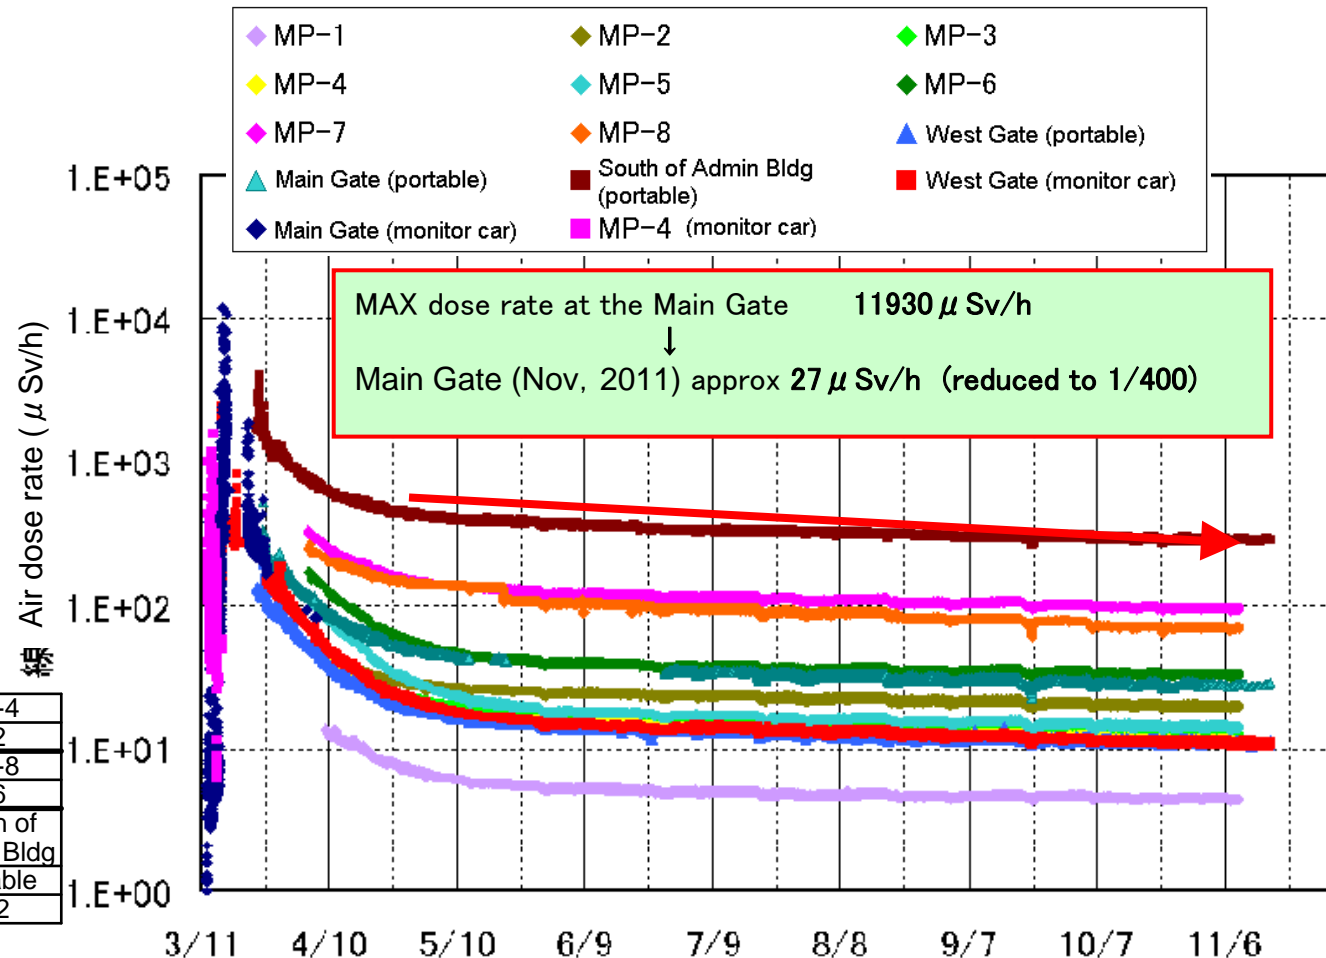
# Dose rate monitoring at Monitoring Post

- The air dose rates at each point were dramatically increased by the accident. After that, indicated steady downward trend and at this moment, at the background level at each point.

MP-1	MP-2	MP-3	MP-4
2.4	4.1	4.6	4.2
MP-5	MP-6	MP-7	MP-8
4.4	1.6	2.3	2.6
West gate		Main gate	South of Admin Bldg
monitor car	Portable	Portable	Portable
2.6	12	4	122

Measurement date: May 6, 2014

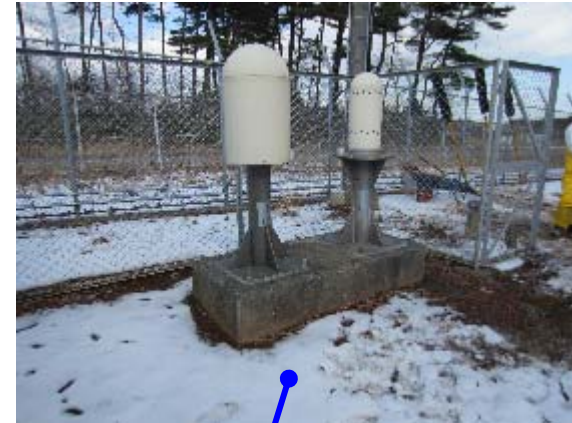
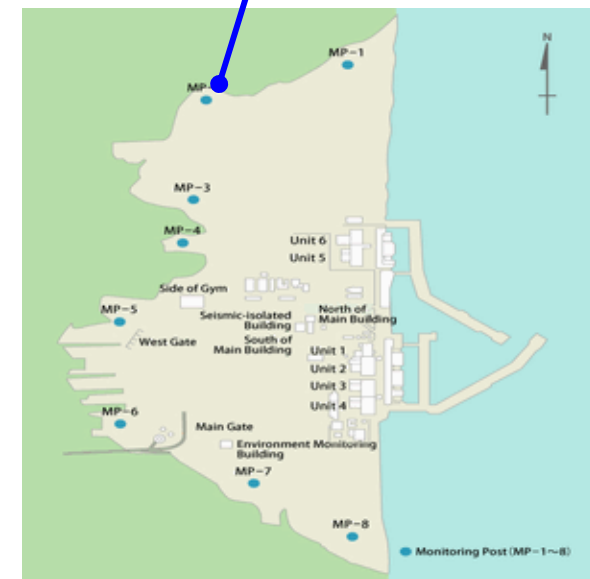
Monitoring post No.2

- There are 8 monitoring posts around 1F site.
- We were monitoring air dose rate continuously.
- We also transmitting monitoring data to the self-governing body and disclosed it on our homepage continuously.

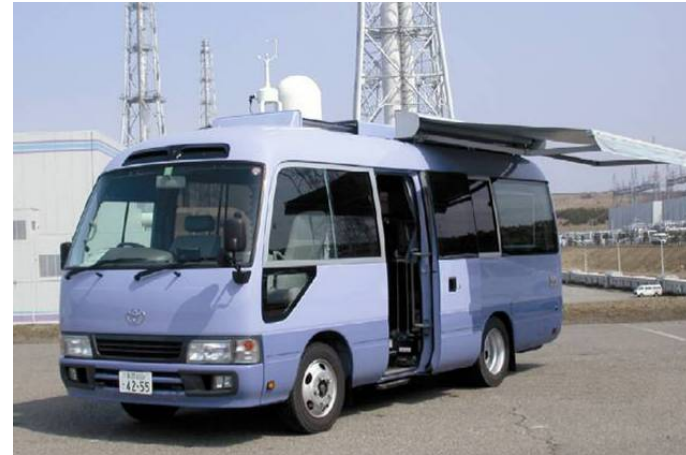
Monitoring car (KK)

- Because of power loss, all monitoring posts became inoperable.(~Apr.8 2011)
- We measured air dose rate by two monitoring cars and three portable monitoring posts.

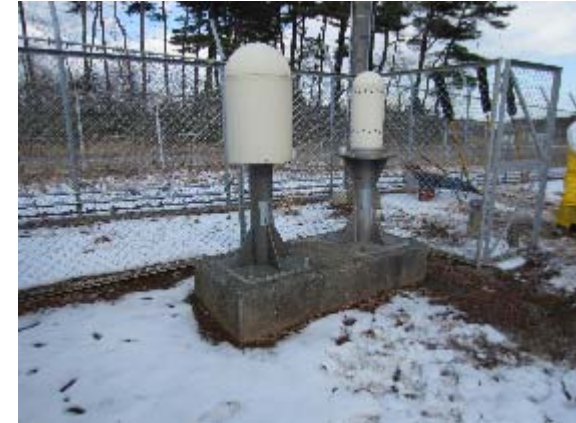
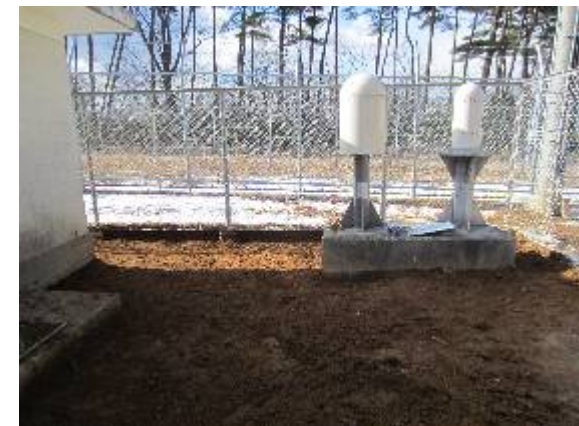
Monitoring post No.2

- Because of fallout, dose rate of monitoring post kept high level.
- We reduced the influence of fallout by surface soil stripping or shielding around monitoring post.

Air dose rate ( $\mu\text{Sv/h}$ )	
	Before (Feb 2012)	After (Apr 2012)
MP-2	18.5	7.9
MP-7	83.6	9.7

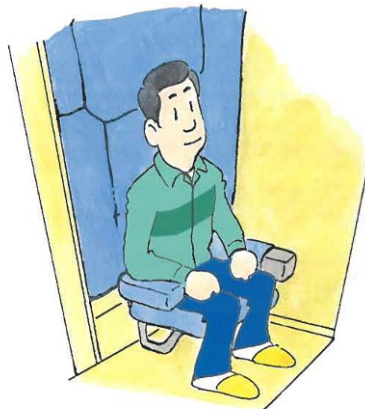
Whole Body Counter (WBC)

Fukushima Daiichi: 4 units  
(1 for spectrometry analyses)  
Fukushima Daini: 4 units  
(1 for spectrometry analyses)

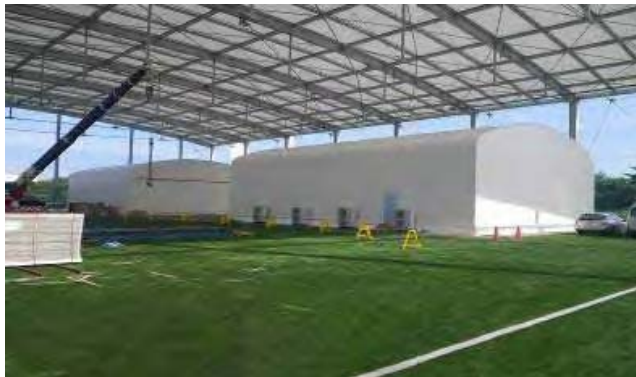
WBC center at Hirono Football Stadium

- 11 WBCs have been operated at Hirono Football Stadium (close to J-village).
- Measuring internal exposure once a month for emergency workers.

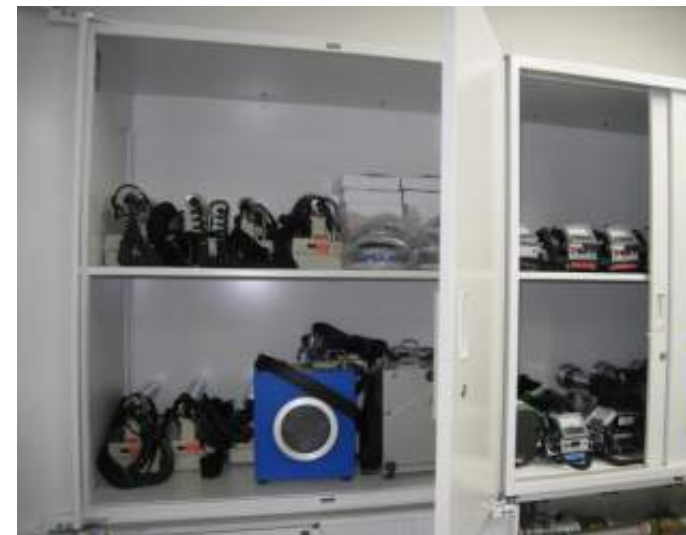
APD 120→500 units

Radiation control materials/equipment

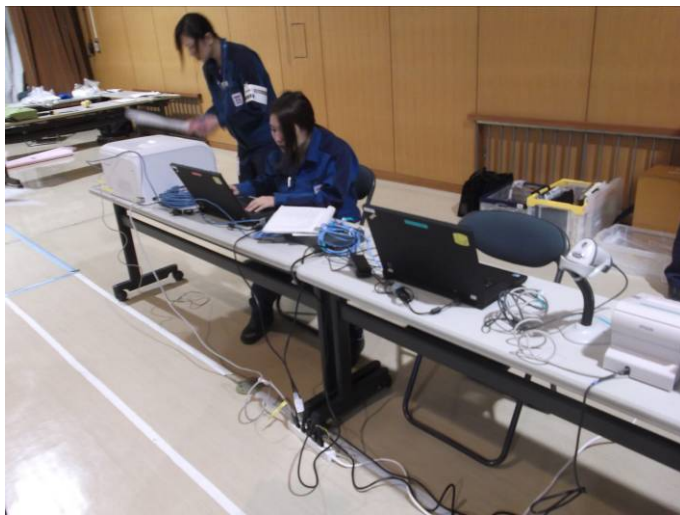
- We determined KK energy hall and Shinanogawa power system office as emergency access control center.
- Members of head office and KK assigned as a establishing staff of emergency access control center .

Training to setup access control area

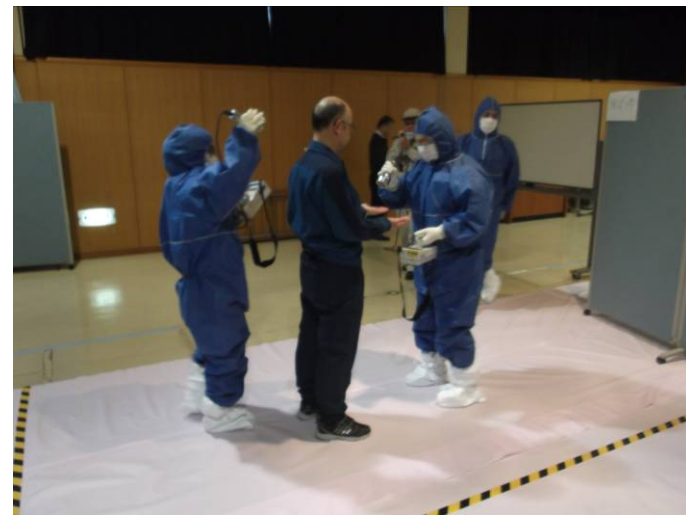
Training of setup screening area

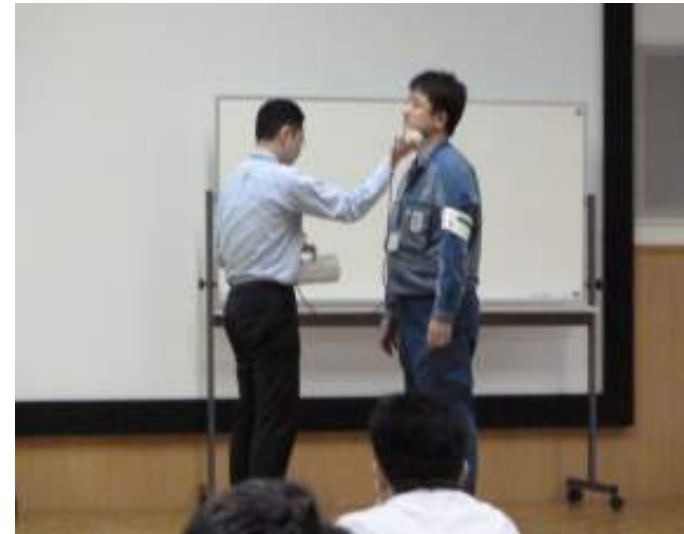
- **Materials used to prevent radioactive substances from flowing into the emergency response room are secured. Staff training has already been made conducted.**
- **Most of employees have undergone radiation measurement training for the entire company.**

Training of radiation measurement

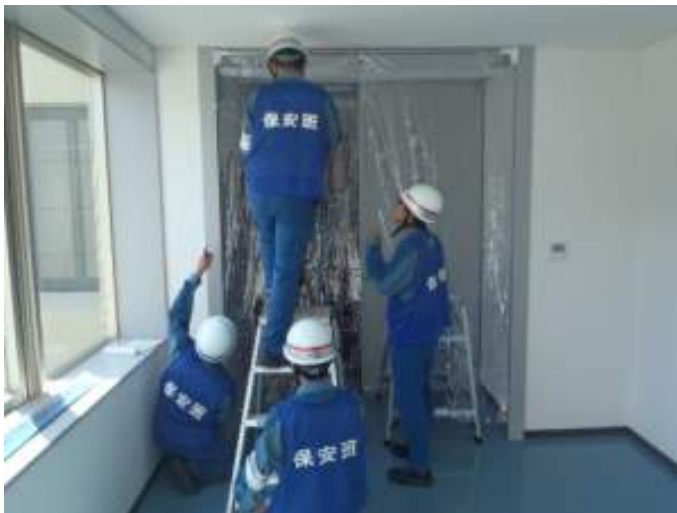
Training to suppress contamination at emergency response room

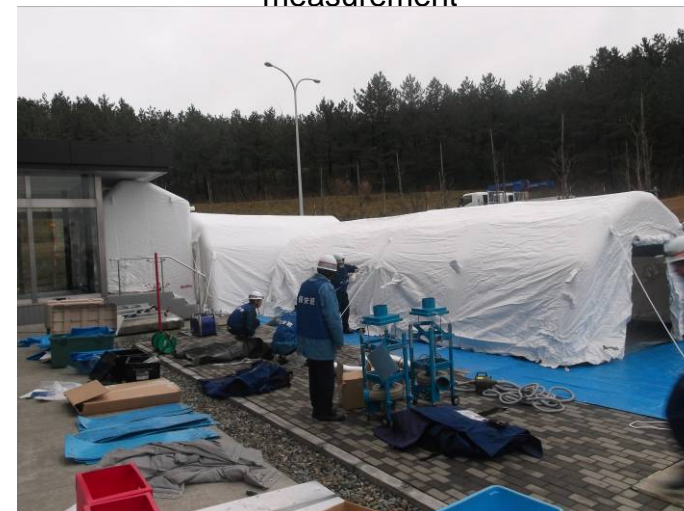
Training to setup screening area at emergency response room
