Ten years at the Fukushima Daiichi Nuclear Power Station, then and now

Tokyo Electric Power Company Holdings, Inc.
Fukushima Daiichi D&D Engineering Company

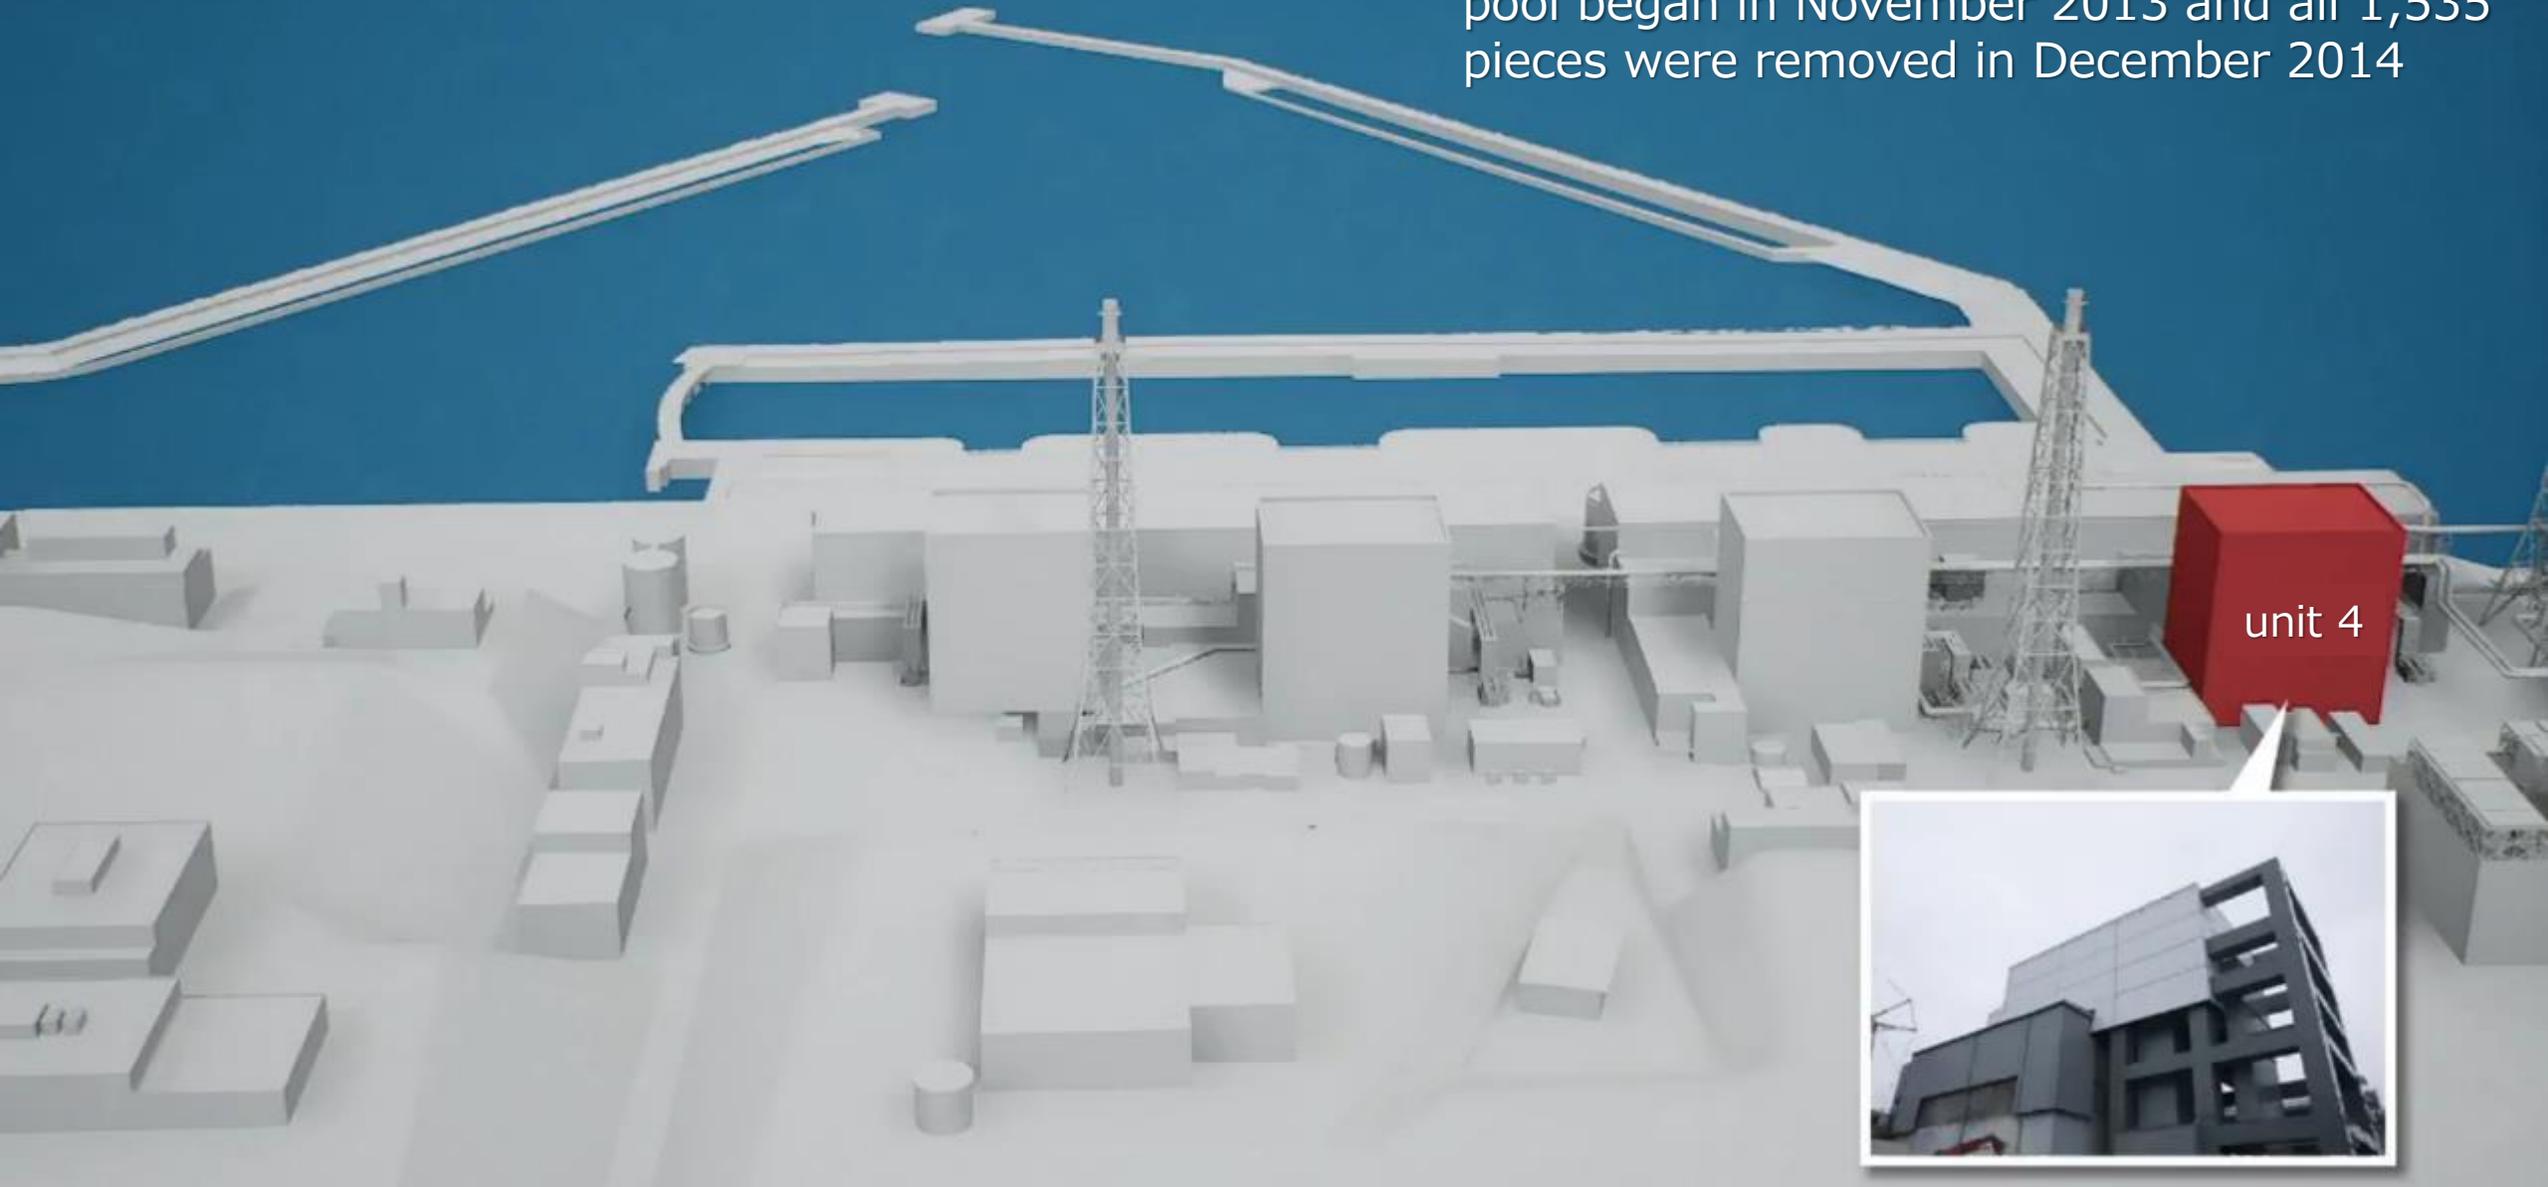
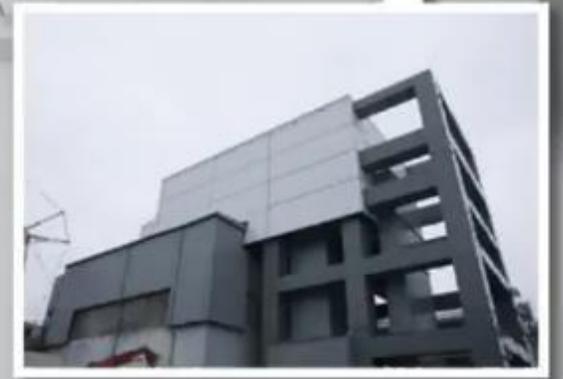
Unit 4

... Completion of nuclear fuel removal

Fuel removal operations from the spent fuel pool began in November 2013 and all 1,535 pieces were removed in December 2014

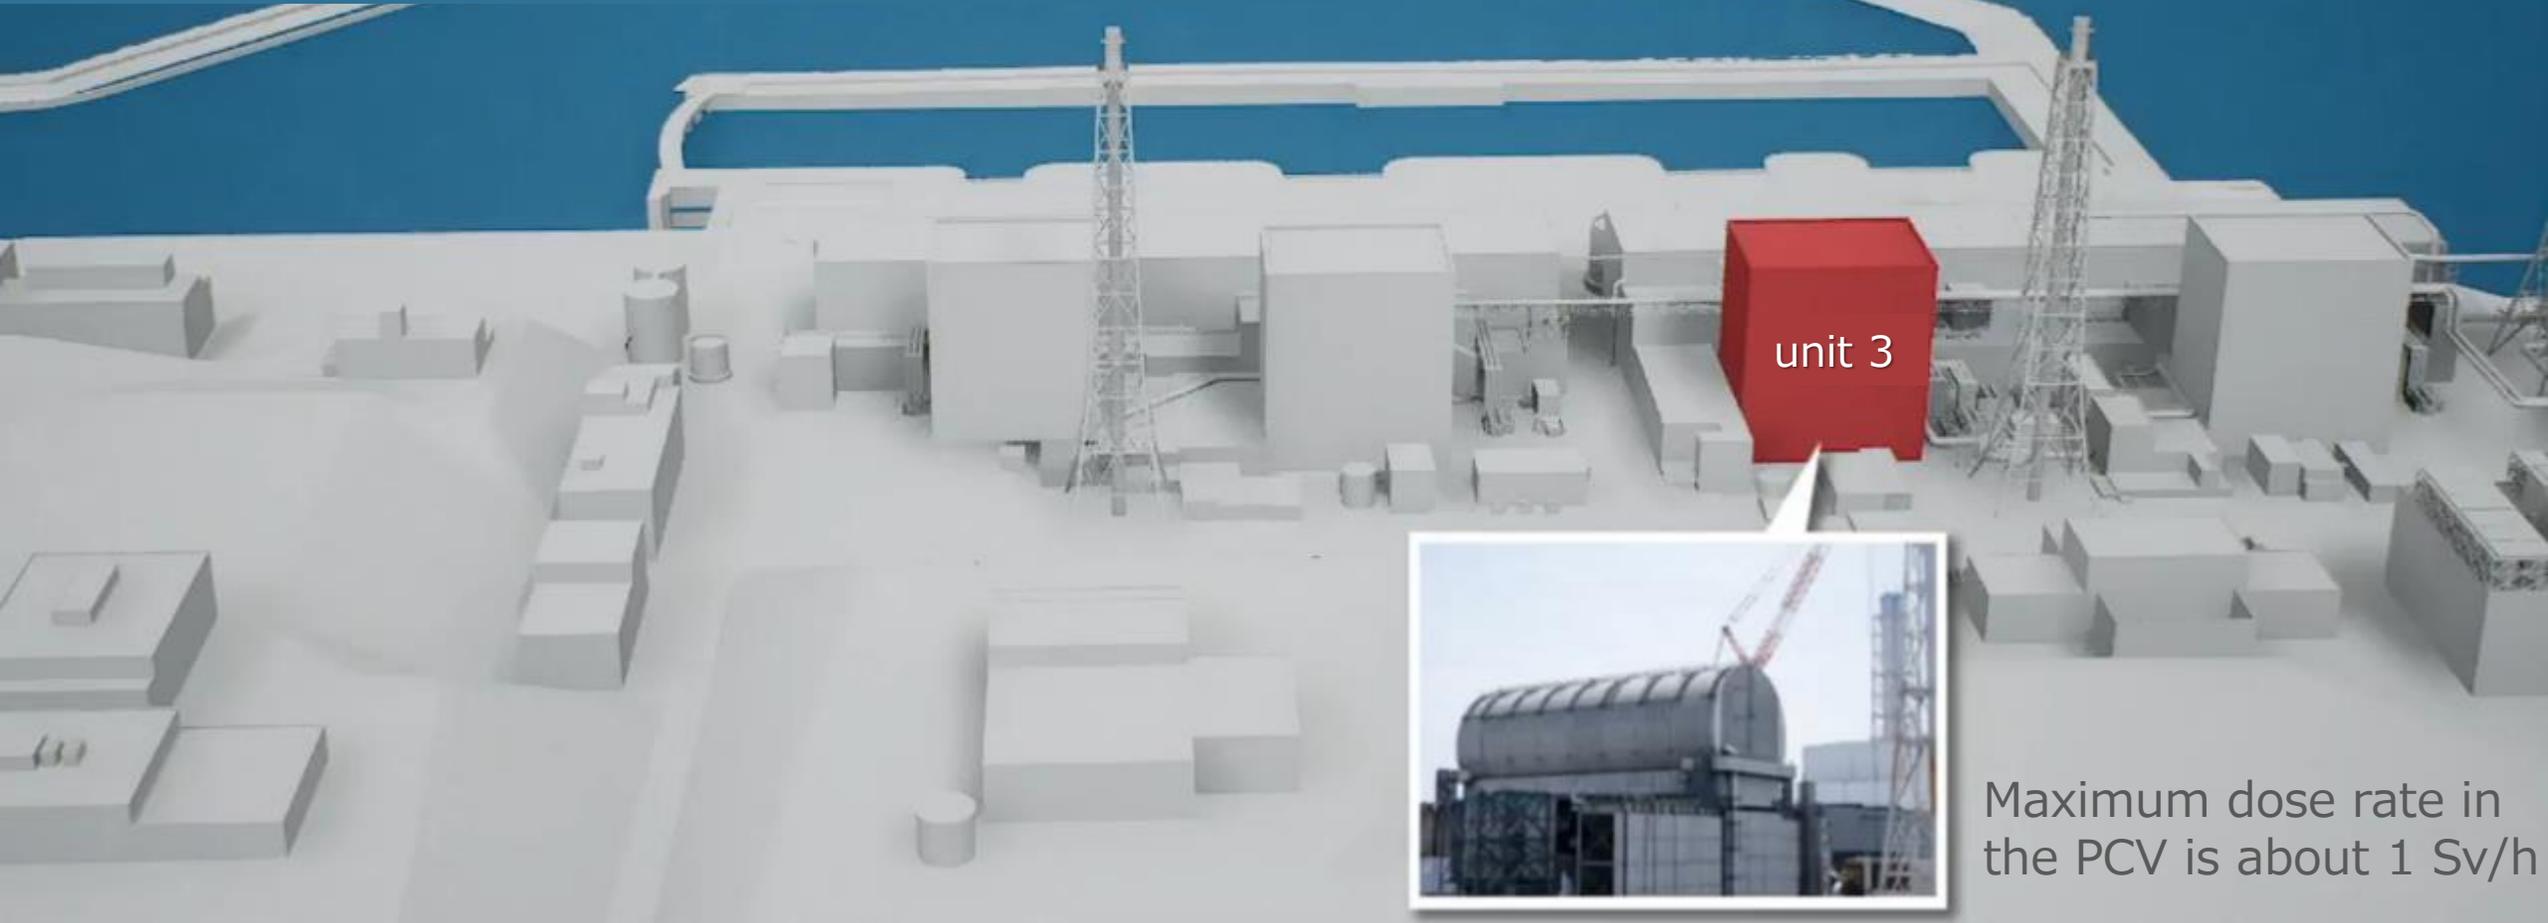
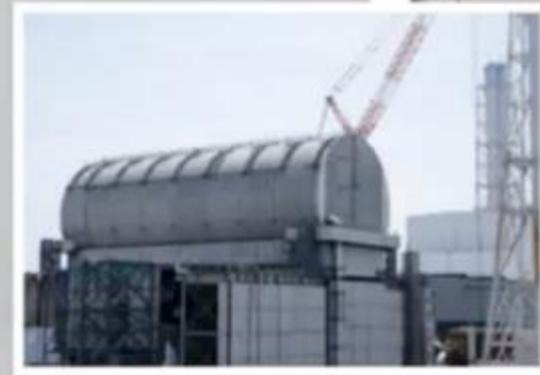
Unit 3

... Completion of nuclear fuel removal

Unit 3, which suffered a hydrogen explosion, completed the removal of debris from the upper part of the reactor building and other work, and the installation of the fuel extraction cover was completed in February 2018. In February 2021, the removal of all 566 pieces of fuel was completed.

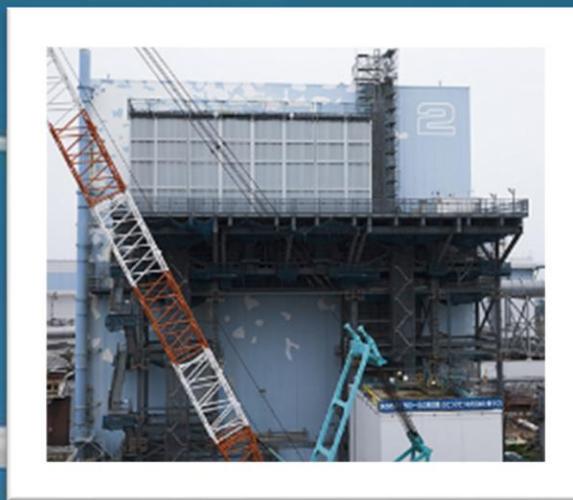
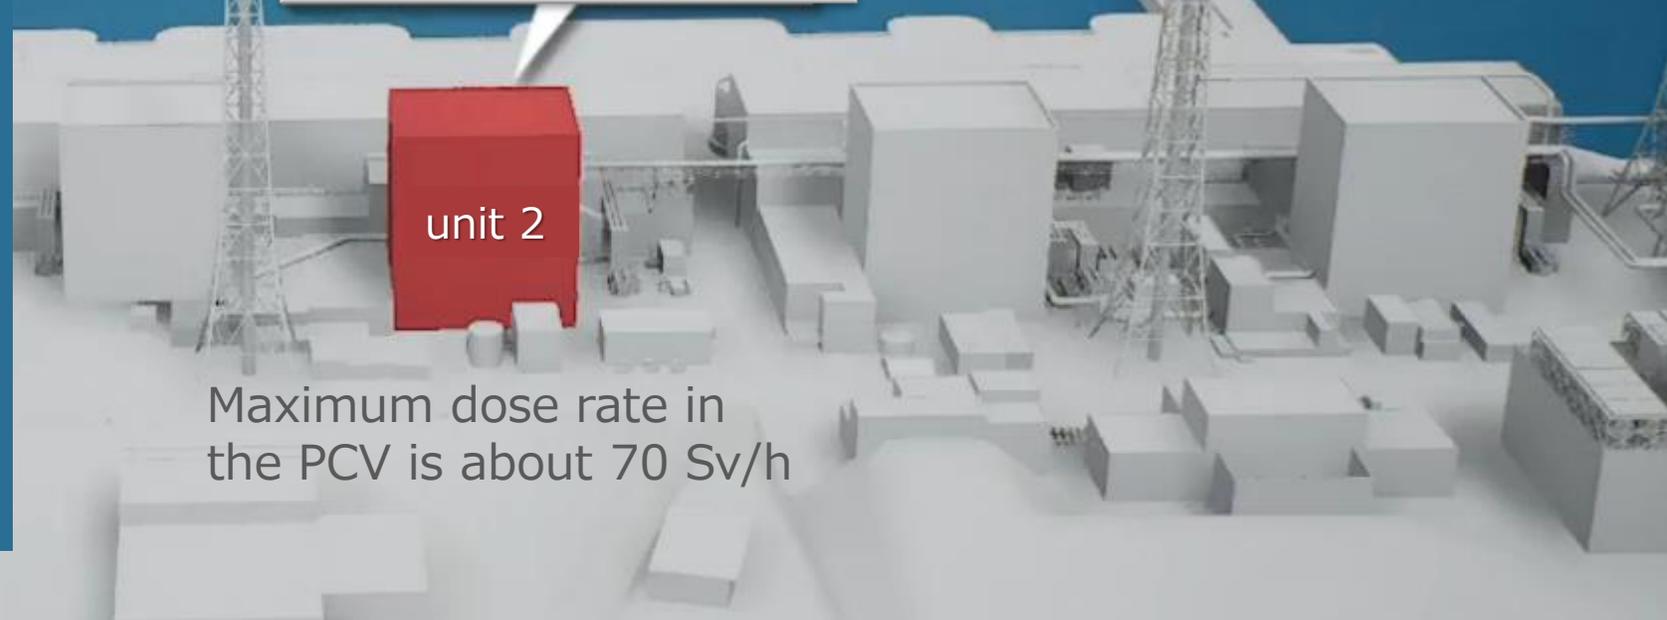
... Under construction of a take-out bunker

Unit 2 did not result in an explosion of the reactor building due to a partial opening of the wall and release of hydrogen. The plan for removing the fuel from the spent fuel pool was reviewed, with the safety of the surrounding area as the first priority, and the upper part of the building dismantled. After the review, a 'fuel removal yard (yard and front room)' will be constructed on the south side of the building for removing the fuel, and the fuel removal equipment will be connected to the building and put into the operating floor, where the fuel will be removed by remote control.

Maximum dose rate in the PCV is about 70 Sv/h

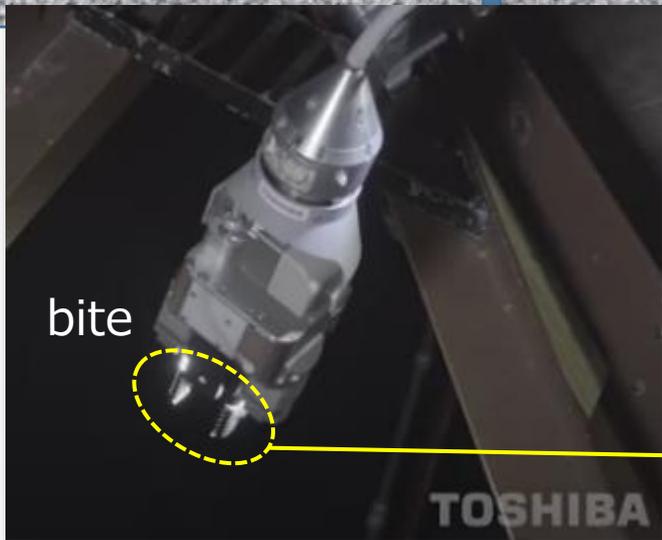
Unit 2

Investigation of deposits inside the reactor containment vessel

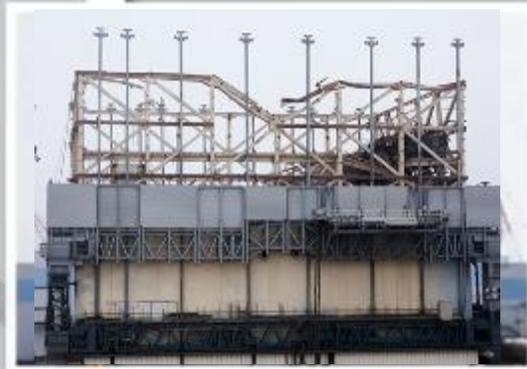
Unit 1

... Under construction to install a large cover

The plan is to cover the entire building with a large cover and remove debris remotely using an overhead crane for debris removal and demolition heavy equipment inside the cover.

After debris removal, the operating floor will be decontaminated and shielded, and equipment for removing fuel (fuel handling machines and cranes) will be installed.

The dose rate in the PCV ranges from 4.1 to 9.7 Sv/h

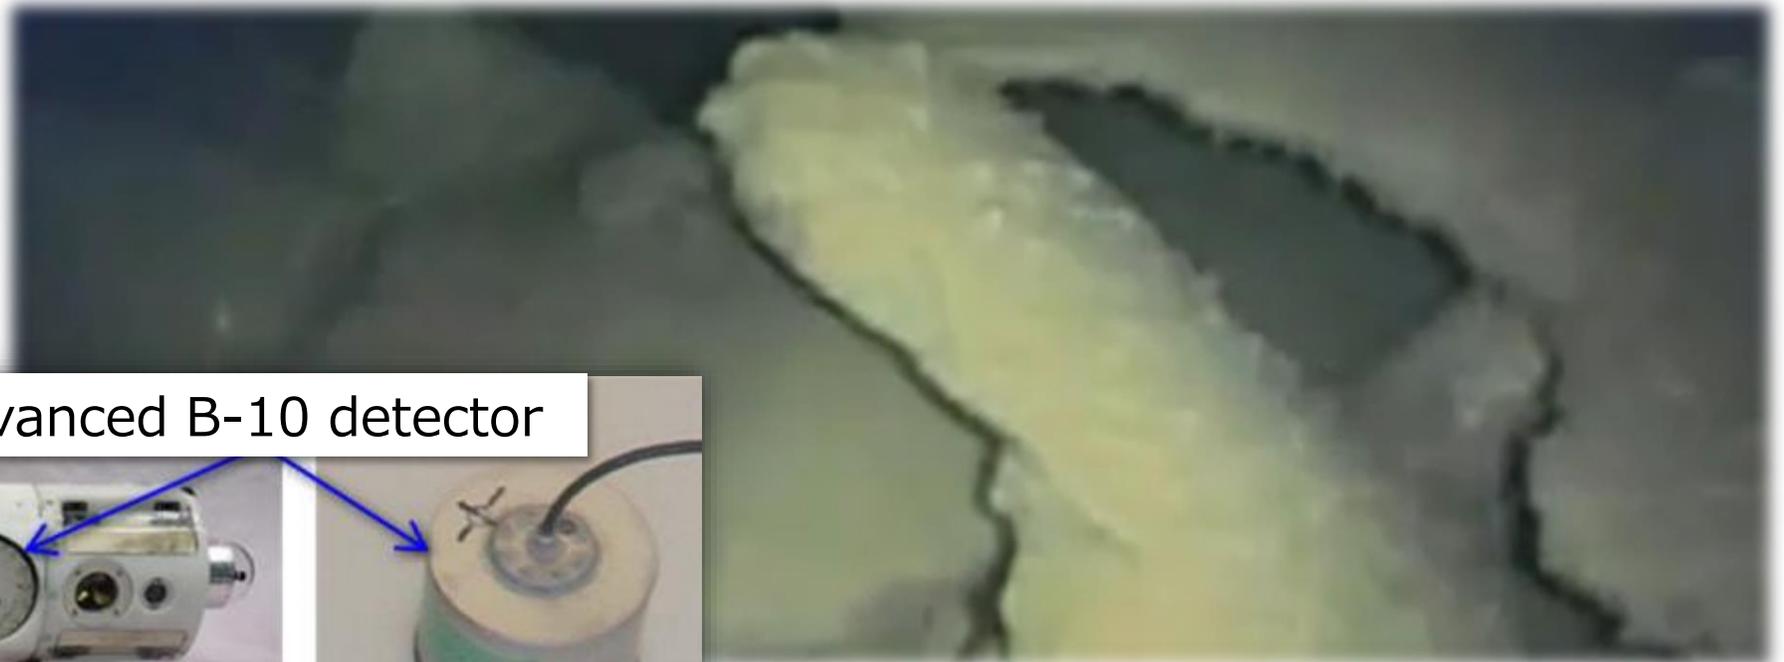
Thermal neutron flux was observed near the pedestal opening at all measurement points (48.0, 29.1, 50.2, 5.8/cm²/sec each).

This result confirms for the first time that the deposit is nuclear fuel debris.

The ROV-D was used for fuel debris detection. It detects the fuel components contained in the deposits by CZT and B10 counter

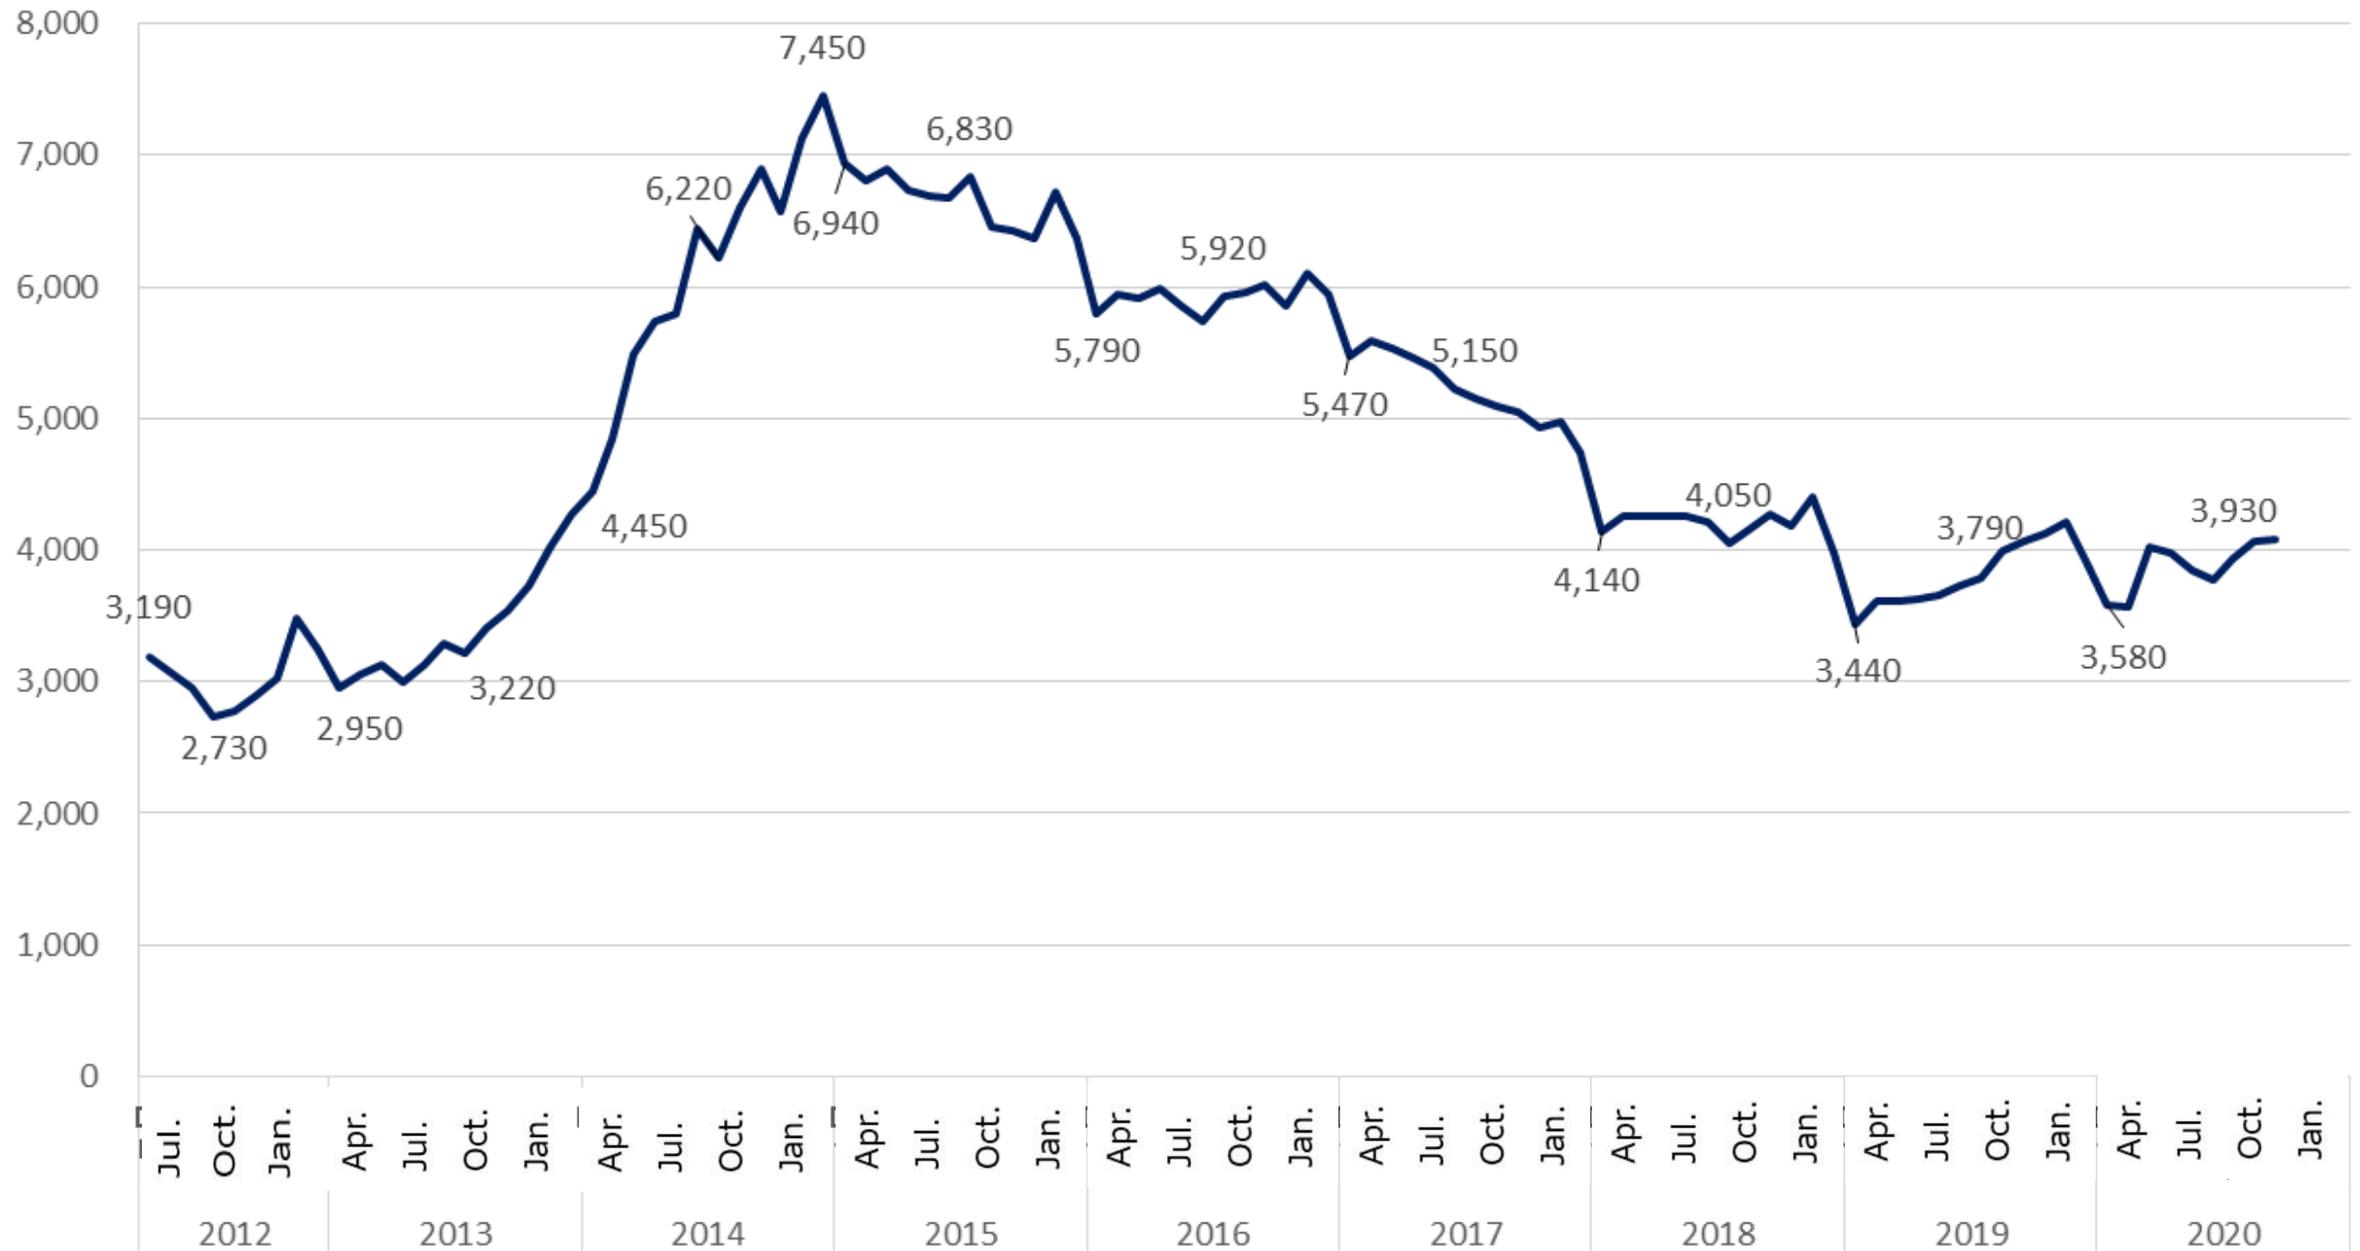
Average number of workers per day
