# Radiation Protection Status in the NPP of Fukushima

2021.06.03 ISOE meeting

Chiyoda Technol Corp.

Tokyo Electric Power Company

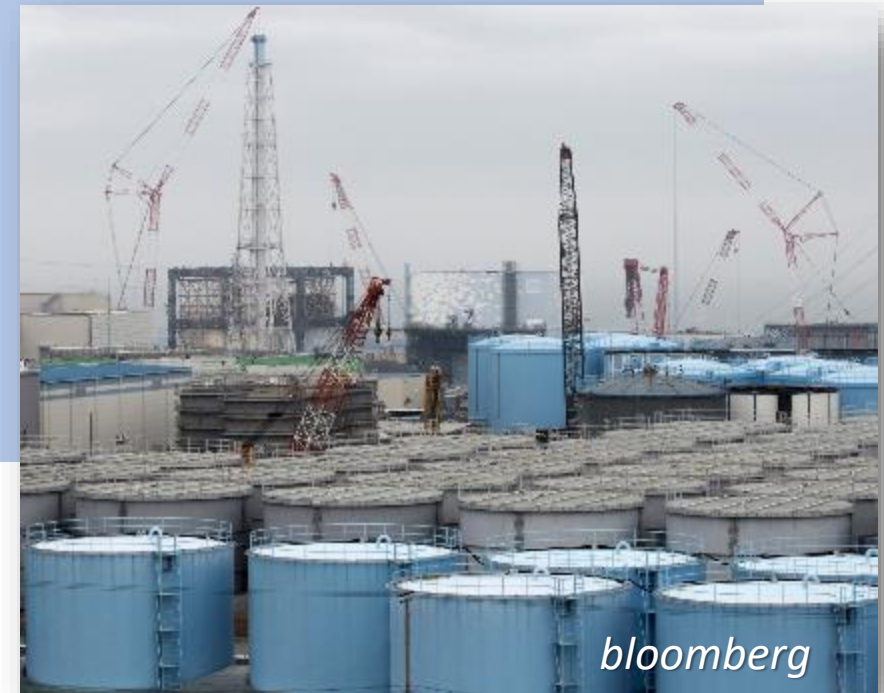
# Contaminated water tanks

- As of April 2021, the number of contaminated water tanks is **1047**
- Volume of water stored in the tanks is approx. 1.25 million m<sup>3</sup>
- Tritium average concentration in the water is approx. 620kBq/L
- Total amount of the Tritium is approx. 780 TBq

- The tritium concentration at the time of discharge into the sea will be determined on the basis of the operational standard for the “groundwater bypass” and the “sub-drain” (**1,500 Bq/L**).  
-regulation:60 kBq/L-

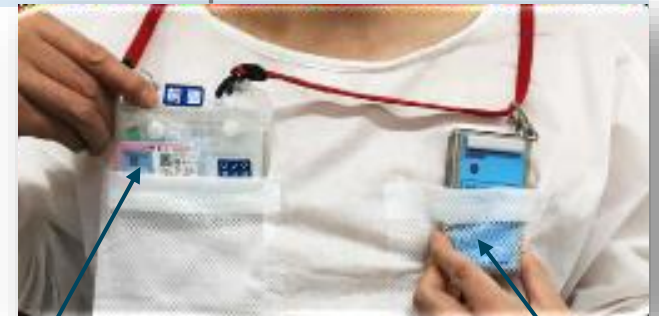
Wearing both active & passive dosimeter

RPL Dosimeter  
“Glass Badge” as **legal dosimeter**  
( $\gamma$  &  $\beta$ )

Electric  
Personal Dosimeter  
( $\gamma$  &  $\beta$ )

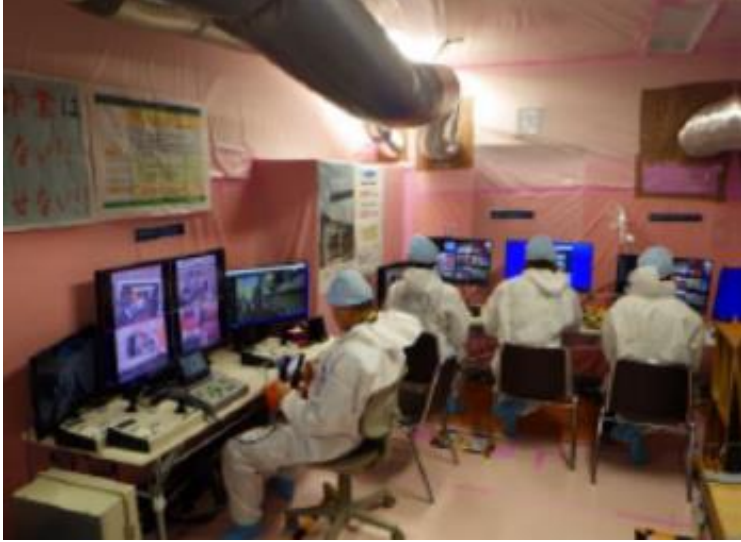
## Unmanned and remote operation to reduce exposure

The 600t crane, suction equipment and unmanned backhoe were **remotely operated** in low dose areas to reduce exposure.

approx. **3.8mSv/h** (T/B rooftop)

approx. **6.0μSv/h** (in the remote control room)

approx. **7.6 man·Sv**

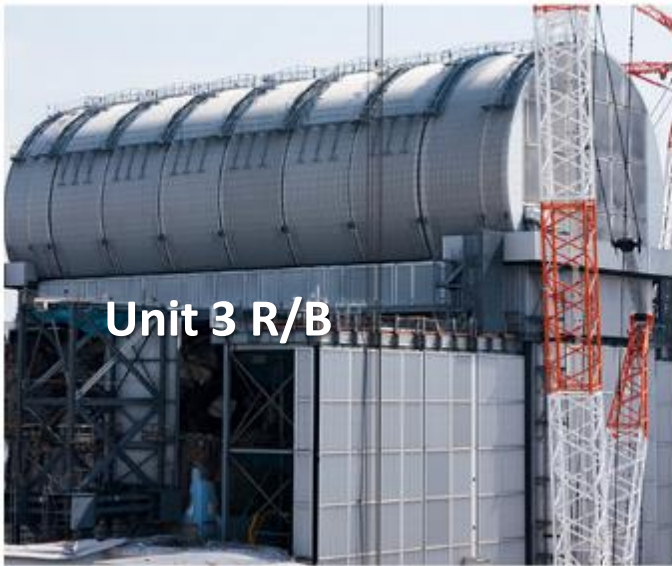
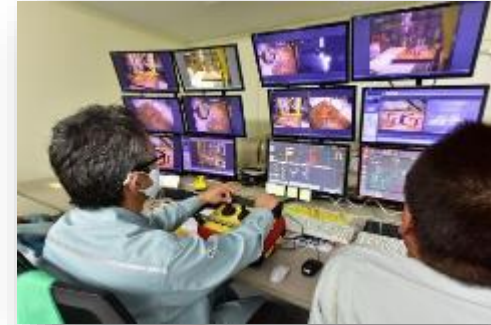
# Status of fuel removal from the spent fuel pool

On **Feb.28/2021**, the last six spent fuel were removed from the transport container into the common spent fuel pool

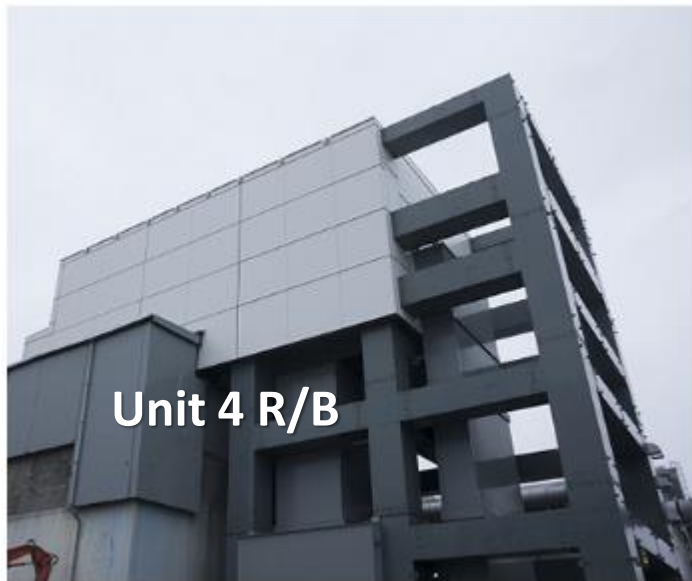
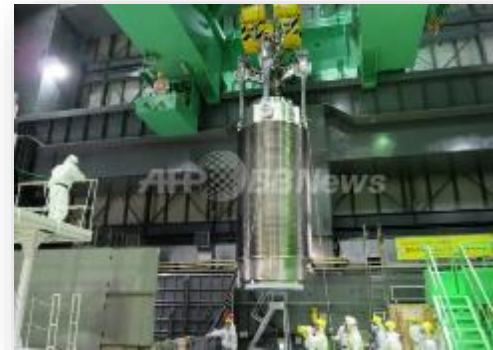
On **Dec.22/2014**, spent fuel was removed from the SFP of Unit 4, which had suffered a hydrogen explosion as a result of hydrogen backflow from a shared stack with Unit 3, despite the reactor being shut down

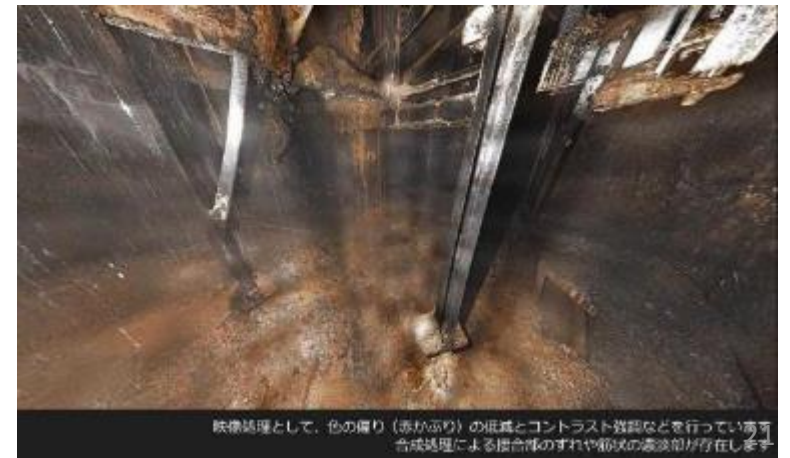
# Fuel debris removal will start from Unit 2...

- Unit 2 is more airtight and more capable of trapping radioactive material than Units 1 and 3, which suffered hydrogen explosions that destroyed parts of their buildings.  
Preventing the spread of radioactive dust is the top priority
- The work environment on the ground floor of the R/B of Unit 2 has been improved and the dose rate level is lower at 5 mSv/h compared to Unit 1 (approx. 600mSv/h) and Unit 3 (10mSv/h)
- In Unit 2, the internal investigation of the PCV is in progress and we have the most information on the access routes to the fuel debris and the status of the fuel debris
